Collapse of permafrost and failure of bridges in the community of Pangnirtung, Nunavut

Entzu Hsieh, P. Eng.,
AMEC Earth & Environmental, Calgary, Alberta
Alexandre Tchekhovski, Ph. D. P. Eng.,
AMEC Earth & Environmental, Calgary, Alberta
Ron Mongeau, Senior Administrative Officer
Community of Pangnirtung, Nunavut

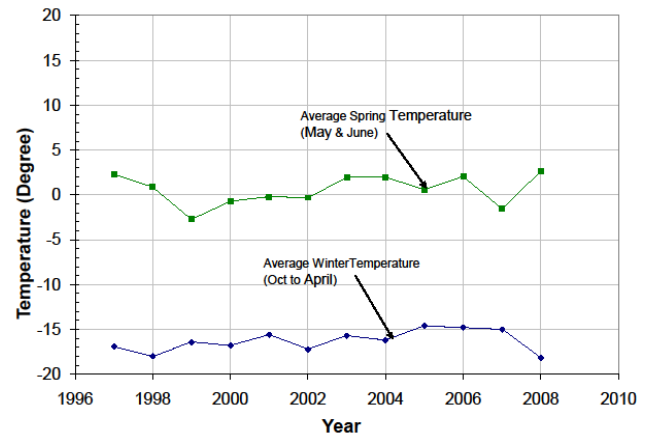
Figure 2: Mean Winter and Spring Air Temperature

The mean winter (October through April) and spring (May and June) air temperatures were also calculated from 1996 to 2008. Figure 2 presents the results of calculations. It can be seen that the 2007/2008 winter and 2008 spring had extremely cold (-18 °C) and extremely warm (2.5 °C) air temperatures, respectively.

The air temperatures in the 2007/2008 winter period and in May/June 2008 spring period formed favourable conditions for accumulating considerable amount of water in the Duval River valley. Figure 2 shows that the mean air temperature for the 2007/2008 winter season was about -18°C , while the average winter temperature between 1996 and 2008 was calculated to be -16.3°C . On the contrary, the mean air temperature for May and June 2008 was about 3°C , which is the warmest temperature between 1996 and 2008. The anomalous winter and spring temperatures would to some extent intensify the impact of the rainstorm and exacerbate the consequence of the surface flooding. It is because the extremely cold 2007/2008 winter might result in freezing to a full depth of the river channel and formation of an ice berm at some distance upstream from the community. In spring time of 2008, ice berm and ponding water were observed at a distance of a few kilometres from the community. Any cracks occurred in the ice berm would cause considerable amount of water flowing through the berm and flooding the river valley.

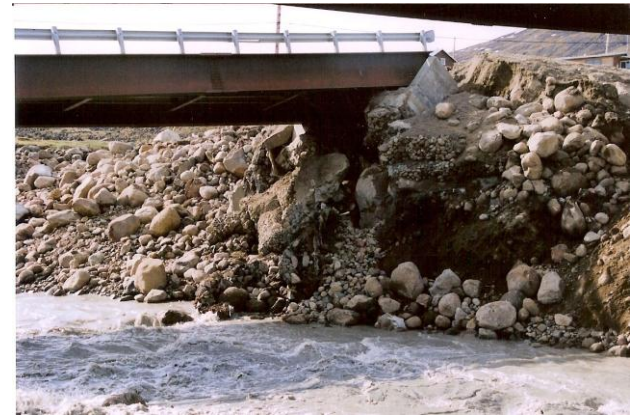
Photograph 3: Failure of South Abutment

The upstream bridge experienced the most severe damage. Photograph 3 shows that failure of the abutment on the south bank of the river resulted in significant tilting of the bridge substructure. Two major cracks and significant displacement developed in the approach embankment behind the north abutment as well as failure of north bank occurred, resulting in considerable settling of the bridge steel structure (Photograph 4 and 5)

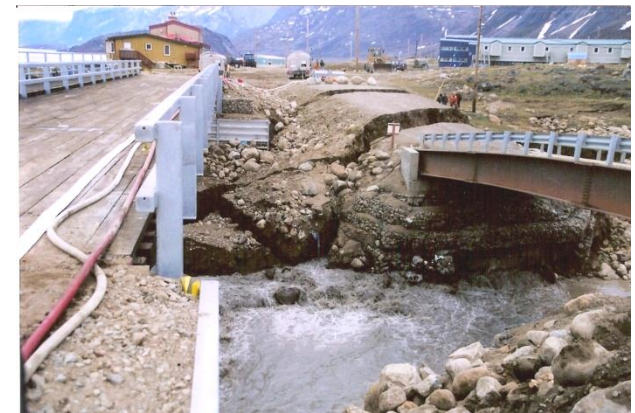
Photograph 4: Failure of North Approach Fill

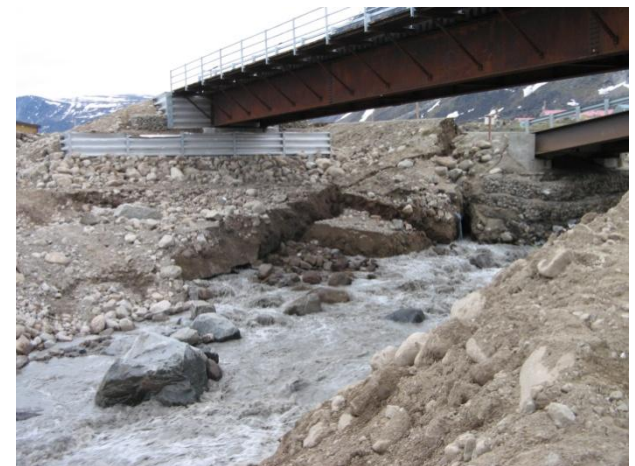
Photograph 5: Failure of North Bank

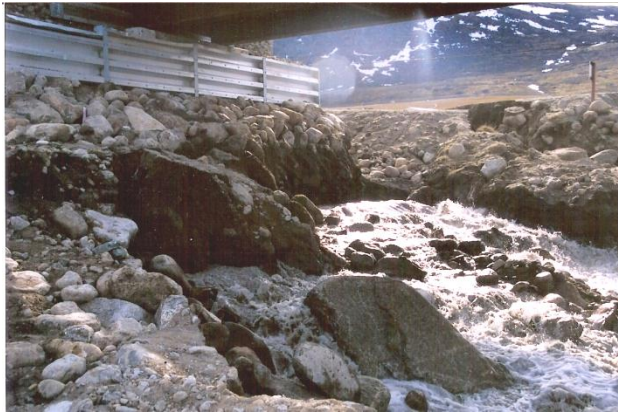
In general, abutment foundation soils were in an unfrozen state during the reconnaissance, and water was flowing out underside of the bridge abutments (Photograph 6), resulting in significant ground loss and lateral/vertical movements of the bridge substructures.

Photograph 6: Water Flowing Underside of Bridge Foundation
