Soil Cracks related to land subsidence. The main geotechnical hazard affecting to constructions in Aguascalientes City, México.

2011 Pan-Am CGS
Geotechnical Conference

J. Pacheco-Martínez, M.E. Zermeño-De-León & J. A. Ortiz-Lozano
CCDC de la UAA, Aguascalientes, México
A. Solís-Pinto
CGeA-Consultores en Geociencias Aplicadas S.C., Aguascalientes, México
Miguel A. Romero-Navarro
MARN-Servicios en Geotecnia, Aguascalientes, México
Francisco Aguilar-Valdez
CITIA-Ciencia de la Tierra Asesores, Aguascalientes, México
Juan A. López-Fuentes
GEO-Geofísica y Geotecnia Aplicada, Aguascalientes, México

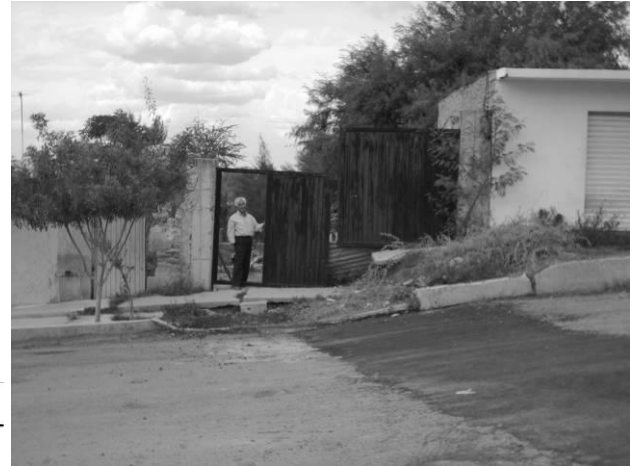
In the figure 3 it is shown an example of soil crack and the differential sinking between the two generated blocks.

Figure 3. Ramp developed by a soil crack at the northwest of the City of Aguascalientes. The vertical displacement of the blocks generated by the rupture is evidenced by the gate.

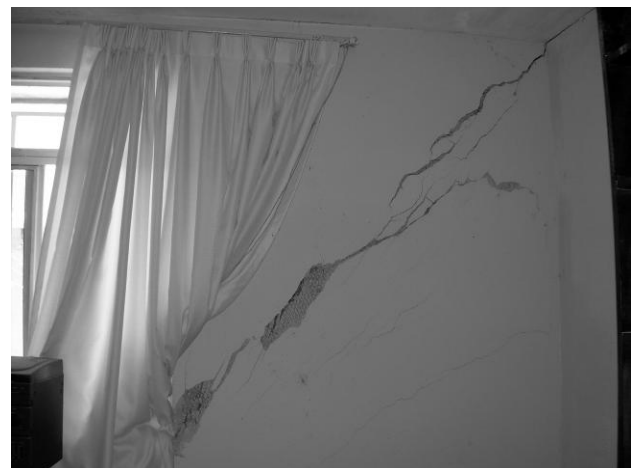
Figure 5. Diagonal cracks in a bearing wall due to diagonal tension.

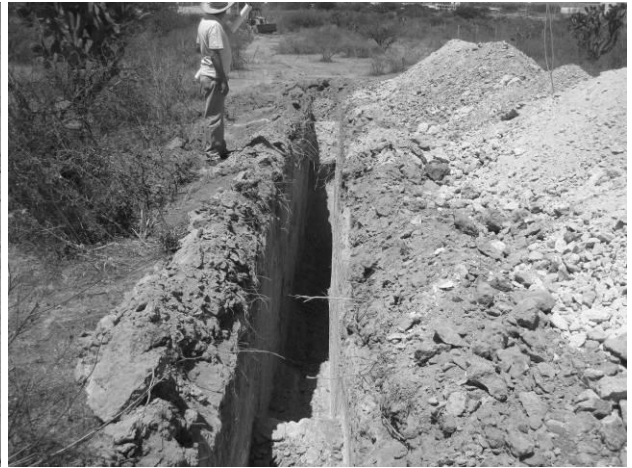
Figure 17. Excavated trench for carrying out a direct exploration in the stretch where the interpretation of the anomalies of resistivity presents ambiguities.

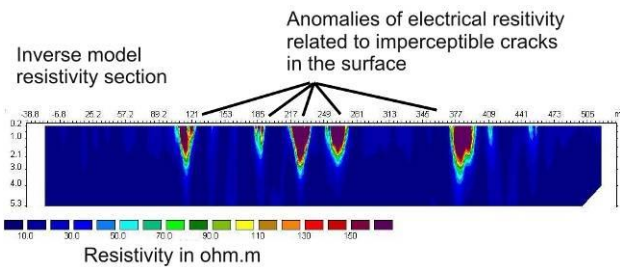
In order to detect the cracks at this stage of formation, the measurement of electrical resistivity profiles of the subsoil have been carried out. The fractured zones in propitious conditions (homogeneous stratigraphy and undisturbed soil) appear like anomalies of high resistivity and then they are easy to find (Figure 16). However, in unfavorable conditions, such as a subsoil with a complex stratigraphy, deposits of anthropogenic fillings, or in zones with lateral moisture variations, the interpretation presents some ambiguities. In these last cases, the excavation of trenches helps to eliminate the doubts. Therefore by doing a direct exploration in the stretch along the profile where the anomalies are observed helps to distinguish and corroborate the presence of a crack on the subsoil (Figure 17).

Figure 16. Electrical resistivity profile used for detection of imperceptible soil cracks
