# Shallow slump stabilization using percussion soil nails at Hamelin creek site on Highway 725:02, Peace Region, AB

Renato Clementino, Robin Tweedie, & Harjeet Panesar  
*Thurber Engineering Ltd., Edmonton, Alberta, Canada*  
Roger Skirrow  
*Alberta Transportation, Edmonton, Alberta, Canada*

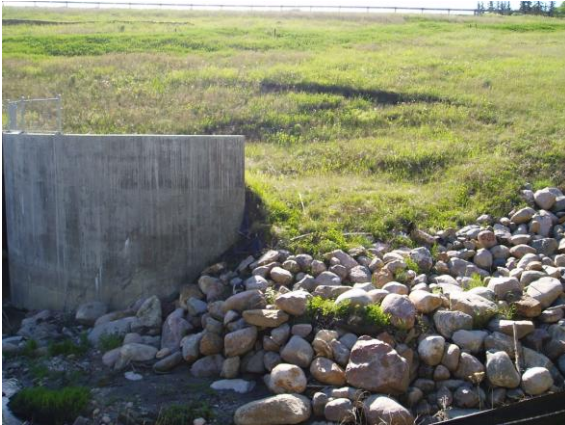
Since the culvert completion, the streambed has degraded 3 m upstream of the culvert inlet as far as 250 m upstream from the culvert inlet. The previous culverts acted as an artificial geomorphological control feature and the culvert invert was lowered intentionally to permit the natural creek bed degradation to continue upstream. However, as an unintentional outcome of this rapid down cutting, two shallow slumps have occurred at the toe of the embankment adjacent to the culvert. These slumps have retrogressed and have raised concerns that they could further destabilize the larger northwest deep seated slide, and thereby increase the rate of deep seated movement and cause more structural distress to the culvert. In addition, the slumped mass had encroached into the creek and was partially blocking the creek flow as shown in Figure 1.

Figure 1. General view of the south slump.

there was concern that excavating at the toe could further destabilize the deep seated landslide. As a result, the approach adopted to remediate these shallow slumps was to use 6 m long by 38 mm diameter steel rods, or 'soil nails' to reinforce the slump mass and improve the local stability. This would also enable removing the slump debris that was partially blocking the creek.

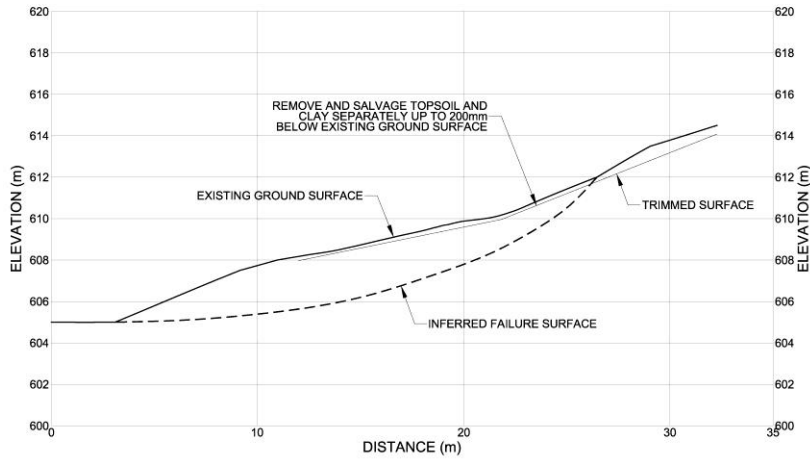
Figure 2 shows the original ground condition after the slump as well as the interpreted slide plane. Based on the slump topography, the depth of slumping was estimated to range from about 2.5 m to 4 m deep. Therefore a 6 m long soil nail was considered long enough to penetrate beyond the failure surface and provide some improvement to the shear strength.

Figure 2. Original ground surface after slump.

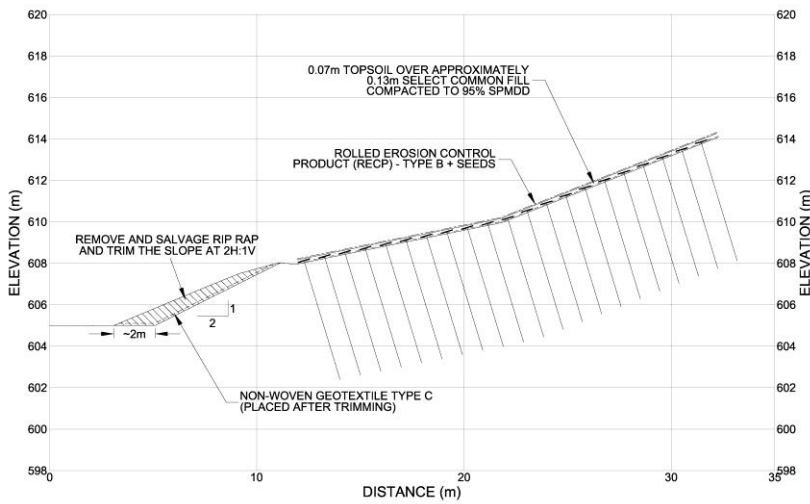
Figure 3. Phase one of percussion soil nails installation.

As noted previously the slumped mass had spilled over the creek banks partially blocking the channel. The creek channel needed to be re-established which required the excavation of the slumped toe material, thereby reducing the local slope stability. To reduce the potential impacts on stability, the percussion soil nails were installed in two phases. The first phase consisted on the reinforcement of the upper section of the slump to improve the overall stability and allow the excavation of the toe of the slump to re-establish the creek channel. The second phase consisted of the nailing of the trimmed toe and replacement of the erosion protection riprap.

Figures 3 and 4 provide an overview of the design cross-sections for the Phase 1 and 2 soil nails installation.

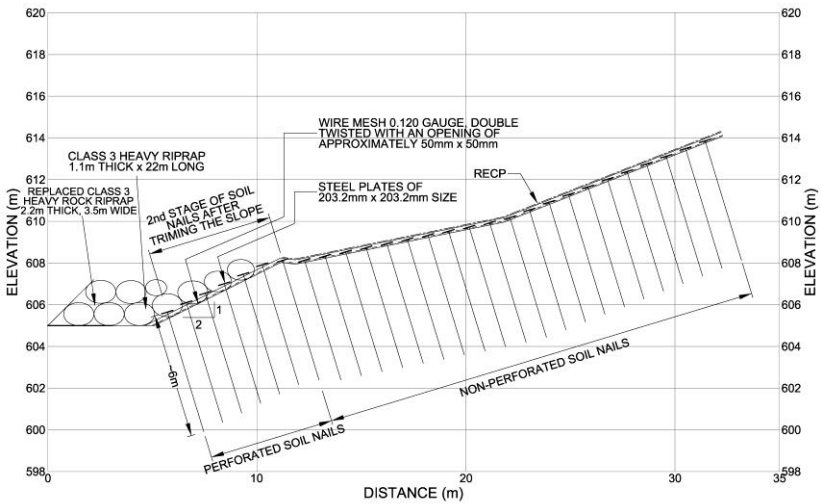
Figure 4. Phase two of percussion soil nails installation.

To improve groundwater drainage, the nails installed during the second phase at the toe of the slump were supplied perforated to aid in the dissipation of excess pore water pressure from the slope.

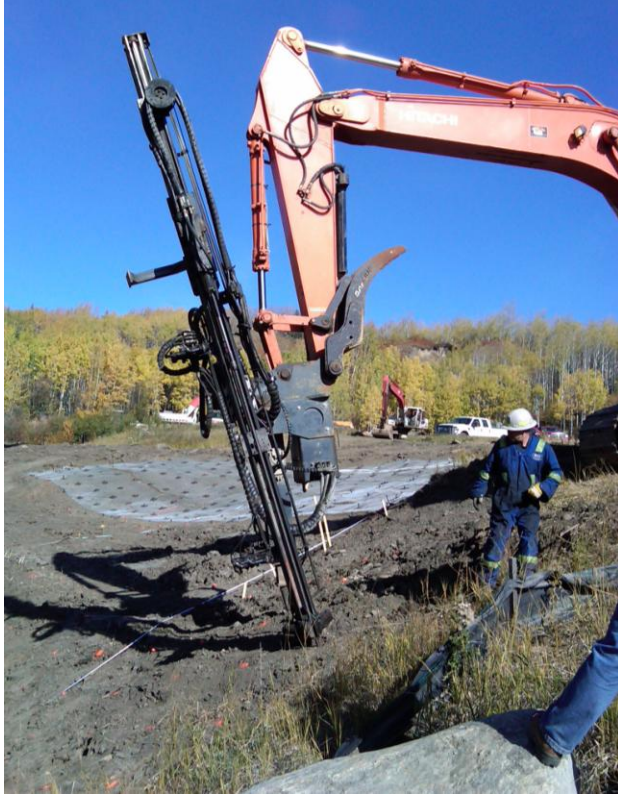
Figure 5. Percussion soil nail installation equipment.

The percussion soil nails were installed by Beck Drilling Environmental Services Ltd. of Calgary, Alberta. The nails were installed using a track mounted excavation equipped with a rotary percussion drill that installed the nails by simultaneously rotating and hammering the nails into the ground as shown in Figure 5.

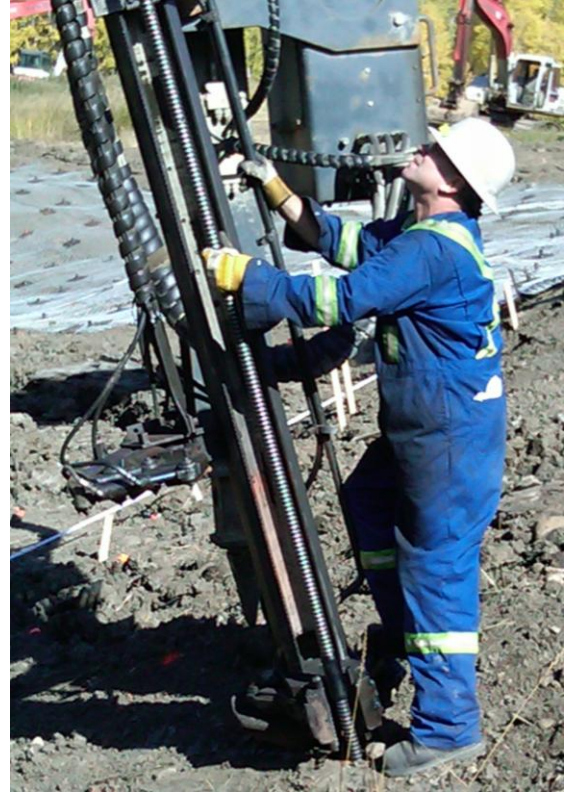
Figure 6. Splicing the second 3 m segment of the nail.

During the nail installation it was noted that nail coupling was creating a slightly oversized hole, raising some concerns about the adhesion between soil and nail on the trailing second half of the nail.

The soil nails consisted of threaded hollow steel bars (R38N) 38 mm outside diameter and 22 mm inside diameter with 250 MPa yield strength and axial capacity of approximately 500 kN. The bars came in 3 m lengths which were spliced with a 52 mm outside diameter threaded coupler to form the 6 m long nail as shown in Figure 6.

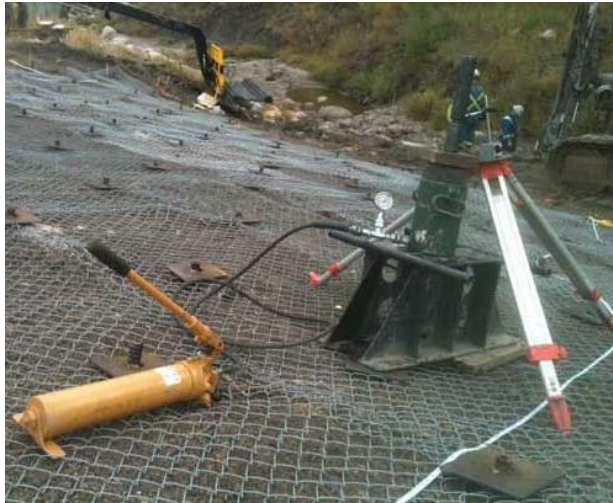
Figure 7. Soil nail pullout test setup

A hollow centre hydraulic jack (530 kN) was placed on a steel reaction beam as shown in Figure 7. The soil nail displacement was measured using a dial gauge (0.01 mm per division) placed on a 25 mm thick steel plate installed at the end of the jack.

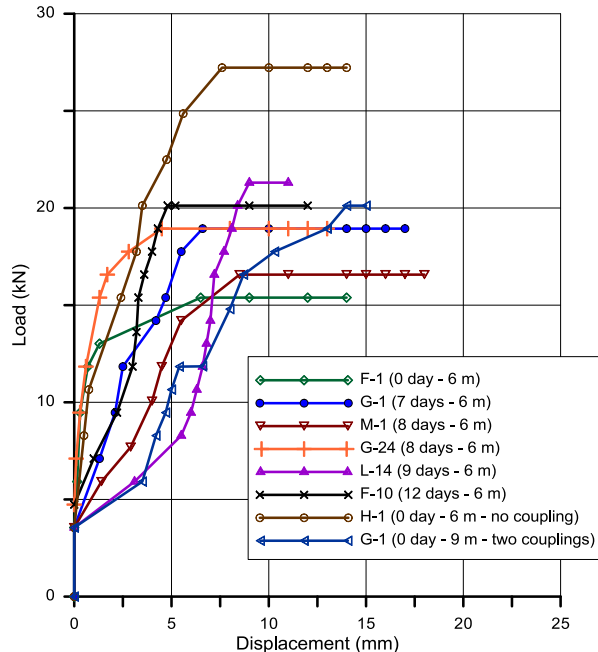
Figure 8 shows the load versus displacement plot for all soil nail pullout tests.

Figure 8. Soil nail pullout test - load versus displacement

The pullout test results indicate that the hole oversize caused by the coupling affected the nail's pullout capacity. Comparison of Nail F-1 and Nail H-1, both installed and tested on the same day, indicated a shaft pullout capacity of 15.4 kN for F-1 with coupling, versus 27.2 kN for H-1 without coupling (i.e. welded nail sections). This represents an increase of 77 % between nail with and without coupling.

Nail G-1 length was increased to 9 m (two coupling) and re-drove into the ground after being first tested with the original 6 m length. The capacity of the 9 m long nail was 20.1 kN, which was about 33 % greater than the equivalent 6 m long coupled nail (F-1 at 15.4 kN at day 0). However, the pullout capacity for the 9 m long coupled nail was still 26 % less the capacity of the 6 m long nailed H-1 that was installed without coupling. This result

supports the conclusion that the oversize coupling affected the nail pull-out capacity.

If required, the skin friction of percussion soil nail could be improved the installing the nails using an oversize bit to create an open annulus around the nail then grouting the nail through the hollow bar and filling the annulus with grout.

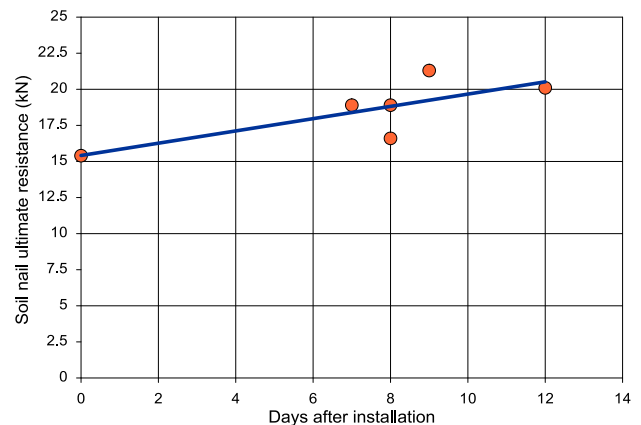
Figure 9 shows the soil nails ultimate pullout resistance versus age after installation time for the specified nail design (i.e. the six first nails in Table 1 which were 6 m length with one coupling).

Figure 9. Soil nail capacity versus time.

Figure 9 shows the increase in capacity with time after installation up to a maximum of 12 days for the 6 m long soil nails. The soil nails show an apparent “set-up” with time similar to driven steel piles. This set-up is likely due to dissipation of excess pore pressures resulting from the driving process and possibly also closure of the void around the soil nail that was created by the oversized coupling.

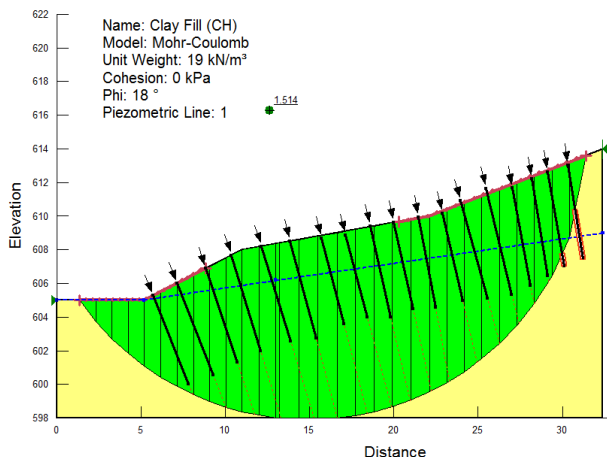
Limit Equilibrium Stability Analysis was performed using the software program Slope W to provide an estimation of the potential improvement in slope factor (FS) of safety due to the installation of the percussion soil nails. A back analysis was first performed to assess the soil parameters. The results of the back analyses indicated that an average friction angle of  $18^\circ$  and cohesion of 0.5 kPa was required to produce  $FS = 1$ . The friction angle values is consistent with the result obtained from the direct shear tests, however the cohesion is much lower, indicating that the slump had resulted in a loss of cohesion at shallow depth.

The results of the pullout test provided the unknown nail unit skin friction to be inputted to the modeling. As shown in Figure 10, the stability analysis indicated that the soil nail should increase the FS to 1.5 which was considered adequate.

Figure 10. Stability analysis result.
