# Highway cut made in a rock formation with precarious stability

Herrera, S., Schmitter, J.J. & Colonia, J.  
Free-Lance Consultancy, ICA & CONNET, Mexico City, D.F., Mexico  
Macedo, V.H. & Reynoso, E.A.  
CONNET & ICA, Mexico City, D.F., México

The paper describes the peculiar deformational behavior observed in the vicinity of a 60 m tall highway cut, where the natural slope of the surrounding ground is of about 33% (18°). A description of the observed behavior and comments about its stabilization are included.

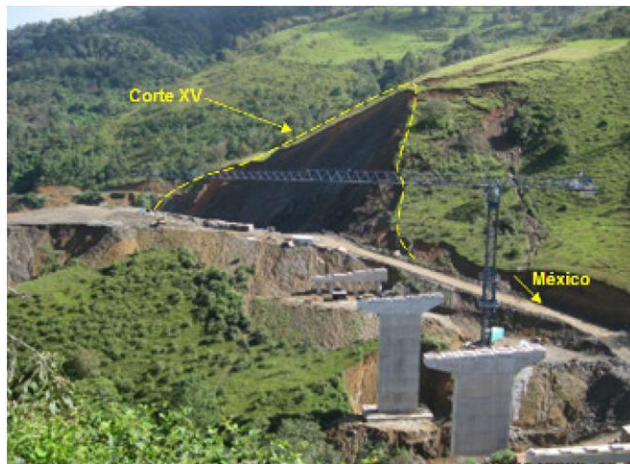
Figure 5. Cut XV

In the pictures of Figures 5 to 7 some aspects of the failures can be observed.

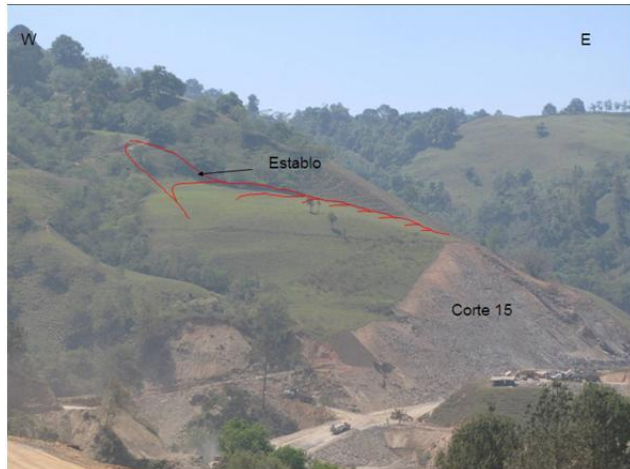
The second failure encompassed a larger volume and it occurred 40 days after the first one, appearing a series of tensile cracks at the upper part of the hillside running to about 120 m behind the shoulder of the cut, between stations km 845+200 and km 845+260.

Figure 6. Cracks on the hill adjacent to Cut XV

Under present conditions found at the hillside of Cut XV, with a large number of tensile cracks due to the displacement produced, the potential effect of water infiltrating into the subsoil is going to be a major factor in the long-term stability and therefore the most important actions to be implemented will imply preventing seepage, the superficial channeling of rain water and the under drainage of the ground through drilling of long drains.

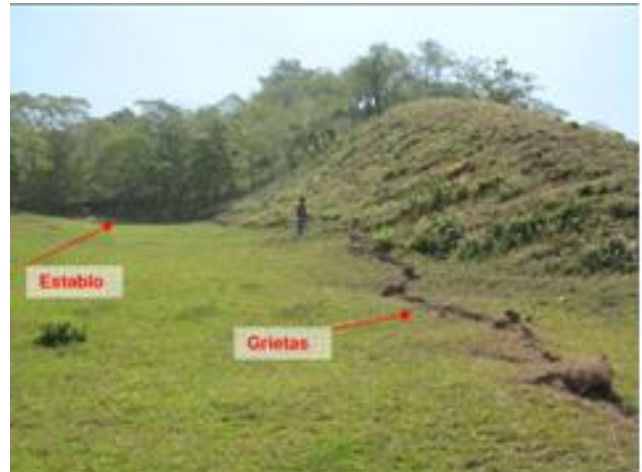
Figure 7. Detail of cracks on the hill adjacent to Cut XV. INGETEC (2009)

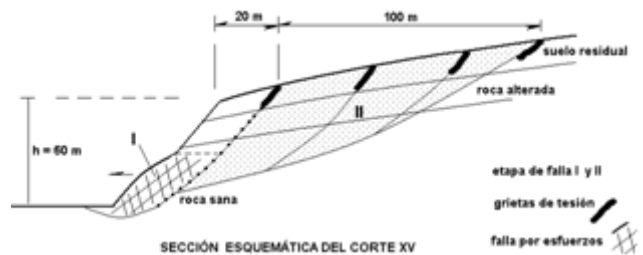
Figure 8 shows schematically the failures occurred.

Figure 8. Schematics of the failures occurred in Cut XV

The initial shear failure developed at the toe of the slope with repercussion toward the upper part along a relatively very short distance (20 m) with presence of tensile cracks.

The second shear failure encompassed the whole hillside with the tensile cracks extending to a distance of about 120 m behind the cut (Figure 8). It is considered that this second failure was due to the fact that the upper part of the hillside is characterized by the presence of materials with smaller shear strength and it is constituted by layers of disturbed rock and residual soil.

The second failure mechanism corresponds to the classic circular approach that is generally developed in soils.

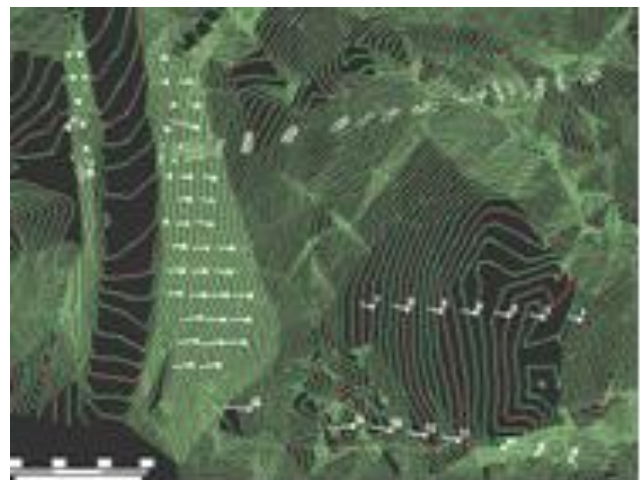
The rate of displacement recorded at the instrumentation bench marks placed at the top and alongside the hill, at the beginning of the movement varied between 2 and 15 cm/day, depending on the location of each bench mark. It subsequently dropped to less than 0.04 cm/day, with a trend to become stabilized.

Figure 9. Vectors of the displacements observed at Cut XV

Recently, at the beginning of the month of July 2010, as a result of the occurrence of heavy rains the trend to movement of the cut reappeared at rates of about 1 to 2 cm/day, dropping again after 2<sup>nd</sup> August to values of 0.3 cm/day and once more with the trend to become stabilized.

Figure 9 shows schematically the displacement vectors observed in the instrumentation installed at the surface of the cut and at the adjacent hillside.
