Geotechnical aspects of damages in Concepción, due to the M_w 8.8 Chile earthquake on February 27, 2010

Manuel J. Mendoza¹, Efraín Ovando¹, Felipe A. Villalobos², Miguel Rodríguez¹ & Paulo Oróstegui³

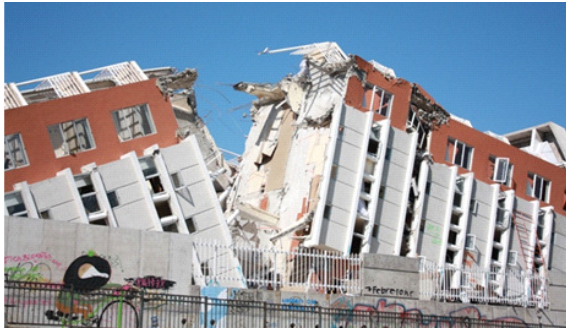
Figure 1. Overturned “Alto Río” building in Concepción.

With respect to the behavior of its foundation, the Alto Río building that completely overturned in Concepción, Fig. 1, deserves a particular review. The construction had 14 floors and two basements. Fig. 20 shows a longitudinal cut of the building, which had a floor plan proportion of length versus width of 3 to 1. The structure consisted of reinforced concrete walls, typically 20 cm thick, and floor slabs also of reinforced concrete, of 15 cm thickness. The building reached a height of approximately 40 m. The foundation was solved with a solid slab of reinforced concrete 80 cm thick in the area under the tower, set from ground level at -5.94 m, from which the concrete walls rose. In the parking area that was located behind the

The failure occurred when the vertical elements of the ground floor and/or basements collapsed, apparently from compression, on the vertical back plane opposite that of the façade, indicated with an arrow on Figs. 21 and 22. Fig. 22 shows the ground floor plan, indicating the area occupied by the building itself, and the underground parking behind it and out of its projection. Apparently, the reduction or non existence of walls along the longitudinal axis of the building's back façade, indicated with arrows, seems to have propitiated the failure by compression which, in turn, gave origin to the failure by tension of the front façade's vertical elements. The building as a whole overturned with rotation from the ground floor level, the vertical elements of the façade zone failing by tensile rupture, Fig. 23, and therefore the building fell on its back.

Regarding the participation or influence of the foundation in this mechanism, it had been speculated among some local specialists that the building's collapse was due to a foundation failure, probably caused by liquefaction of the underlying sands.

The authors had the opportunity to review the results of geotechnical soundings in which the presence of compact to very compact sand and sandy silt, not susceptible to liquefaction, were detected.

According to the evidence that we could observe during our visit to the site, the foundation did not contribute to the building's overturn, because no

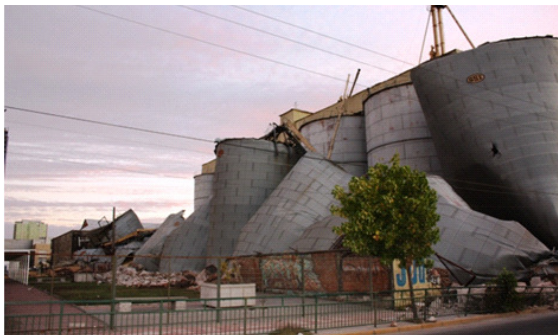
Figure 2. Silos that failed at center of Concepción.

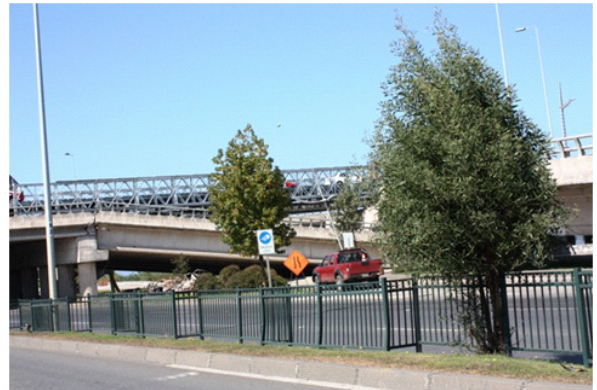
Figure 3. Provisional metal bridge over collapsed section of bridge over Bío Bío river, Concepción.

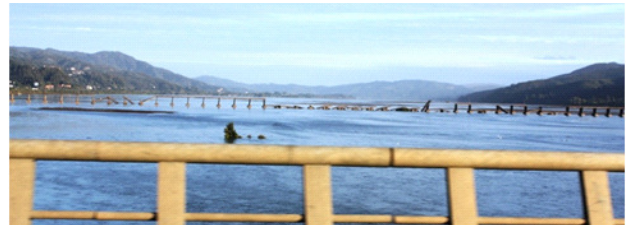
Figure 4. Multiple collapsed panels of “old” bridge over Bío Bío river.

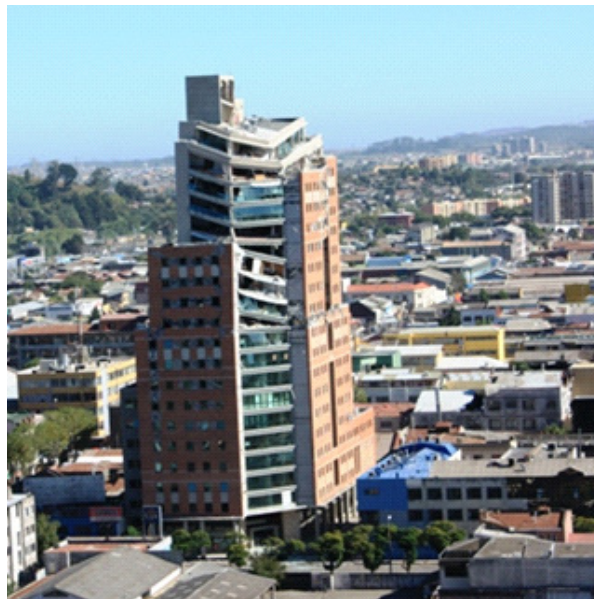
Figure 5. O'Higgins Tower, collapsed from tenth floor upwards, at Concepción.

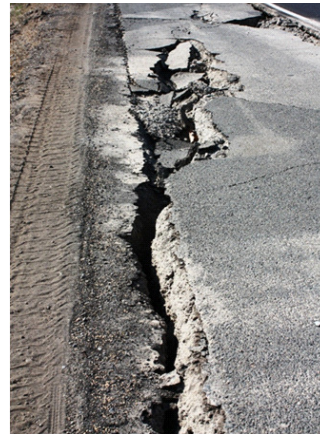
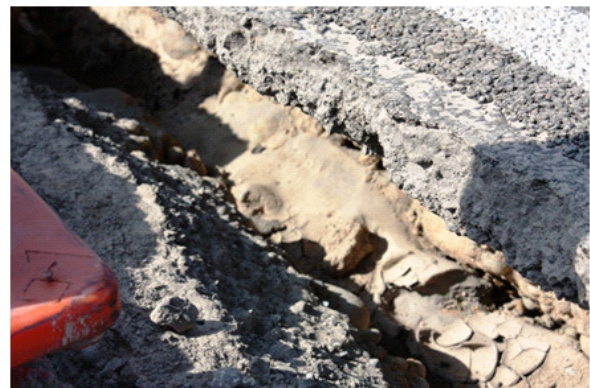
Examples of the occurrence of liquefaction on roads are shown in Fig.10, which correspond to Road 5 South from Santiago to Concepción, at the detour to Parral, some 150 km from the epicenter.

The typical pattern is the generation of longitudinal cracks tens of meters long, usually located on the shoulders of embankments no more than one meter high, or else near their middle, and on occasion at the start of slope of small embankments. Dragging, and sand at the bottom of the cracks can be distinguished.

Figure 10. Liquefaction on road 5 South, Santiago-Concepción.

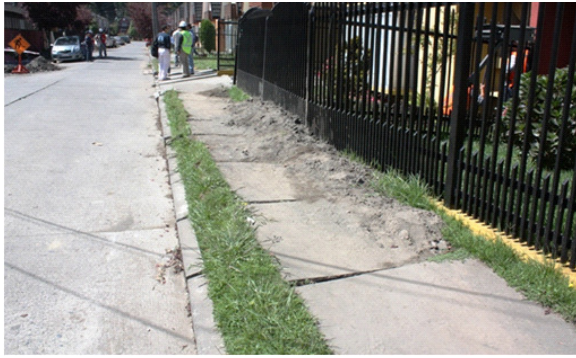
The commune of San Pedro La Paz is located south of Concepción and on the other side of the Bío Bío river. At a certain urbanization of that town profuse liquefaction of its mid size gray and uniform sands in loose state occurred, Fig. 11, to which an almost superficial phreatic

level was added. The sand was dragged not only through the joints of concrete slabs, but also through gardens and garages of single family homes consisting of a ground floor and a second level, causing total and differential sinking, with significant collapse in many homes, Fig. 12.

Figure 11. Generalized liquefaction in a group of single family homes. San Pedro La Paz.

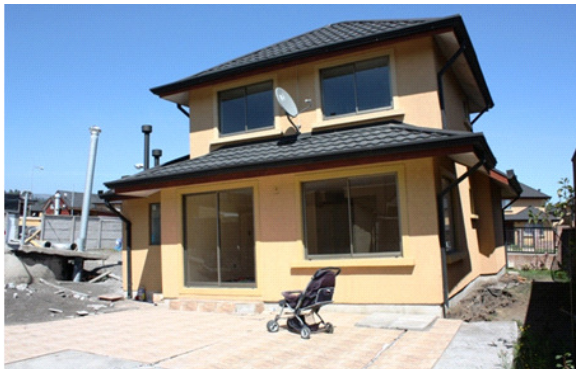
Figure 12. Heavy sinking and collapse in a single family home due to liquefaction.

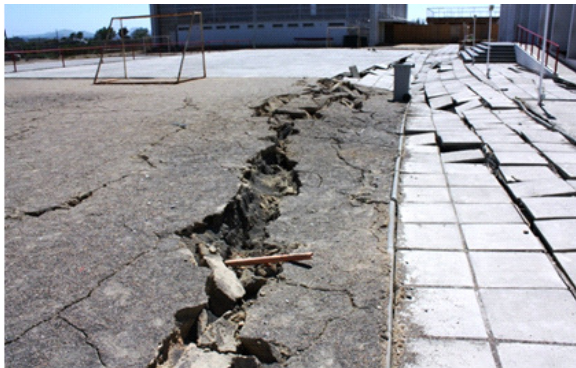
At another site of the commune of San Pedro La Paz we observed generalized liquefaction at a school of great extension and of relatively recent construction, Fig. 13. It was clear that the light brown mud-sandy surface filling had cracked and allowed the flow of water through and the loss of dark gray sand from underneath, causing settlements of up to 60 cm at the foot of the stairs visible in the photo.

Figure 13. Liquefaction at a school's patio in San Pedro La Paz.

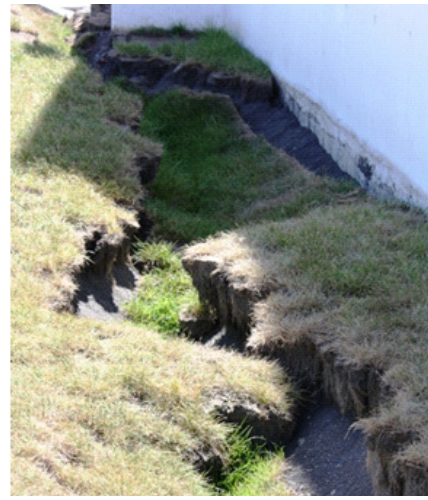
loss of effective stresses underneath them, determining that liquefaction only occurred a few decimeters from them, developing cracks in the soil parallel to the walls of the buildings, Fig. 14. In no case we observed ground cracking "crossing" under a wall; the rigidity of the buildings contributed to their not cracking. Only in one case we observed relative movement between two bodies of buildings, which caused their fracture.

Figure 14. Cracking parallel to the school's constructions, caused by liquefaction. San Pedro La Paz.

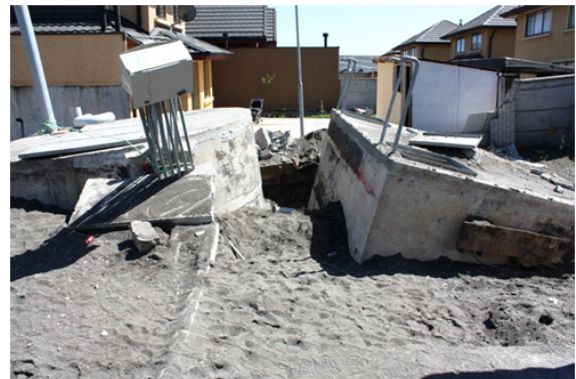
plant, as shown in Fig. 15, as well as of an adjacent booth. As in the case of the urbanization's light homes, the weight of those boxes was not sufficient to prevent the annulment of effective strains in the sandy, saturated and loose ground, generating liquefaction and the flotation of the boxes.

Figure 15. Flotation of boxes of a treatment plant in San Pedro La Paz.

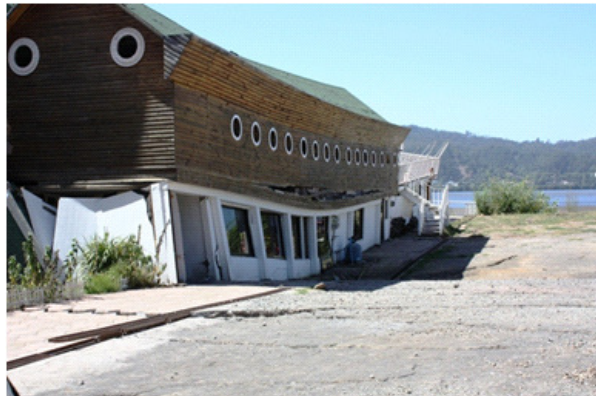
A marked crack occurred on the left bank of the Bío Bío river, land also belonging to the commune of San Pedro La Paz, on the road to Santa Juana. It developed along hundreds of meters as result of the profuse liquefaction and lateral spreading phenomena, causing multiple damage to homes and restaurants, some not yet opened, that had been built near the river's border, Fig. 16; the liquefaction phenomenon was even present on the floor inside one of the restaurants, as the result of structuring with very light materials.

Figure 16. Extended cracking on the bank of the Bío Bío river.

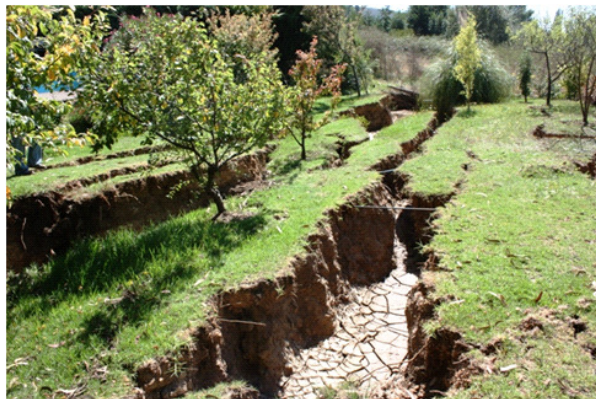
Lateral spreading was favored by the slight slope toward the plentiful river, and preceded by liquefaction; the cracks were multiple, with widths of up to a couple of meters, as shown in Fig. 17, and similar depth. These cracks allowed us to witness directly the presence of the

layer of mid size and uniform sand of dark gray color, rich in mica, that suffered liquefaction. The sand is the product of the Antuco volcano eruption, and it is located between 1.6 and 1.9 m of depth from the terrain surface, with thickness of 22 cm. We had the opportunity to take samples of the sand to determine its granulometric distribution, finding that it is located just within the zone in which technical literature has defined granulometries for liquefaction-prone soils. Over that sandy layer are sandy soils with clay matrix which upon initially encapsulating the sandy layer, propitiated the generation of high pore pressure and therefore liquefaction.

Figure 17. Liquefaction, cracking and lateral spreading on bank of Bío Bío river.

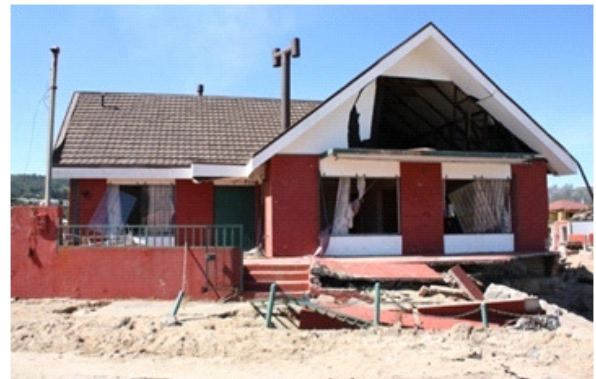
In general, the behavior of building foundations was satisfactory. It became possible to verify the virtues of a construction consisting of a robust structure supported by a continuous and resistant foundation. Figs. 18 and 19 show the conditions in which a couple of homes built a few tens of meters from the coast of Dichato were left, which suffered the onslaught of the violent tsunami that caused marked undermining. The superstructure, made of confined masonry, had no damage; only the diaphragm that constitutes the front of its roofing, and its windows, showed clear evidence that the water had flowed through them. The foundation formed by continuous footing of a

poor concrete proved capable of maintaining the structure whole and with no distortions, even though part of the footing lost its soil support.

Figure 18. Intact foundation and superstructure of a home that suffered the onslaught of the tsunami in Dichato.

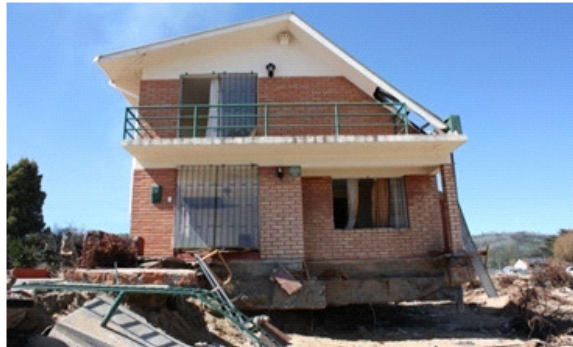
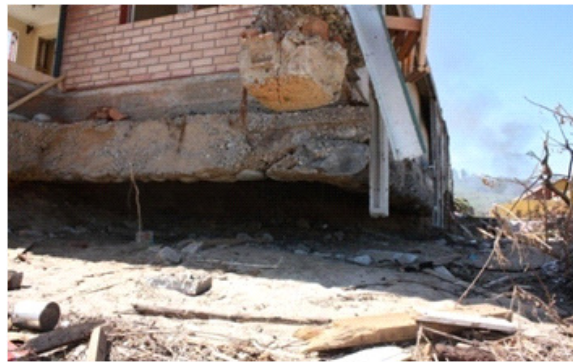
Figure 19. Intact foundation and superstructure of a house that was submitted to the tsunami in Dichato.

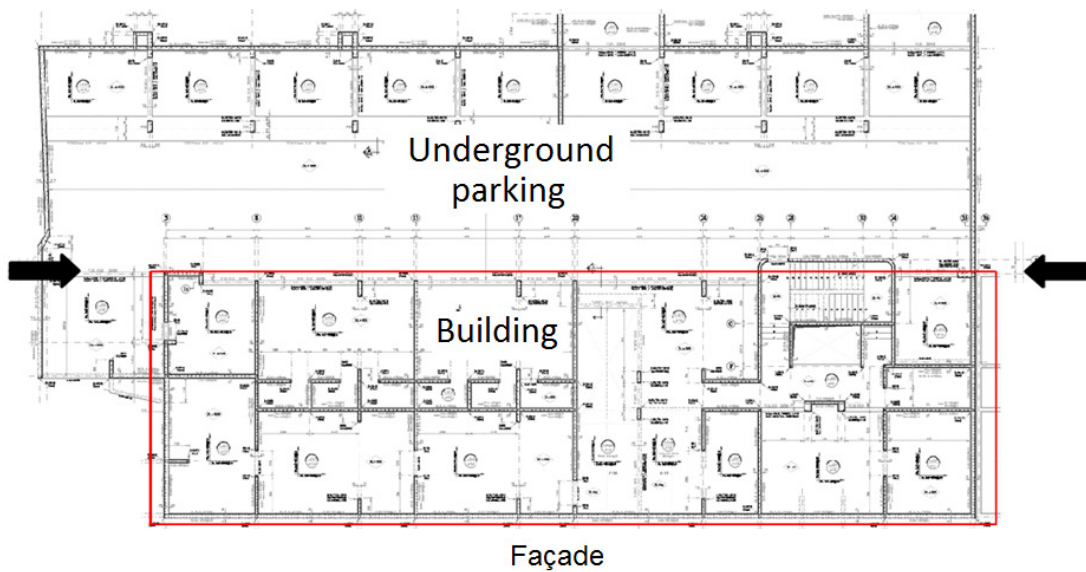
Figure 22. Plan of the first basement of the Alto Río building. Note the scarcity of vertical elements on the longitudinal axis of the building's back façade (arrows).

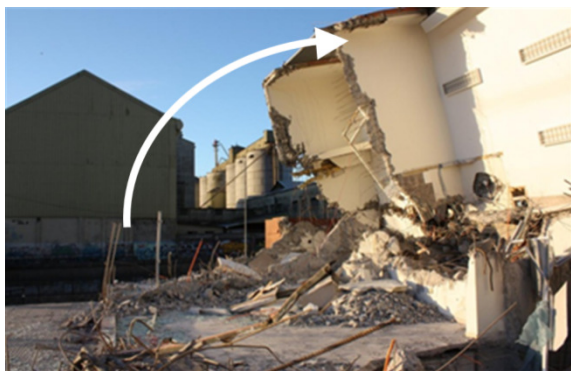
Figure 23. Final tension failure of the front portion of the ground floor, which determined the building's overturn and collapse.

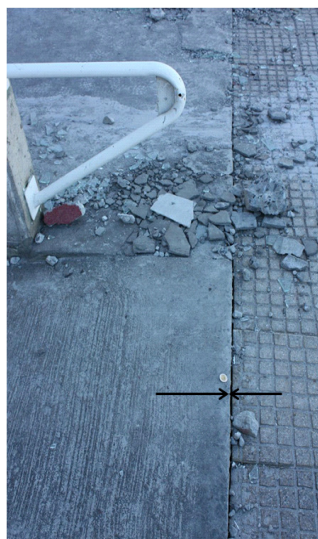
indication that it had experimented settlement or rotation was detected. To support this, the image in Fig. 24 shows that the lateral displacements suffered by the foundation box were of very small magnitude, only 6 mm. This means that the continuous concrete wall of the basements on the façade's plane underwent very reduced displacement with respect to the surrounding ground.

Figure 24. Lateral displacement of the foundation box of only 6 mm.

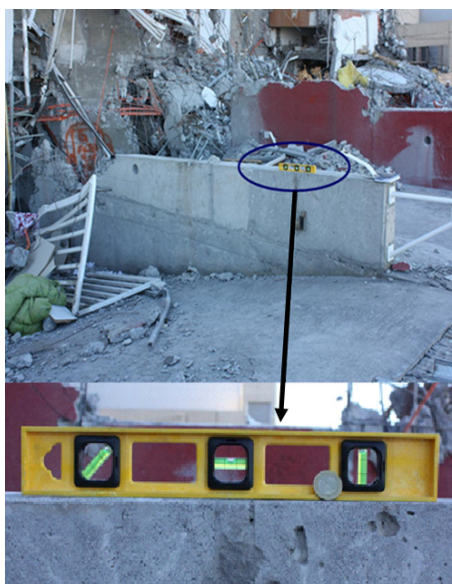
Another image that supports the foundation's practical immobility is included in Fig. 25. The bubble is completely level when placing the level on a low wall on the ground floor, indicating that the foundation did not suffer permanent angular distortions. In summary, when the building suffered its overturn, its vertical support elements failed at ground floor level, with the foundation box completely remaining in its original position, with no rotation and with only minuscule lateral displacement.

Figure 25. Low wall on ground floor totally level after the building's collapse.
