Stability slopes study of dams of Necaxa Hydroelectric System

Nicolás Melchor-García & Roberto Ruedas-Medina
Instituto de Investigaciones Eléctricas, Cuernavaca Morelos, México
Oliver Nava-Tristán
Comisión Federal de Electricidad, México.

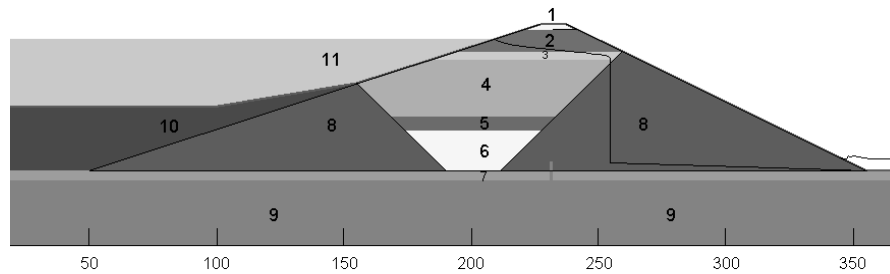
Figure 8. Critical section 3, Necaxa dam

In the curtain of Necaxa dam were drilled 6 geotechnical boreholes, four on the crest (66, 68 and two 45 m deep) and two on the downstream slope. The slopes borings were aligned with crest borings, to obtain cross sections. In two boreholes the basement rock was reached and deepened further 4 and 5 m, respectively. In some parts of the curtain, during the standard penetration test, the bars were driven into the material by its own weight, which indicates a very low resistance. The minor strengths were between 5 and 25 m of depth and represent a potential area of failure by sliding surfaces, which was considered in the stability analysis. It was observed that materials that include boulders and gravel do not form well defined layers. Rather they were erratically deposited forming regions or areas with resistance due to friction and cohesion and higher permeability, where significant seepages may occur. On the downstream face, deformations were observed altering the flat geometry of the slope. It was not possible to measure the age or the speed of these deformations to determine whether they

are growing or stable. The installation of inclinometers is recommended. Table 2 and Figure 8 present a summary of the properties of the Necaxa dam.

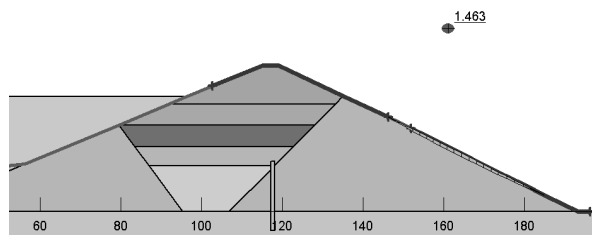
Safety factors of the three sections analyzed for Tenango dam are greater than the minimum recommended ones (USACE, 2003). Only in the downstream slope safety factors were slightly lower than those recommended, however, these granular materials are stable if the angle of inclination of the slope is greater than the angle of resistance. In addition, the slip surfaces associated with these SF occur on the surface of the slope, containing a small amount of material and do not represent a condition of instability of the slope. The slip surfaces that penetrated deeper and other critical sections had SF greater than 1.5 for the same condition. Using the criteria Hynes-Griffin and Franklin, the 3 sections have pseudostatic safety factor greater than one, therefore, they will not suffer large deformations that could threaten the safety of the dam. However, the loss of drilling mud during the geotechnical exploration indicated the existence of cavities and they could facilitate the development of slip surfaces.

Figure 13. Critical section 3, Tenango dam. Steady flow condition, downstream failure. F.S = 1.463 (Spencer's method)

The Tenango dam does not have stability problems due to the strength characteristics of materials. However, during the drilling of some boreholes, large quantities of drilling mud were completely lost through pipings of unknown dimensions and trajectories, which suggests that slip surfaces could be developed to continue the path of the pipings and the safety factors could be considered as intolerable. Moreover, the results of chemical analysis of water from the reservoir and spring revealed that the into the curtain of Tenango dam reactions may occur between clay and sodium ions and generate a dispersive behavior, so there probably is a piping phenomenon under way as might be confirmed by the loss of drilling mud described above. Based on the results here reported LyFC carried out the construction of plastic walls of bentonite-cement to reinforce those areas.

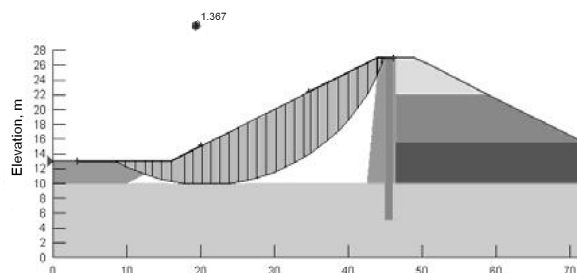
Figure 15. Critical section 3, La Laguna dam. Slip surface on upstream slope., rapid drawdown condition. F.S = 1.367 (Spencer method)

The stability analysis of La Laguna dam showed safety factors above the minimum acceptable in the three conditions of analysis. The chemical analysis of water from La Laguna dam showed no conditions for the development of piping but, because this phenomenon already occurred long ago, it is advisable to install instrumentation in the dam to observe changes in behavior that could indicate in time the possible development of a fault.

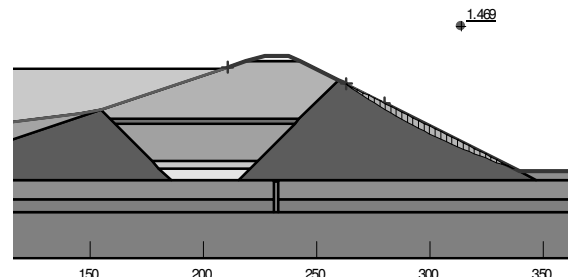
For Necaxa dam, the SF for steady flow condition is greater than the minimum recommended by Reséndiz (1975) and is considered satisfactory for the stability of the dam. The seismic coefficient $c = 0.065$, equal to half the peak ground acceleration produces a $SF = 1.26$, according to the Newmark method, so the dam is not expected to become permanently deformed.

Figure 14. Critical section, Necaxa dam. Steady flow condition F.S = 1.69 (Spencer's method)

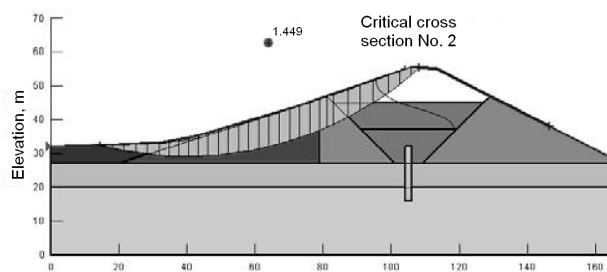
For steady flow condition, Los Reyes dam has SF greater than the minimum acceptable. Analysis of the

drawdown condition on effective stress results in SF less than acceptable ($0.770 < 1.2$) for one section, but in terms of total stress the SF is adequate (1.459). Seismic analysis results in proper SF margin, and no permanent deformations are expected, according to the Newmark method because the peak ground acceleration is below the yielding acceleration ($0.14g < 0.295g$).

Figure 16. Critical section 2, Los Reyes dam. Rapid drawdown condition. F.S = 1.449 (Modified Bishop Method).

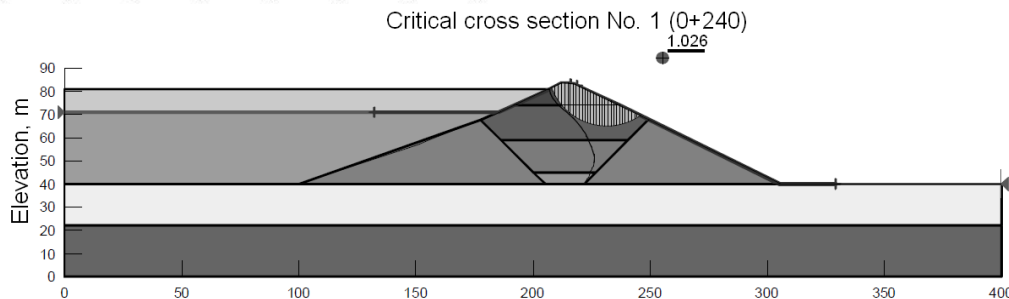
Figure 17. Critical section 1, Nexapa dam. Dynamic conditions. F.S = 1.026 (Spencer's method)

However, in Nexapa Dam, one of the critical sections has values somewhat lower than recommended. In this section the failures for steady-state flow, rapid drawdown and seismic excitation occur at the base of materials of brown silty clay with undrained strength of 21.5 and 35.75 kPa. It was mentioned above, that the resistance obtained with SPT tests corresponds to a material with hard consistency. So it is recommended to obtain

undisturbed samples in these materials, to assess the stability of this dam in a more reliably way.
