Sudden failure of an embankment resting on a clay soil that behaved as a fluid

Schmitter, J.J. & Vázquez, S.
ICA, Mexico City, D.F., Mexico
Orozco, R.V. & Reyes, L.
RVO and Cía. & Consultant, Mexico City, D.F., México

3 PROBLEM OF INSTABILITY BETWEEN STATIONS KM 134+800 AND KM 134+940

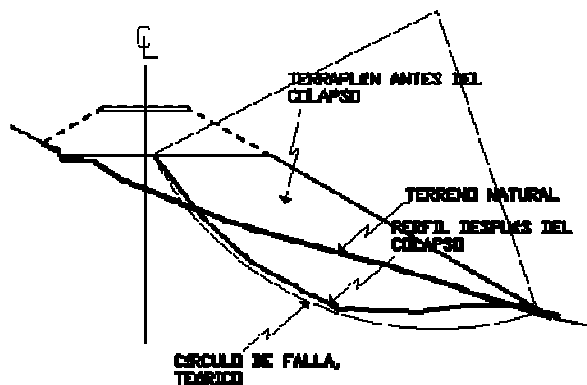
One of the most conspicuous problems of instability that developed during the construction of the highway section referred to before occurred when shaping a side supported embankment (Figure 1), located at the left bank of the canyon where at its bottom the Mazantla River flows. Such embankment, with a length of about 200 m and crest width of 15.5 m, slope inclination of 1.7:1 (close to 30°) and designed to reach a maximum height of about 42 m, with respect to the toe of its right slope, suddenly failed when reaching 75% of the total height.

Figure 1. Cross section of the side supported embankment after failure took place. From RVO y Cía. (2006)

Observing the geometry of the failure, as shown in Figure 1, and reasonably confirmed by means of the circle of failure plotted in Figure 8, it can be estimated that close to 45% of the materials that flowed corresponded to clay or silt materials belonging to units U-2 and U-3. This represents close to 45,000 m³ of the total volume of 100,000 that flowed and, if it is considered that the area covered by the failed material was of almost 2 hectares, it can be deduced that the cover of liquefied soil above which the embankment material flowed had an average thickness of 2.3 m.

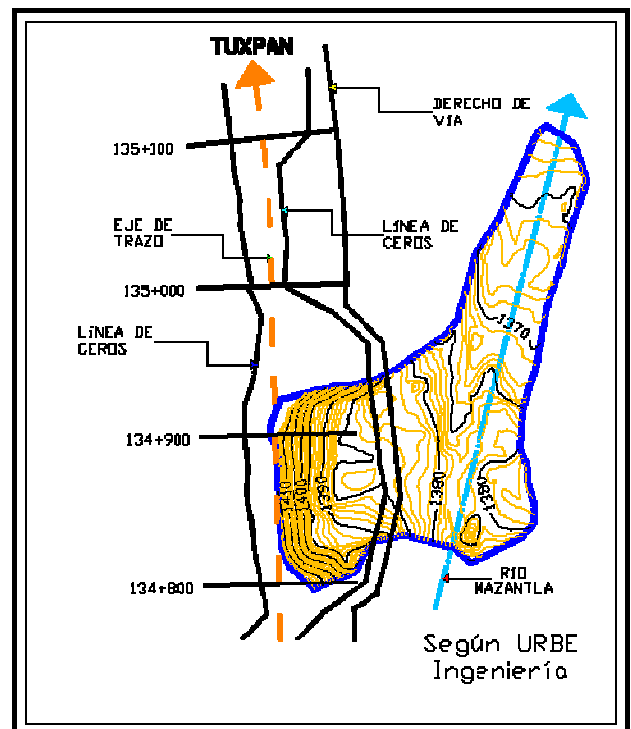
At the end of its travel, the failed material covered an area of almost 2 hectares in the shape of a "jester shoe" having a remnant superficial gradient, along the direction of the river flow, of about 6% (Figure 2).

Figure 2. Topographic configuration of the failed material that was deposited in the Mazantla river bed. From URBA Ingeniería (2006)

Mention should be made that when the material was deposited in the Mazantla river bed it obstructed the flow and this made it necessary to excavate a relief trench that regulated the flow of the river.

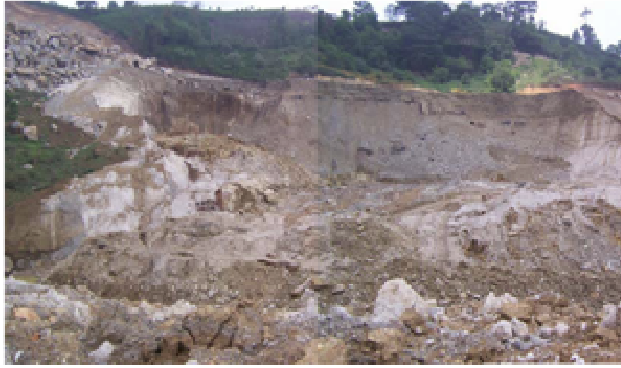
Figure 3. Remnant escarpment of failure seen from the right bank. From RVO y Cía. (2006)

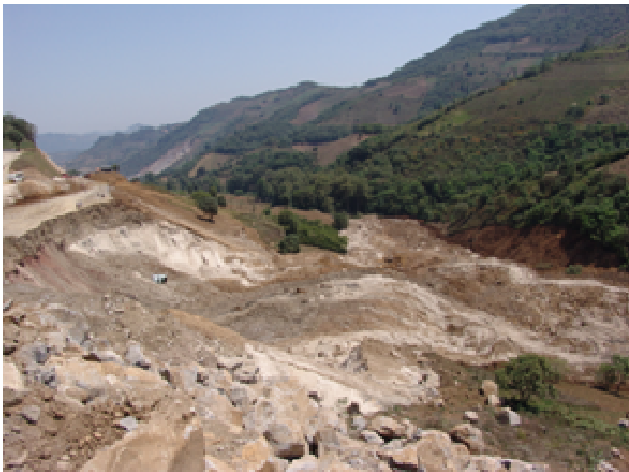
Figure 4. Remnant escarpment of failure (at left) and flow of the failed material toward the river bed (at right)

In the pictures of Figures 4 and 5 the presence of a trapped dump truck can be observed after being carried away by the flow of the material. On the other hand, a tree dragged by the avalanche of materials can be appreciated in Figures 6 and 7 as well as the presence of the relief trench being excavated by the contractor to reinstate the flow of the Mazantla River that was blocked by the slide.

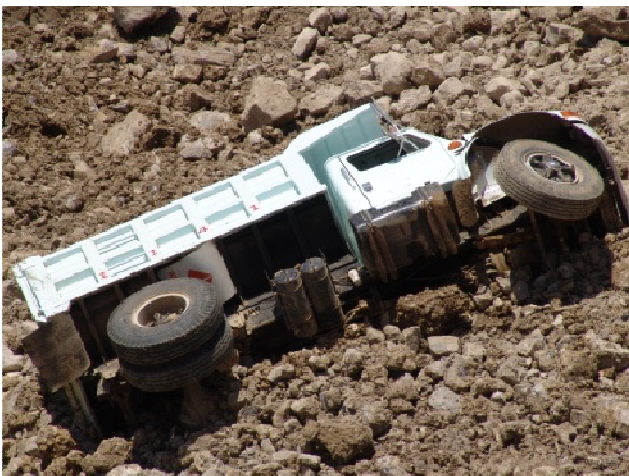
Figure 5. Truck carried away by the failed material

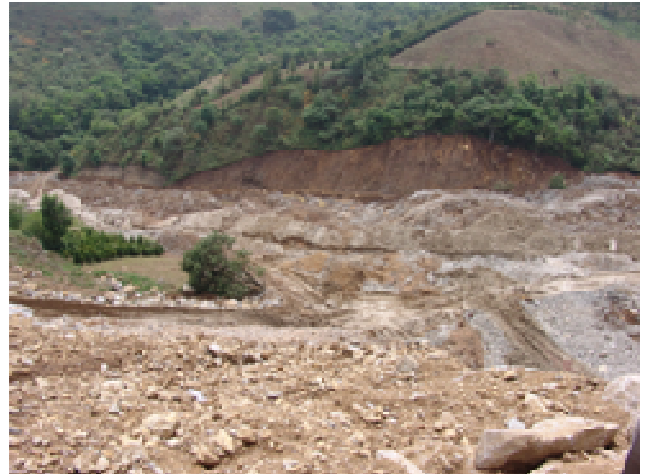
Figure 6. Traces of the splash against the right bank of the failed material that flowed like a fluid

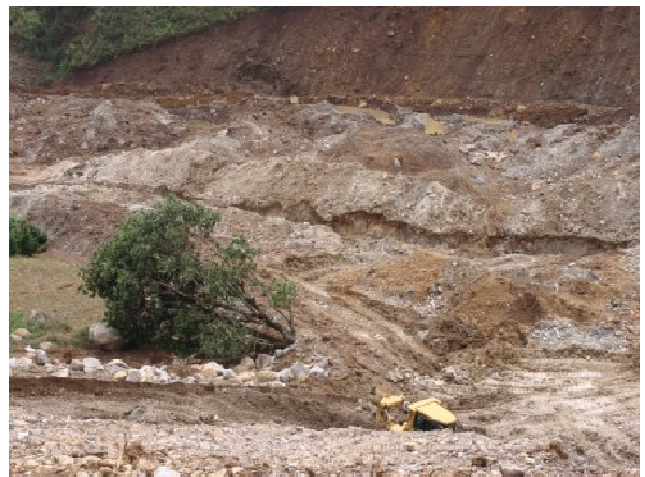
Figure 7. Tree dragged by the failed material

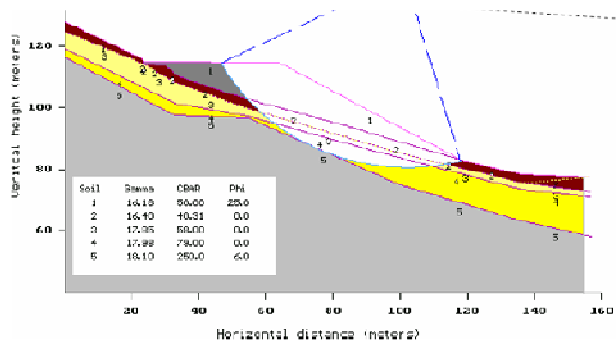
together with the most critical failure circle resulting from the stability analysis performed by RVO y Cía. (2006), taking into account the “undrained” shear strength of the local materials, having obtained a minimum safety factor of about 0.92.

Figure 8. Stratigraphic profile of the site

- In Figure 8, the crust of stratum U-2, depicted with a different color, seems to correspond to a disturbed zone, associated to the growth of vegetation. The mechanical properties of this crust are not apparently playing a relevant role in the stability of the failed embankment.
