Retrofit of a pile-supported bridge in soft clay damaged by failure of adjacent soil stockpile

Sy, A., Thavaraj, T. & Hamersley, B.
Klohn Crippen Berger Ltd., Vancouver, BC, Canada
Gillespie, D.
Ministry of Transportation and Infrastructure, Victoria, BC, Canada

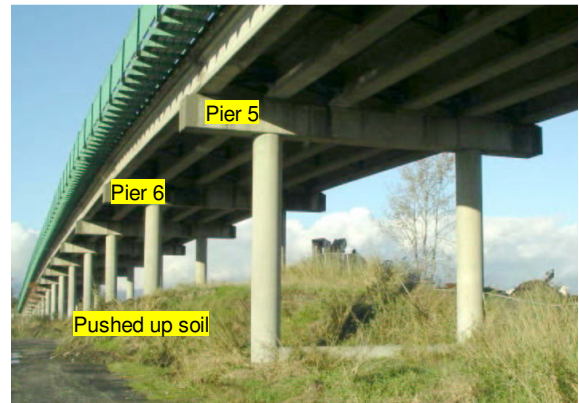
full-length of the south approach of the bridge, failed. The soil failure pushed up the ground level between Bents 5 and 6 to a height of 3 to 4 m, and to a lesser height between Bents 6 and 7 (see Figs. 2 and 3). The bridge centerline moved horizontally by more than 150 mm between Bents 4 and 7, with up to 428 mm at Bent 6, resulting in a noticeable kink in the structure at this location. Fig. 4 shows the surveyed permanent horizontal displacements of the pier centreline after the event.

Figure 2. Soil pushed up between Piers 5 and 6 (looking north)

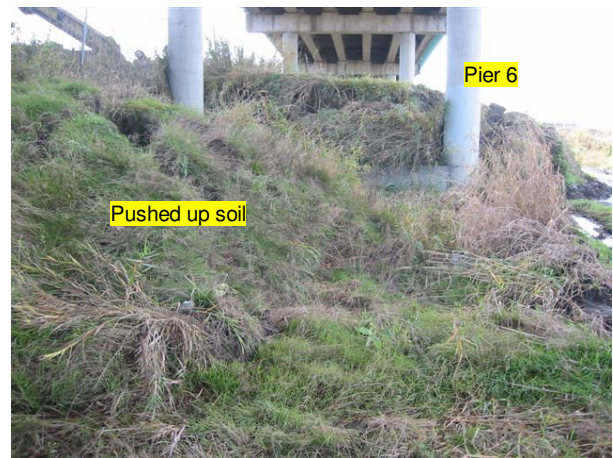
Figure 3. Soil pushed up near Pier 6 (looking south)

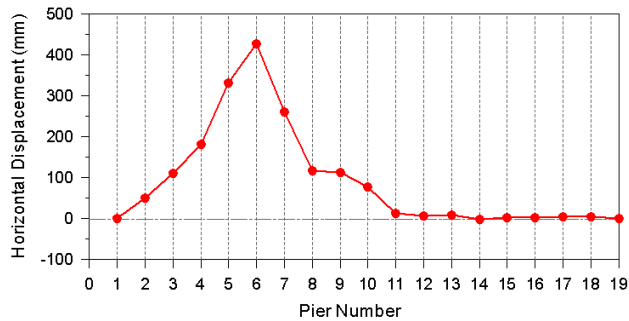
Figure 4. Horizontal displacement profile of pier centreline (Note pier numbering starts from south end of overpass)

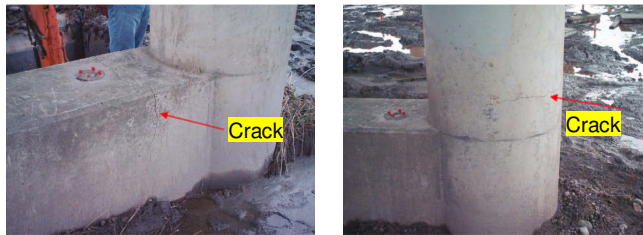
In addition to the transverse pier movements, significant tilting or rotation of pier columns was observed at Piers 5 to 7. Top to bottom relative displacements of up to 45 mm transversely and up to 84 mm longitudinally, were measured. Substantial cracks on pier columns and pile cap beams were observed (see Fig. 5). Several girders at Pier 6 also shifted over the bearing pads, reducing the available bearing seat lengths (see Fig. 6).

Figure 5. Cracks in pile cap beam and column at Pier 6

Figure 9 summarizes in schematic the damages observed on the south approach of the bridge due to the November 2004 soil failure. Shortly after the event, cracks in the columns, tie beams and exposed piles (described in Section 4) were epoxy injected, the soil stockpile in the adjacent property was re-profiled to a much flatter overall slope, and the heaved soil between Piers 5 to 7 was removed. Despite the displacement and damage, structural assessment showed the bridge to be safe for traffic, but all repair and construction activities were carefully controlled with constant monitoring of the bridge and foundation.

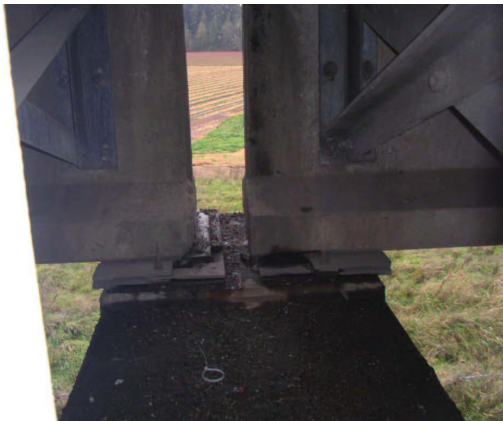
Figure 6. Displaced girder at Pier 6 (looking west)

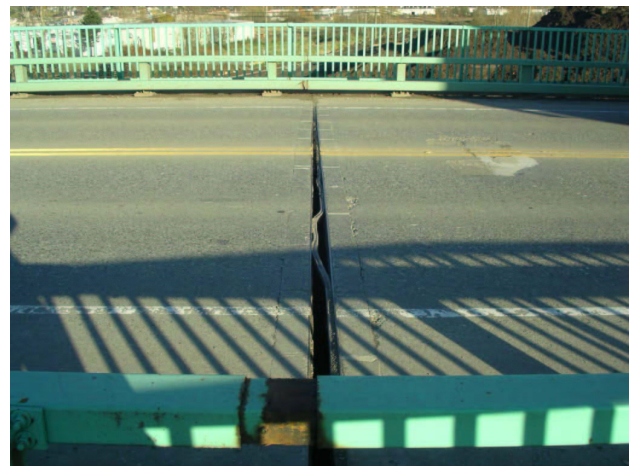
The deck expansion joint at Pier 6 had opened to 147 mm on the west side compared to 14 mm on the east (see Fig. 7). On the other hand, the joint at Pier 8 opened

Figure 7. Uneven displacement of expansion joint at Pier 6, and traffic rail pulled apart at the west side (foreground)

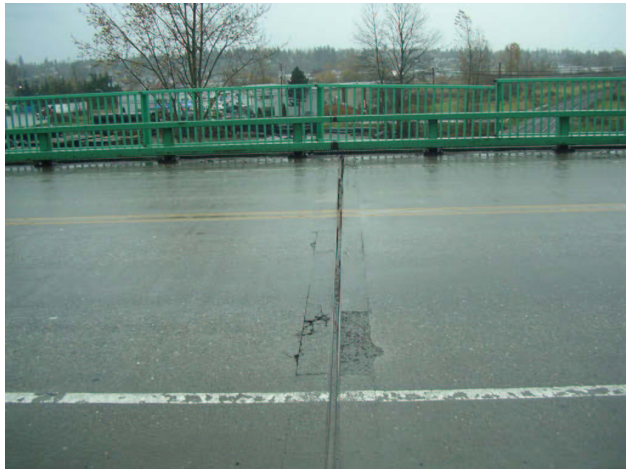
the opposite way, and was measured at 72 mm on the east side and 14 mm on the west (see Fig. 8).

Figure 8. Uneven displacement of expansion joint at Pier 8, and handrail pulled apart at the east side (far side)

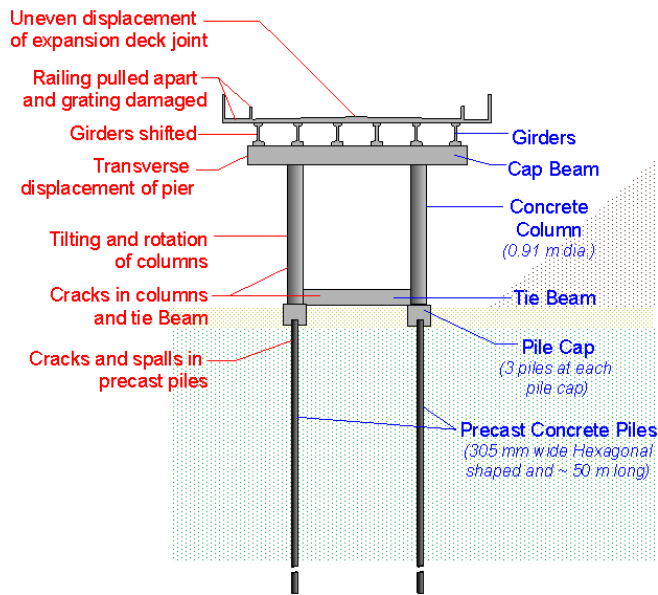
Figure 9. Observed damages on bridge after soil failure

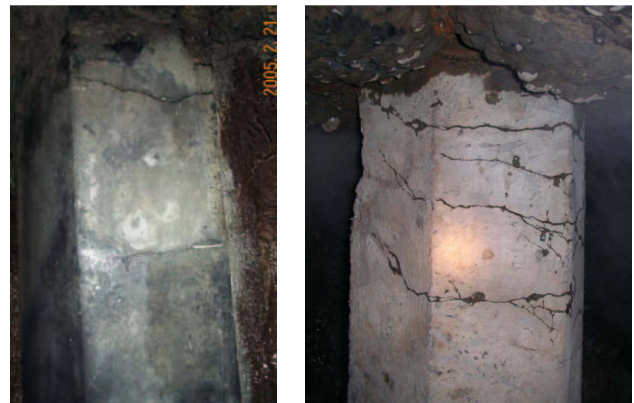
1. The visual inspections indicated cracks and spalls in the upper part of many piles on the west side of Piers 4, 5 and 6. Note in particular, that cracking was observed on the west side of the individual piles and spalling on the east side of the piles. The piles on the east side of the pier (adjacent to the soil stockpile), however, did not show any apparent damage in the upper 1 m of the pile length. Figure 10 shows photos of cracks in the top part of concrete piles observed upon excavation.
2. The low strain integrity testing indicated impedance reductions of piles on both the east and west sides of Piers 4 to 8. These impedance reductions suggest presence of partially opened joints and/or concrete cracks, but no evidence of complete pile separation.

Figure 10. Cracks in precast piles at Pier 5 and Pier 6 on the west side

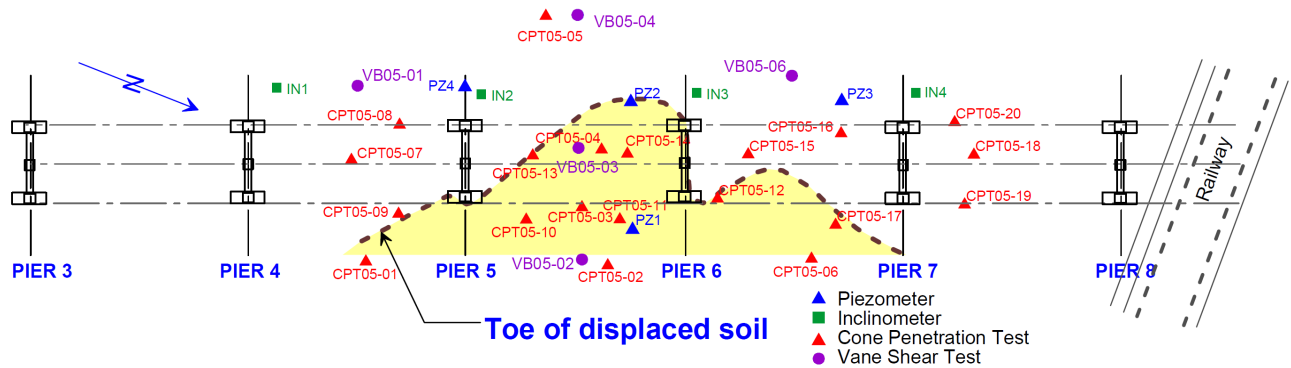
Site investigations consisting of cone penetration tests (CPT) and in-situ field vane shear tests were carried out in and around the significantly displaced piers and soil failure area. Inclinerometers and piezometers were also installed to monitor lateral ground movement and pore pressures, respectively. Figure 11 shows the locations of the test holes and instrumentation, as well as the approximate outline of the displaced or heaved soil around Piers 5 to 7. Note the soil stockpile was on the east side (bottom of figure) of the bridge.

Figure 11. Locations of test holes and instrumentation, and toe of displaced soil

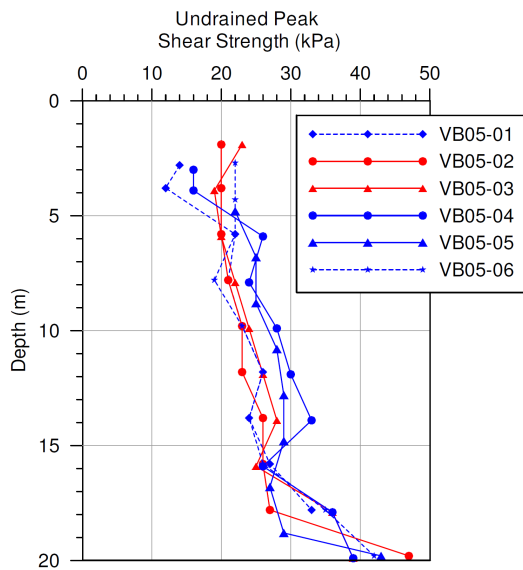
Figure 12 shows the peak undrained shear strength profiles obtained from field vane shear tests carried out inside (red lines) and outside (blue lines) the failure area. The vane shear test results were not able to definitively differentiate between the disturbed clay in the failure area and the undisturbed clay outside the failure area.

Figure 12. Undrained peak shear strength profiles from field vane shear tests

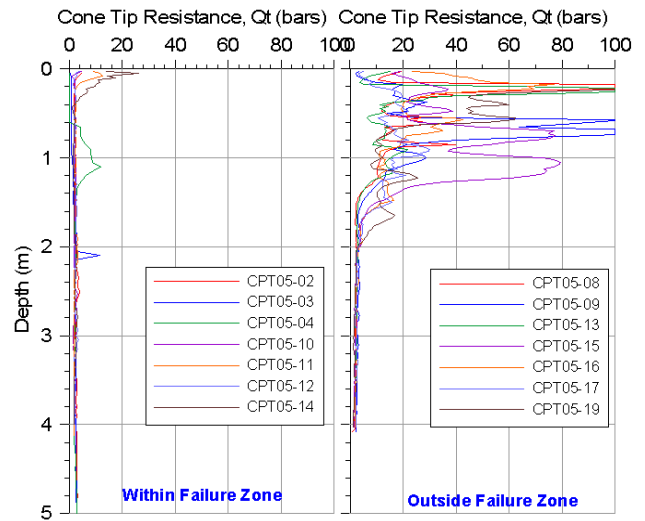
Figure 13 shows cone tip resistance profiles of the CPTs separated into two groups or plots: within failure area (left plot) and outside failure area (right plot). Note the CPTs within the failure area clearly show absence of the typical 2 m thick clay crust that is evident in the CPTs performed outside the failure area.

Figure 13. CPT tip resistance profiles

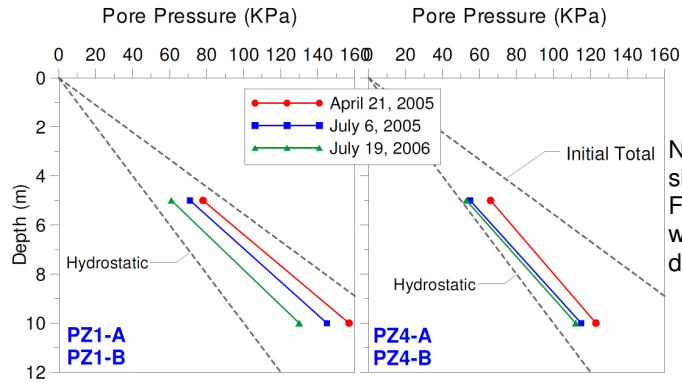
The piezometer data indicated high excess pore pressures existed in the ground, even one and a half years after the soil failure, particularly on the east side of the bridge. There was very slight dissipation during that period (see Fig. 14).

Figure 14. Measured pore pressures in piezometers PZ1 and PZ4

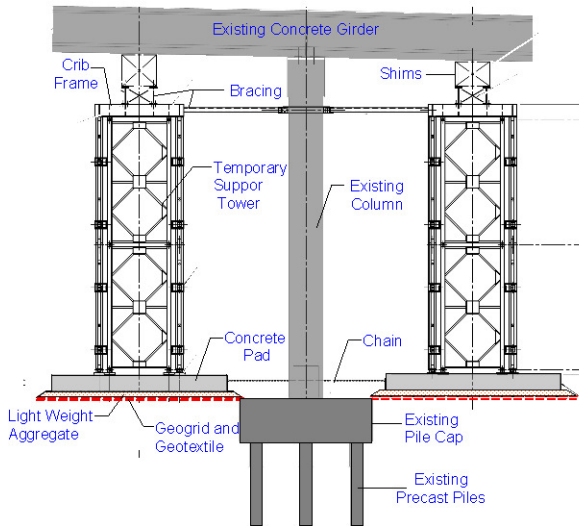
Figure 16. Temporary support towers around pier (longitudinal view)

Figure 17. Temporary support towers as constructed

- Temporary shoring towers (using Acrow temporary bridge panels) were erected to support the girders between Piers 4 to 8, as shown in Figs. 16 and 17. The towers were founded on concrete pads on a layer of lightweight pumice fill. The footings were sized to limit bearing pressure to 50 kPa and to minimize settlement. The tower height was adjustable by shims to accommodate expected settlement.
- Longitudinal restrainers were installed between the girder ends at Piers 4, 6 and 8 to prevent loss-of-span failure. The restrainers consisted of Dywidag bars with steel brackets bolted onto the web of the girders.

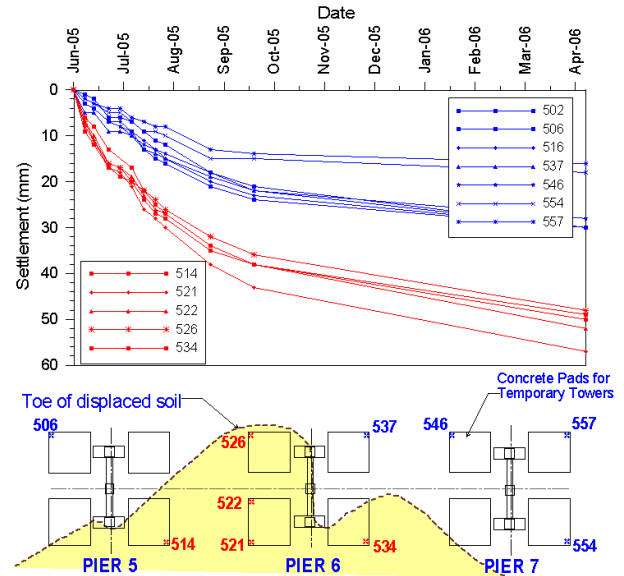
Figure 18 shows typical time-settlement plots of the temporary tower concrete pads, as well as a location plan. Note the significantly higher settlements recorded on pads within the failure area (red curves), compared to those outside the failure area (blue curves).

Figure 18. Time vs. settlement plots of the temporary tower concrete pads, and location plan

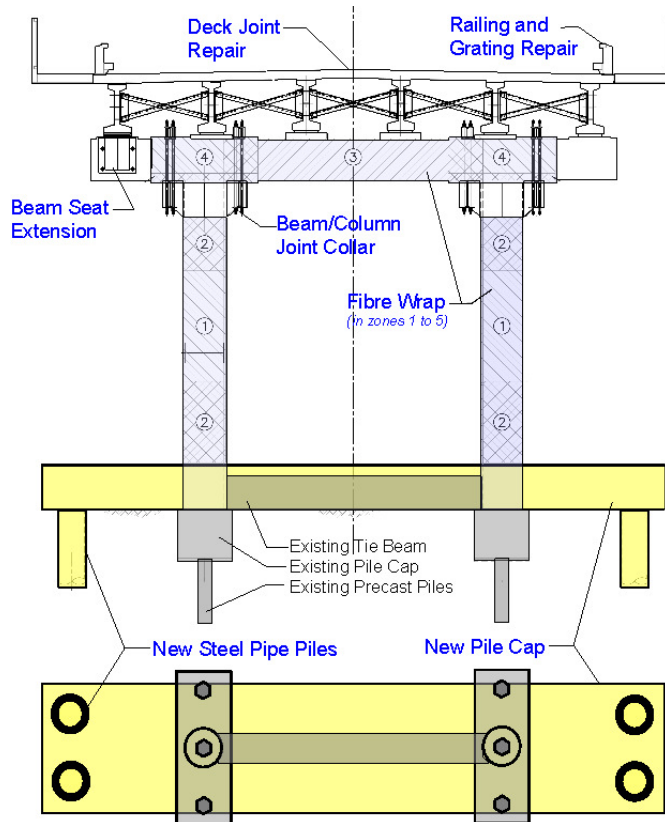
Figure 19 Permanent bridge retrofit including new pile caps and steel pipe piles

- New piles, pile cap extensions and tie-beams at Piers 3 to 8 to replace damaged piles;
- Fibre wrapping of damaged columns to limit concrete spalling and increase column strength;
- Beam-column joint retrofit using steel collars and fibre wrap;
- Transverse shear keys between girders at the top of capbeams;
- Deck joint repair;
- Beam seat extension at Pier 6; and
- Sidewalk grating, fence and roadway railing repair.

Figure 19 shows details of the permanent retrofit at a typical bent. The permanent retrofit was carried out during shutdown of the existing bridge between October 2006 and May 2007, while traffic was diverted to the new bridge to the west.

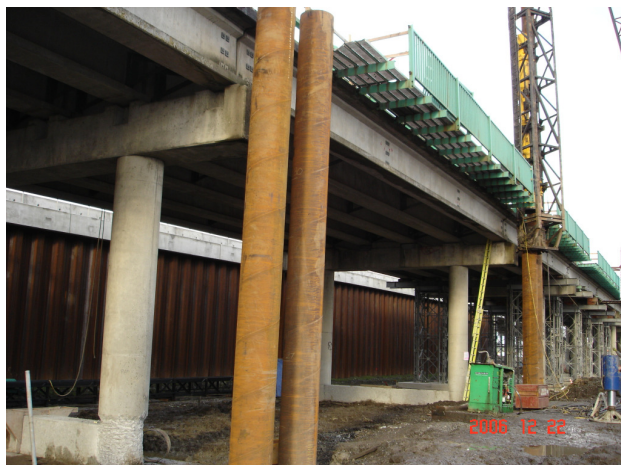
Figure 20. Installation of replacement steel pipe piles at east side of bridge

Open-toe steel pipe piles, 610 mm outside diameter by 12.7 mm wall thickness, driven to toe bearing in the dense till-like soils underlying the soft marine clay were used to replace the existing damaged concrete piles. Two new piles were installed at each existing column or pile cap at Piers 3 to 8. The pipe piles were driven to practical refusal (15 blows for last 25 m of penetration) using a Berminghammer B64 diesel hammer (see Fig. 20). Pile

lengths varied from 43 m to 57 m. Selected piles were monitored with a Pile Driving Analyzer (PDA). CAPWAP analyses of PDA wave traces during pile re-strikes indicated fully mobilized capacities between 4300 kN and 5000 kN per pile. During pile driving, the bridge structure from Piers 2 to 9 was monitored. No measurable movements or excessive vibrations were recorded at the existing pile supported piers.

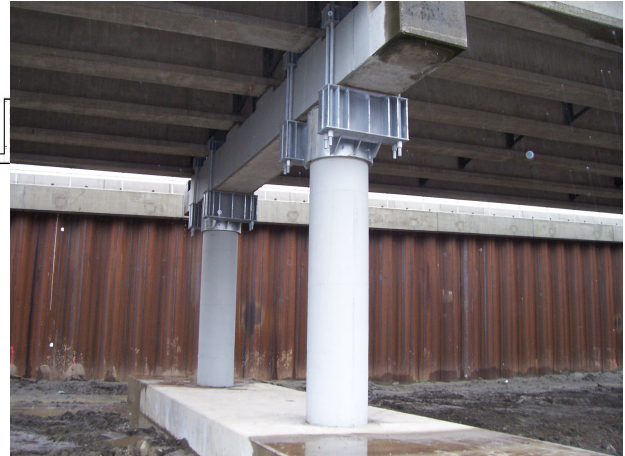
Figure 21. Bent after permanent retrofit (looking west)

Figure 21 shows a typical bent after permanent retrofit. Note the new parallel overpass in the background.
