Horizontal displacement of a catalogued house in Mexico City

Erika B. Valle-Puga, José A. Segovia-Pacheco & Enrique Santoyo-Villa
TGC Geotecnia, Mexico City, Mexico.

ABSTRACT

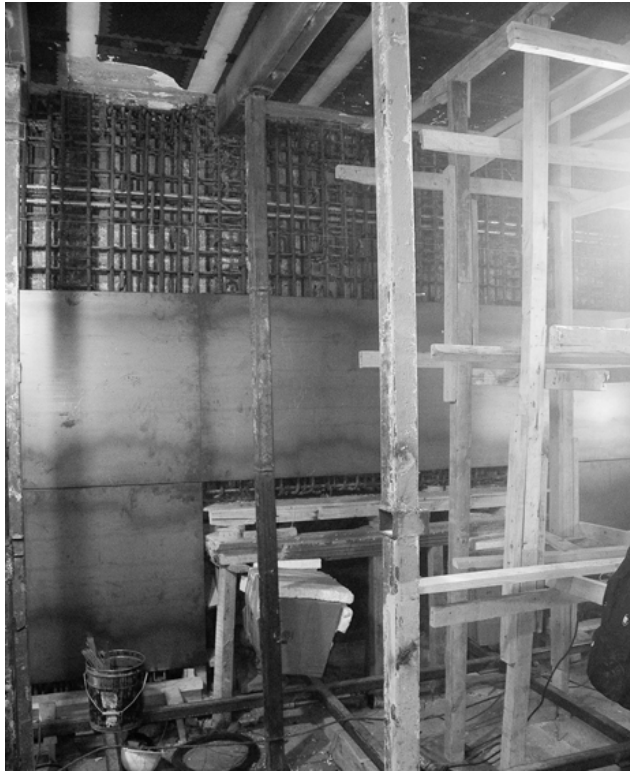
In addition, some of the internal walls were covered with a steel mesh plastered with mortar and others protected with a reinforced concrete wall (Fig. 4).

Figure 4. Strengthening of the house with reinforced concrete walls (Courtesy of Fondo Hexa)

Being it a structure built at the beginning of the 20th century, the old catalogued house was quite susceptible to any deformation; therefore, to guarantee the minimum cracking it was necessary to reinforce it structurally and for this purpose turnbuckles and bracing were placed so the few centimeters of deformations expected would not affect the structure.

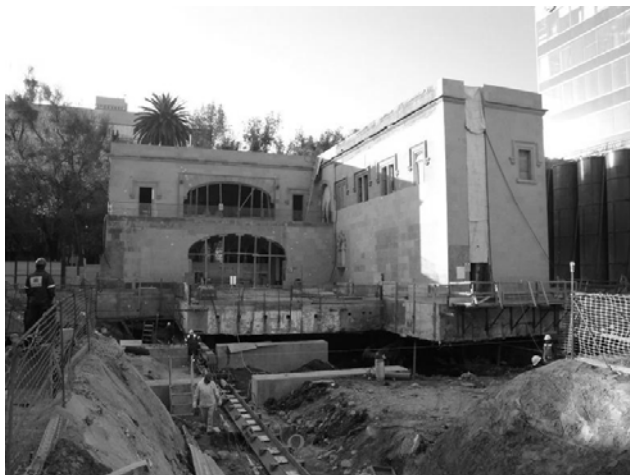
During the movement, the house was supported only in two of its ends, with a support separation of 19.0 m approximately. As the house is fragile, the main challenge was to control the deformations that could be experienced with a span of such dimensions. The solution consisted in placing the house on a sort of "tray" with enough stiffness to have only small deformations when the house was lifted and moved (Fig. 5).

Figure 5. View of the house prior to the movement

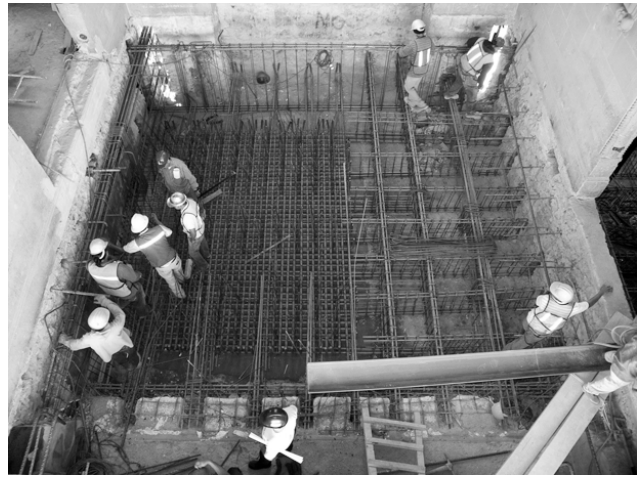
This tray underpins the house and is a light-weight slab formed by ribs with a depth of 1.75 m and by other secondary ribs with a depth of 0.8 m, all of them poured in concrete with a strength, $f'c = 70$ MPa (Fig. 6).

Figure 6. Construction of the ribbed slab for underpinning

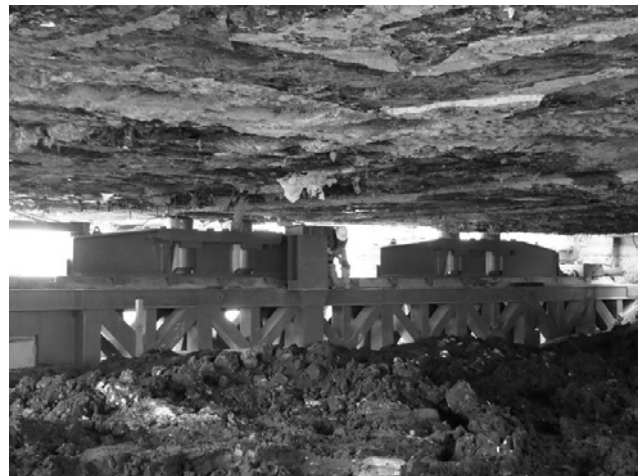
The tower diaphragm walls were used as supports for the rails. It was also necessary to place steel trusses among some of these walls, at zones where there was no

slurry wall because they were part of the architectural and structural solution of the building basement, (Fig. 7).

Figure 7. View of the truss placed between diaphragm walls after the hydraulic jacks had been positioned

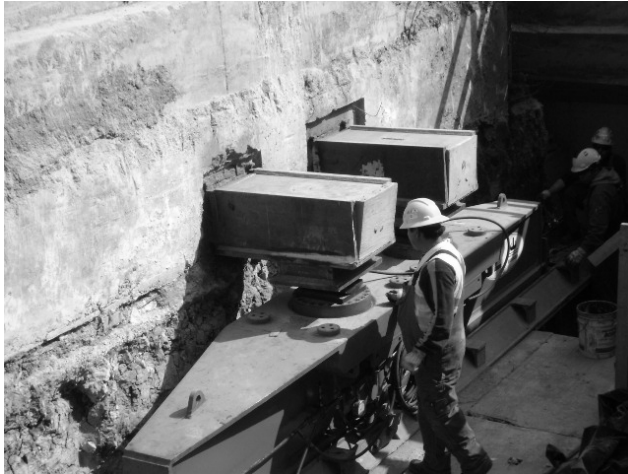
On the other hand, the location of the house prevented an accurate placement underneath of the elements designed to support the rails; therefore, some brackets embedded in the underpinning slab of the house were installed to serve as supporting points for the hydraulic jacks (Fig. 8).

Figure 8. Detail showing the hydraulic jacks (skid shoes) and the brackets embedded in the foundation slab

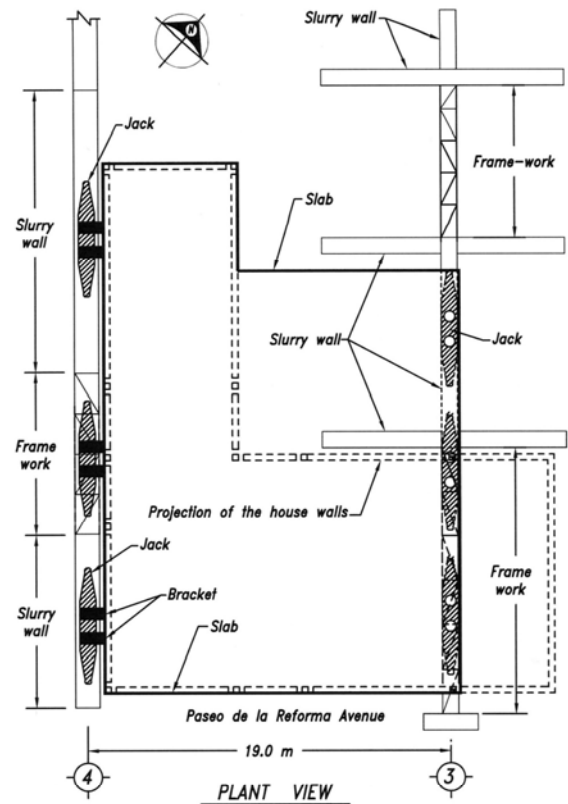
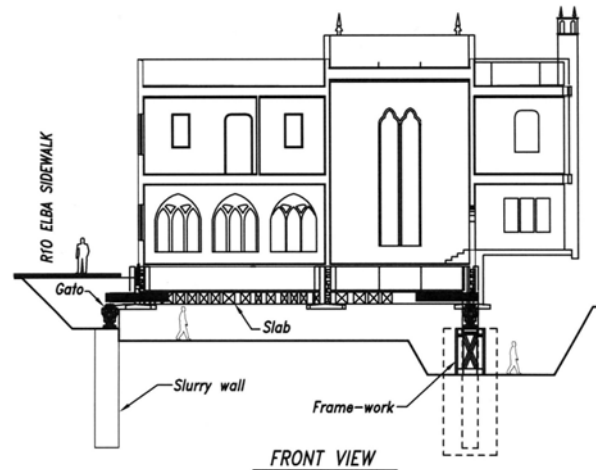
Initially, the excavation was made under Axes 3 and 4 where temporary hydraulic cylinders were placed to support the house while completing the rest of the excavation (Figs. 9 and 10).

After the skid shoes were properly placed, the jacks were pushed for the first time to support the house on them. Initially contact was made with all jacks placed at Axis 3 followed by those at Axis 4 (see Fig. 9). Subsequently, pressures in the jacks were measured and levels were verified to confirm that the theoretical weight of the house corresponded to the actual value.

Figure 9. Schematics of the location in plan of the supporting foundation for the rails during the sliding

The six skid shoes placed were distributed between two axes, as shown in Figure 9; these sliding runners supported loads varying from 432 t and 782 t, depending on their location and on the loads transmitted by the structure. Each skid shoe was 5.5 m long and had a total capacity of 1000 t, distributed in two vertical hydraulic cylinders with an individual capacity of 500 t and a stroke of 30 cm each.

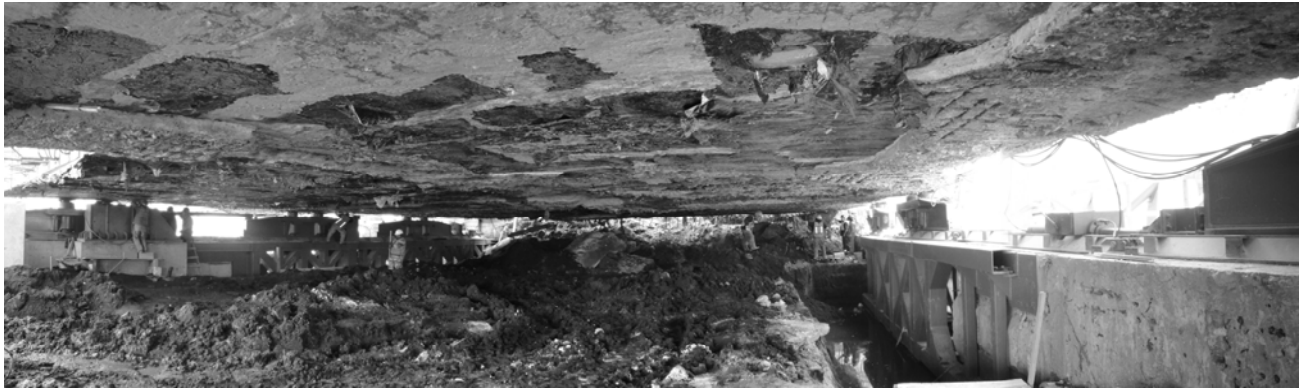
Figure 10. Panoramic view under the house foundation being supported by the hydraulic jacks prior to its moving

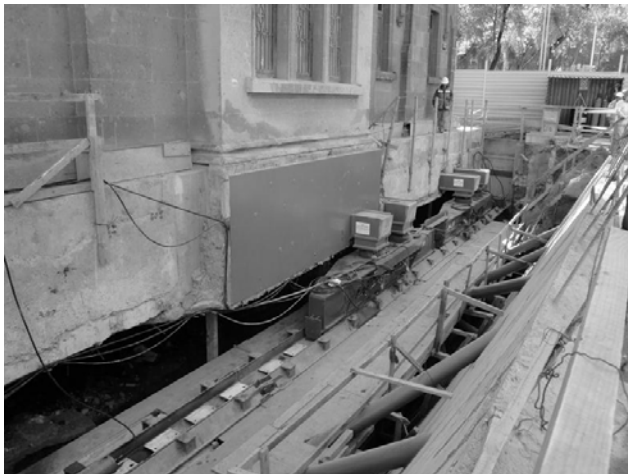
A system SKS1000 was used for the movement, which included modular rails and sliding runners or skid shoes (Fig. 11).

Figure 11. System SKS1000 constituted by modular rails and sliding runners (skid shoes)

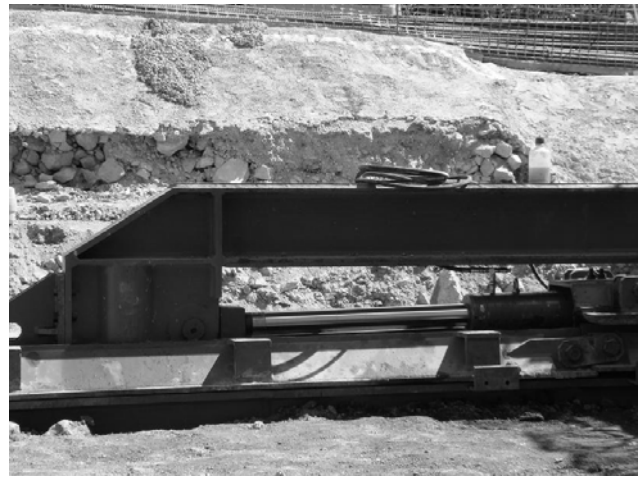
Four thrust hydraulic cylinders SS500 placed along two rows of rails supported by the skid shoes with an individual capacity of 64 t were used to supply the movement force (Fig. 12).

Figure 12. Detail of one of the thrust cylinders SS500

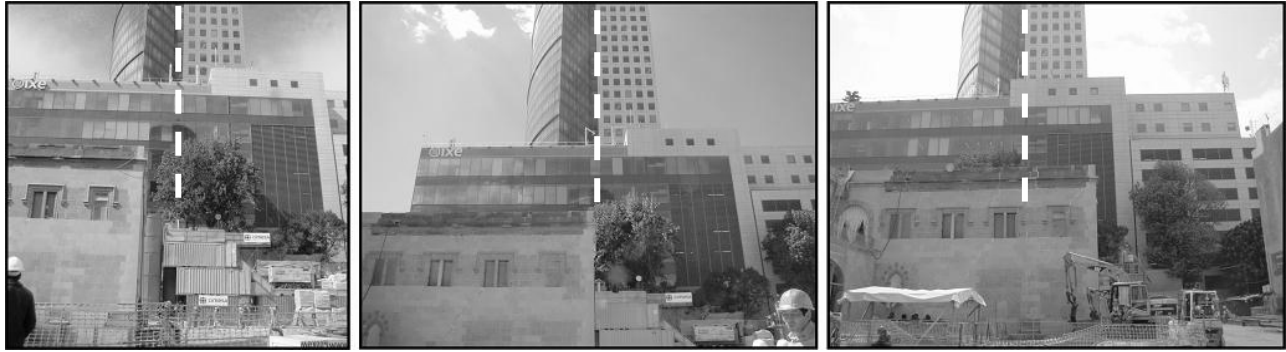
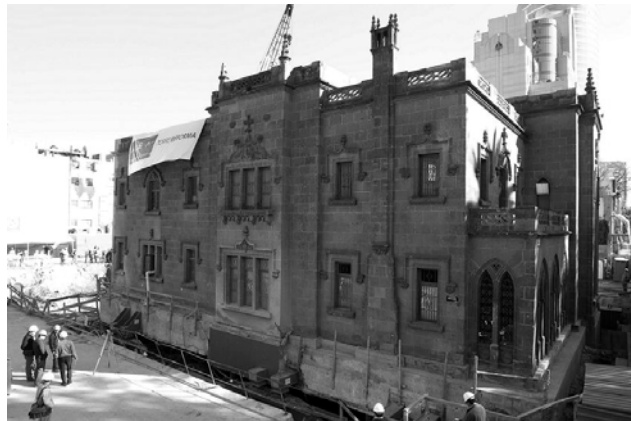
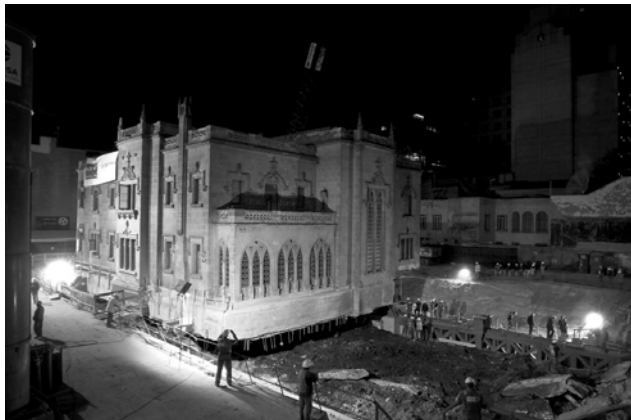
Figure 13. Sequence showing the movement of the house taking as reference one of the edges of Torre Mayor.

Figures 13 to 15 show the sequence of the first movement carried out. This initial movement lasted approximately 10 hours; the house only experienced some small fissures that, in general, corresponded to cracks that had been plastered at the beginning of the project but not represented any risk to the stability of the structure. During the time elapsed in its temporary position, the inside of the house was strengthened protecting its walls with steel mesh plastered with mortar. When the house was moved back to its original site no problems were found.

Figure 14. Original location of the house (Courtesy of Fondo Hexa)

Figure 15. Location of the house after its moving (Courtesy of Fondo Hexa)
