# The effects of deep excavations in soils and rock on adjacent structures

## The 2011 R.M. Hardy Address

K.Y. Lo  
GRC Director and Professor Emeritus  
*The University of Western Ontario, London, ON, Canada*

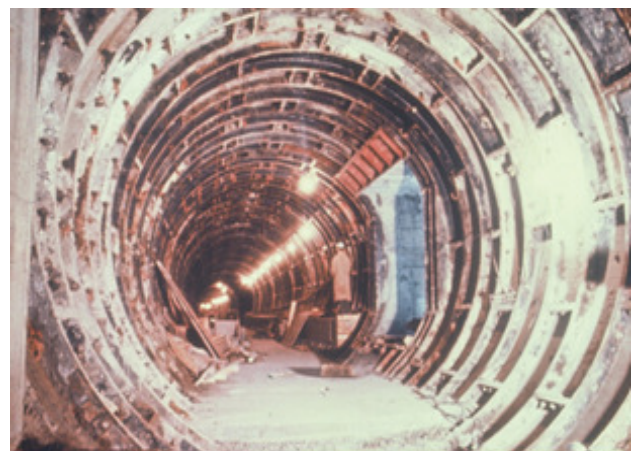
Figure 2. TTC Subway tunnel

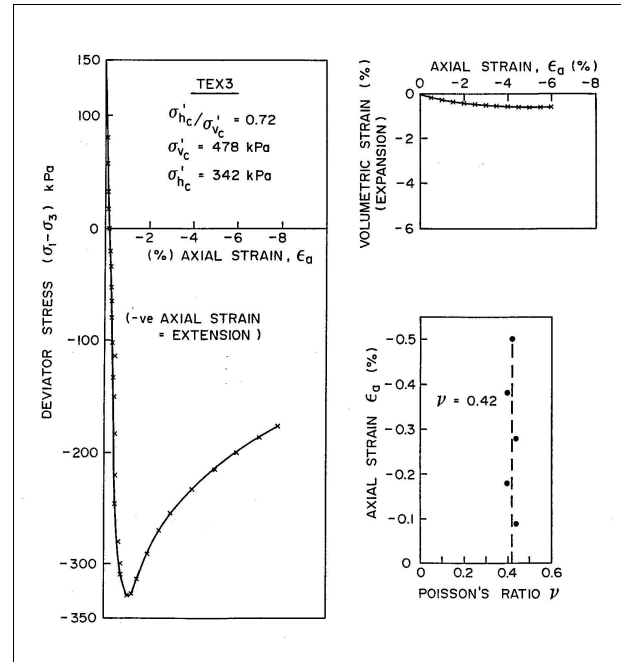
Typical results of a triaxial extension test are shown in Figure 4. It may be seen that the initial portion of the stress-strain curve is linear up to at least 0.4% axial strain. The strain at failure is approximately 1%. The sample dilates during shear but the volumetric strain is small. The Poisson's ratio is 0.42 in this test.

Figure 4. Typical results of anisotropically consolidated drained triaxial extension test

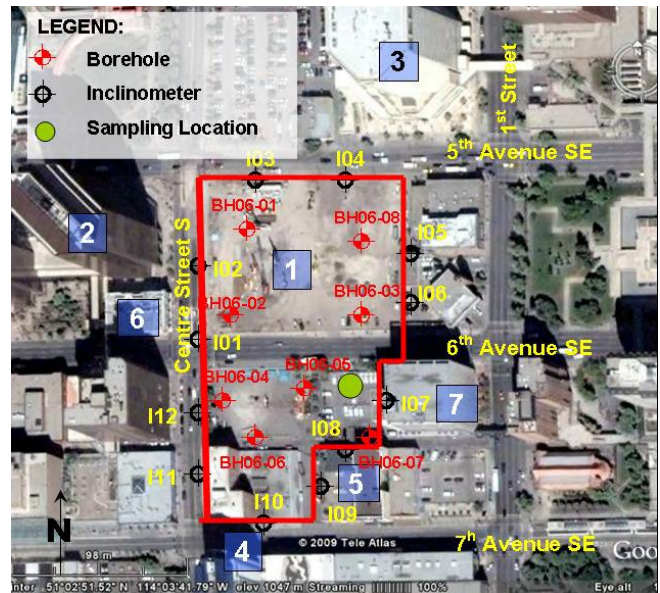
Figure 15. The Bow site: (1) The Bow; (2) Petro-Canada Centre; (3) Telus; (4) Calgary's Light Rail Transit; (5) The Royal Canadian Legion No. 1; (6) Chamber of Commerce and (7) Andrew Davidson Building (modified from Lo et al. 2009)

To obtain the required strength and deformation parameters, block samples were recovered from the bottom of the excavation at the location shown in Figure 15. The highly fissile nature of the mudstone rendered both sampling and preparation of specimen for triaxial and shear box tests very difficult. Nonetheless, adequate test results were obtained for the on-going analysis and excavation process.

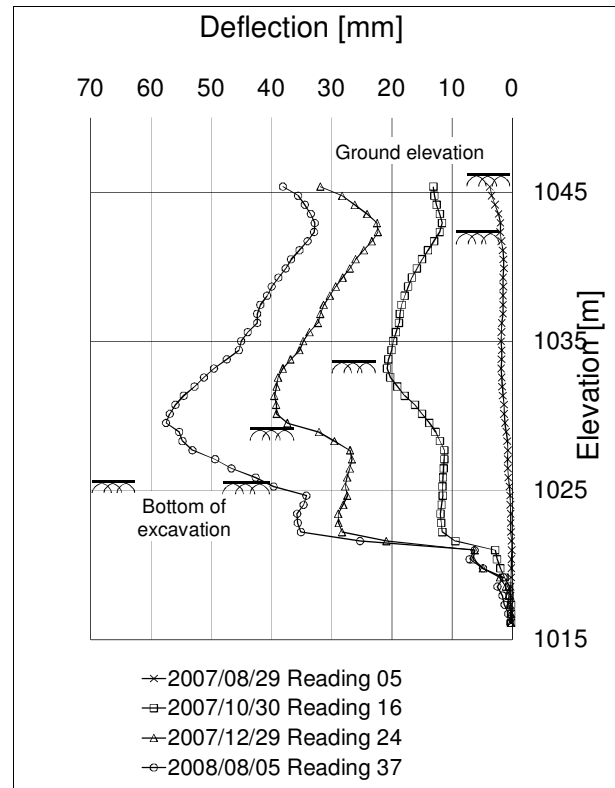
As excavation proceeded and results of monitoring became available, it became evident that potential threat of excessive deformation exists. Figure 17 shows that even though the excavation was only 12 m deep and was 6 m into rock and 14 m above the shear band, the displacement at the shear band had already been triggered resulting in a displacement of 10 mm. It was therefore necessary to define the uncertainties involved in the design problem and address these issues so that construction may proceed with a better understanding of the rock behaviour for construction control.

Figure 17. Inclinometer 4 Readings

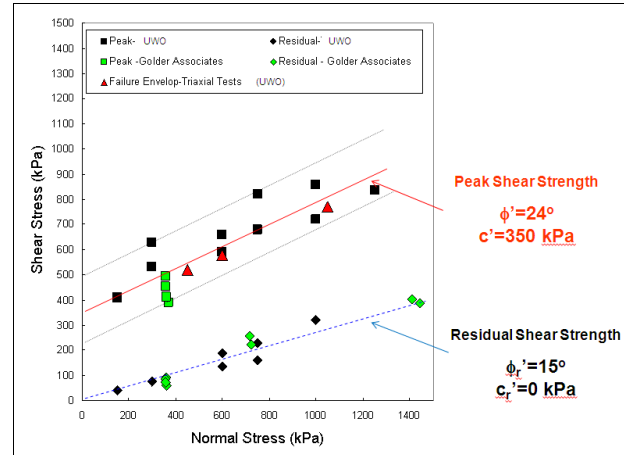
The results of shear box and triaxial tests are shown in Figure 19. To verify the reliability of test results, tests were performed at two laboratories. It can be seen that the results were quite consistent, yielding peak strength parameters of  $c' = 0.35$  MPa and  $\phi = 24^\circ$  and residual parameters  $c'_r = 0$  MPa and  $\phi'_r = 15^\circ$ . Further details of test results and deformation parameters obtained therefrom may be found in Lo et al (2009). The engineering parameters employed in numerical analysis for each rock unit are summarized in Figure 20.

Figure 19. Multistage direct shear test results

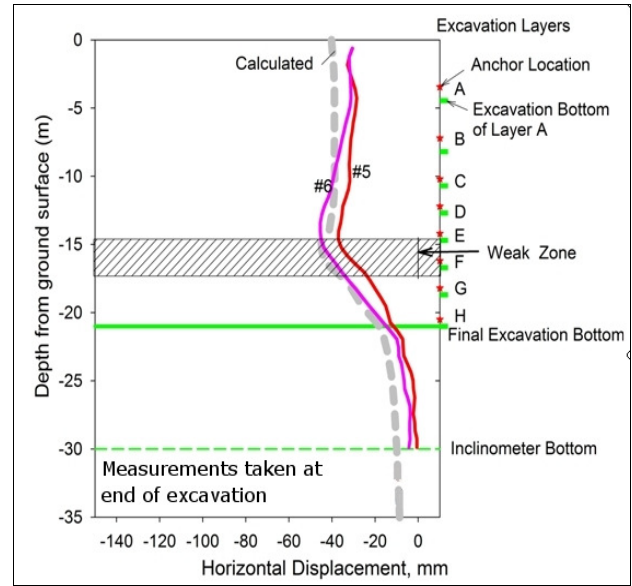
Figure 24. Calculated and measured deflections – East wall

The calculated and measured deflections at the East Wall at locations of inclinometer 5 and 6 are shown in Figure 24. At these locations the shear band did not exist but the effect of the weak zone was apparent. No abrupt discontinuity of the displacement distribution with depth occurred. As can be seen in Figure 24, the results of numerical analysis represent the measured deflections of

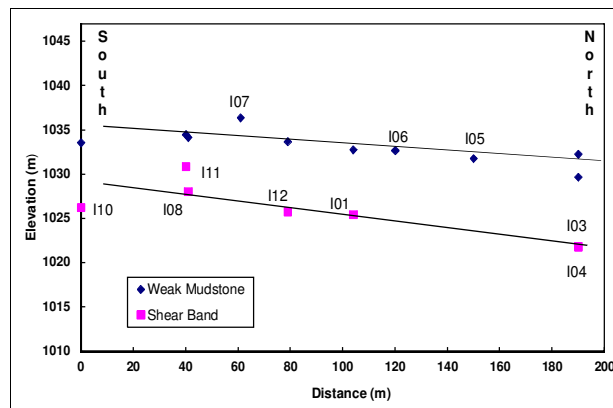
From results of inclinometer monitoring, it is possible to identify the occurrence and location of the weak zone and shear band across the site. The results are shown in Figure 26. It is noted that the weak zone was present at all locations monitored by the inclinometers.

Figure 26. Inclination of the weak zone and shear band across the site

The shear band, however, was not exhibited at locations of I05, I06 and I09. It is also interesting to note that both the shear band and weak zone have apparent movement towards the Bow River in the north.
