Collapsible clayey soils in the north-eastern region of Venezuela

José I. Amundaray, Alvaro Boiero
Amundaray Ingeniería Geotécnica, C.A., Caracas, Venezuela
Escuela de Ingeniería Civil – Universidad Católica Andrés Bello, Caracas, Venezuela.

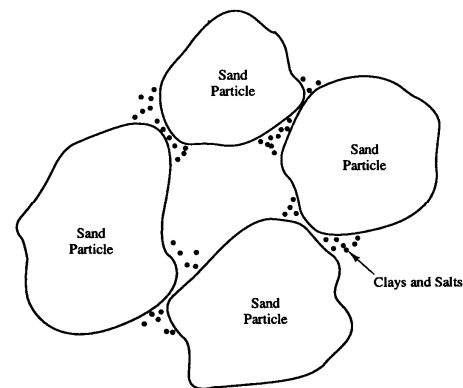
Figure 1. When deposits of highly saturated earth flows dry off by evaporation, clay particles and salts move towards the points of contact among sand particles (from Coduto, 1994)

When earth flows are developed, their saturation levels are high and their corresponding void ratios are high. After they reach a static condition, these soils dry off quickly by evaporation. Then, the generated capillary tension draws smaller particles of clay, silt, and probably dissolved salts towards the points of contacts among sand particles, forming bridges of cementation that keeps an stable structure while the partial saturation is maintained, Figure 1. These deposits are erratic with variable thicknesses depending on the topography (Coduto, 1994).

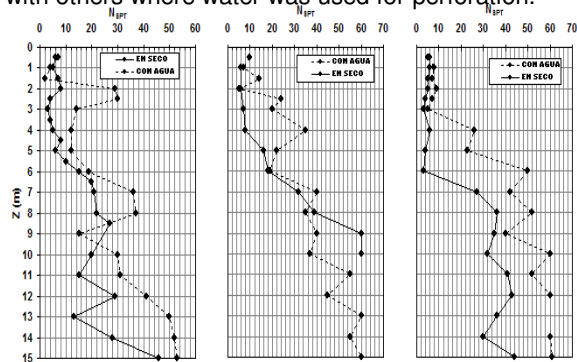
Figure 2. Comparison of values of SPT values measured in dry conditions and using water injection.

The penetration resistance values (SPT) of these soils are generally lower than 10. However, it is necessary to take some precautions when performing the SPT such as avoiding the use of water injection and the use of driven casing to prevent the collapse of the soil prior to the execution of the SPT. Usually, the hole walls are stable for collapsible soils and the use of casing is unnecessary. The effect of early collapse during the execution of the SPT is shown in Figure 2, where SPT penetration resistance values from dry test are compared with others where water was used for perforation.

The use of water and a driven casing induces a significant and random increment in soil density, giving the impression that the soil has a higher penetration resistance than its actual value (Geohidra, 1997; Geohidra, 1998).

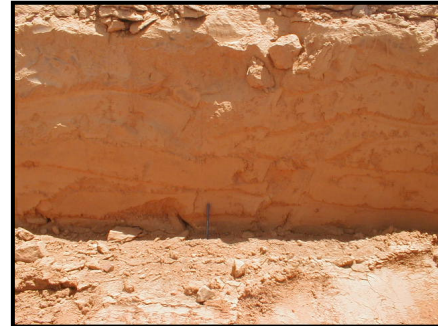
Figure 3. Excavation in collapsible soils showing vertical walls and big lumps of soil.

Visual identification of collapsible soils in test pits is of crucial importance. In test pits excavated in collapsible soils in the area of Jose, it was observed that walls are stable. During the excavation, the soil broke down in big and fragile blocks, as shown in Figure 3. These blocks are light easy to disaggregate with bare hands.

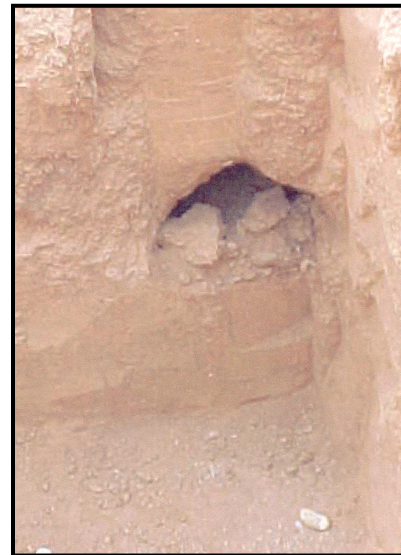
Figure 4. Natural cavity in collapsible soils found during an excavation.

Along the walls of the test pits, typical cavities and voids are frequently observed, they act as natural pipes for percolating rain water, producing piping and increasing the fragility of these soils. Many cavities are also associated with the activity of insects and other animals. Typical cavities found in tests pits are shown in Figure 4.

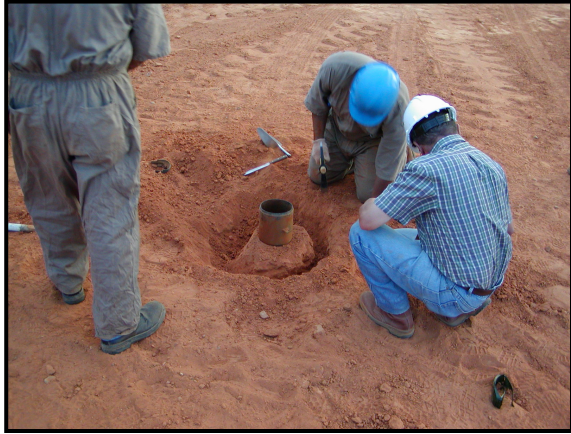
Figure 5. Undisturbed samples with ring.

carved cubic samples, and 4 and 6 inch diameter ring samples. However, retrieving undisturbed samples in other regions could be more difficult if the soils are more sandy or have less cementation. Retrieving of undisturbed collapsible soil sample with ring sampler is shown in Figure 5.

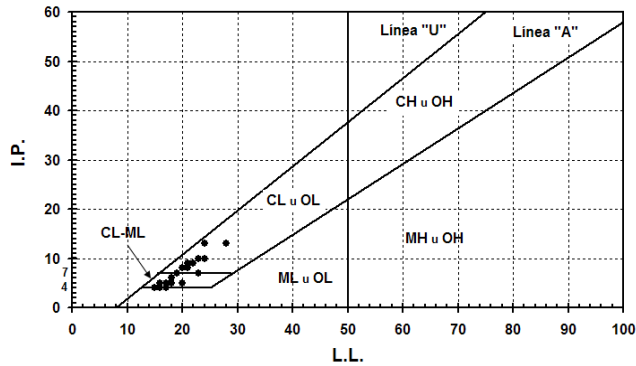
Figure 6. Classification of collapsible soils using the Casagrande's plasticity card

The soil classification tests performed on undisturbed samples, that were used for collapse tests, showed unexpected results since the visual classification of such soils in the field always indicated fine clayey silty sands (SM-SC). However, the vast majority of the laboratory classification indicated low plasticity clays (CL) or sandy silty clays (CL-ML), as shown in Figure 6.

The classification tests are very useful for identifying collapsible soils in this area because they are very homogeneous. Hence, the plots shown in Figures 6 and 7 can be used as guidelines when the presence of these soils is suspected. However, these plots are representative of the Jose area, and particular plots should be developed for different places.

Classification plots for collapsible soils shown in Figures 6 and 7, can be used as a guide for comparison when the presence of collapsible soils is suspected.

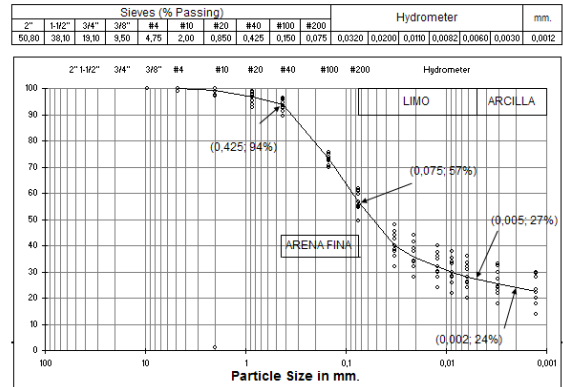
Figure 7. Granulometric curve of average trend of studied collapsible soils

The average grain size distribution curve for 10 samples that were used to perform collapse tests is shown in Figure 7. The envelope of all the measurements is well defined. If the limit between clay and silt is considered as 2μ as per the M.I.T criteria, then 24% is clay, 33% is silt, 37% is fine sand, and 6% is medium to coarse sand.

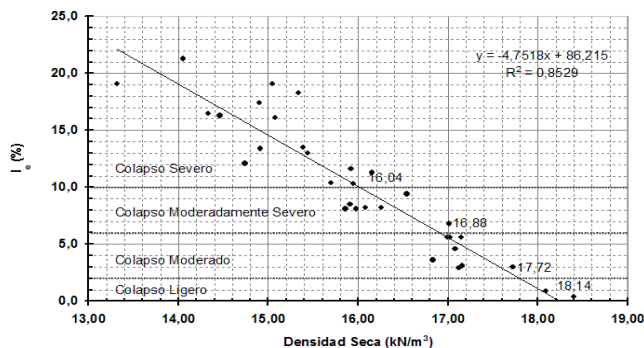
Figure 11. Linear correlation between the *collapse index* and the *dry density* (kN/m^3) of collapsible soils from the Jose area. Based on these results, *dry density* ranges can be defined for the different *collapse indices*, as shown in Table 2:

The results of 33 collapse tests performed on soils from the Jose area are summarized in in Figure 11 (Group Delta, 2001; Ingeniería Geotécnica Prego 2001,

2002, 2003). This figure shows a linear correlation between the *collapse index* and the *dry density* (kN/m^3) of the soil in its undisturbed conditions. The coefficient of determination is $R^2 = 0,85$.

When the presence of collapsible soils is suspected in the Jose area, the in situ *dry density* measurements can be used to estimate the collapsible index from Figure 11. In addition, the soil classification and its grain size distribution can be compared with the trends presented in Figures 6 and 7..

In cases where the presence of collapsible soils is suspected, a measurement of in situ *dry density* can be compared with the plot shown in Figure 11 in order to establish the severity degree of its collapse potential.

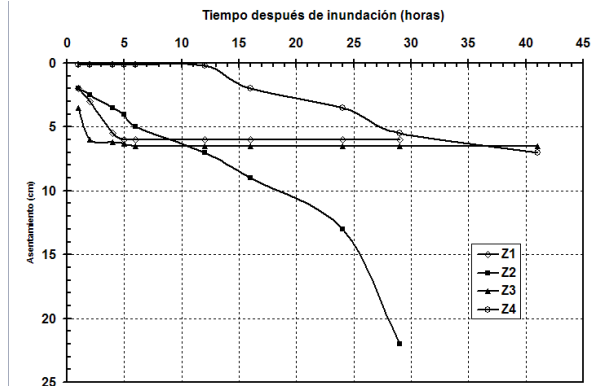
Figure 12. Load test results in collapsible soils of Jose

In situ load tests have been performed in collapsible soils to validate laboratory results. Figure 12 shows the results of field load tests following the ASTM standard D-1194, which requires the saturation of the area after applying a vertical stress of 2 kg/cm^2 .

It can be seen that the magnitude of the recorded collapses varies between 6 cm and 22 cm. These results not only confirm the collapse values obtained in laboratory tests, but also validate the applicability of such tests to reproduce the occurrence of in situ collapse. It is important to highlight, that given the high permeability of these soils (10 a 20 ft/day), water can penetrate fast and quite deeply and produce the settlement of a foundation in a period of 24 hours (Group Delta, 2001).

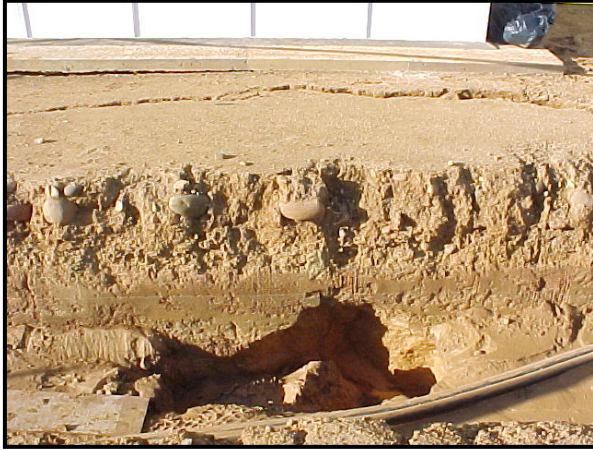
Figure 13. In-situ measurement of the induced settlement in collapsible soils of area of Jose.

The heavy rains on July the 22nd and the 23rd, 2001, provoked the opening of two sumps on the bottom of a trench opened for the piping of power lines, telephone and fiber optics cables. The size of the sumps was approximately $0,60 \times 0,60 \text{ m}$ and $1,5 \times 1,0 \text{ m}$ and it was reported that a large amount of water was flowing into the subsoil through both of those holes. Tension cracks of approximately $15 \times 12 \text{ m}$ with elliptical shape appeared around the trench. These cracks affected the structures of surrounding buildings and a compressor adjacent to the trench. The phenomenon can be observed in Figures 13 and 14.

The possible cause of the phenomenon is presumed to be the collapsible nature of the soils, composed by fine silty sands and sandy silts, whose structure might be prone to collapse in the presence of water. This soil was isolated from rainwater by a layer of compacted soil, but once the trench was excavated the subjacent collapsible soil was exposed. This fact, together with the occurrence of heavy rains that kept the trench flooded for more than 12 hours was enough to generate the collapse without the application of any external loads.

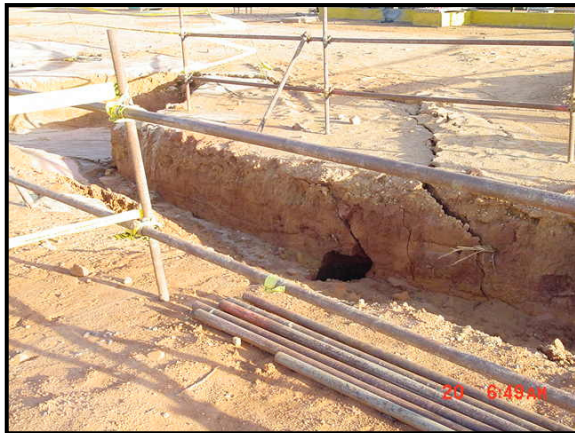
Figure 14. Crack and settlement in the area of collapse of the soils after intense rains.

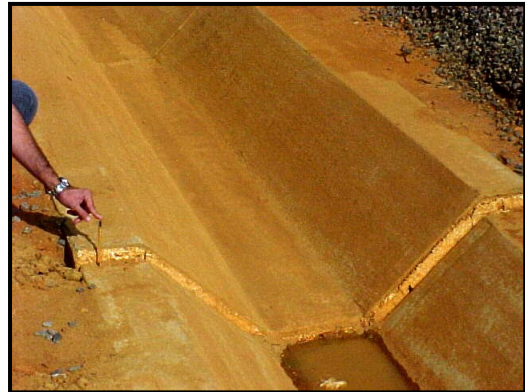
Figure 15. Settlement of 5 cm induced by the collapse of the underlying soil

Drainage channels on collapsible soils are prone to generate collapse problems due to water seepage. In Figure 15, the occurrence of a 5 cm settlement due to collapse after a rain can be observed. It is presumed that the water infiltrated through the construction joint saturating the subjacent collapsible soil.

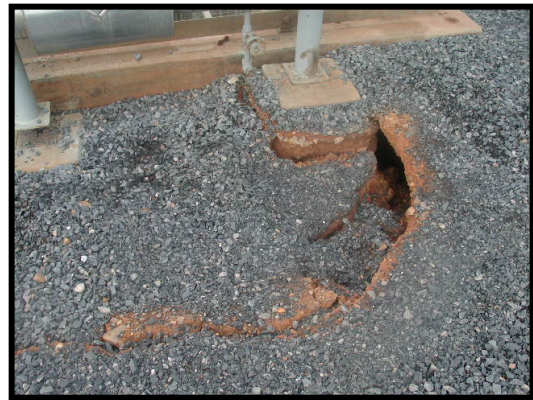
Figure 16. Settlement of an area close to a water structure with an opening cavity.

The opening of cavities and natural piping is commonly observed where rainwater tends to pond (see Figure 16). Such cavities can increase in size and number due to the effect of successive rains, provoking larger collapses with time.

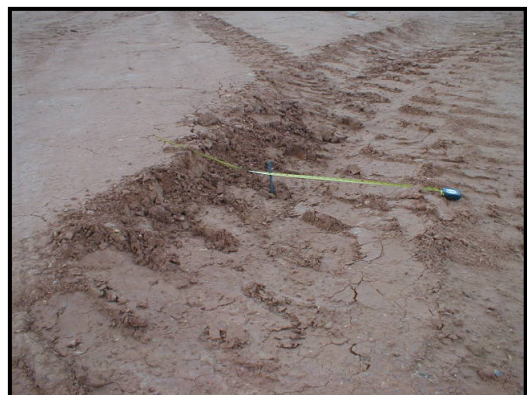
Figure 17. Evidence left by the step of a truck wheel on area in court of collapsible material after rain

In a cut area where collapsible soil outcrops were found, the traffic of water trucks caused settlements of

approximately 10 cm after raining (see Figure 17). In the same place, under dry conditions, no settlement was observed.
