Fulton street transit center – foundation design and construction in a dense urban environment

Joseph Appleby & Craig Covil

Arup, New York, NY, USA

The project is being constructed as a number of separate construction packages. This paper focuses on the design and construction of the substructure of the Transit Center, Contract A-36119, highlights some of the key challenges faced and explains how these were

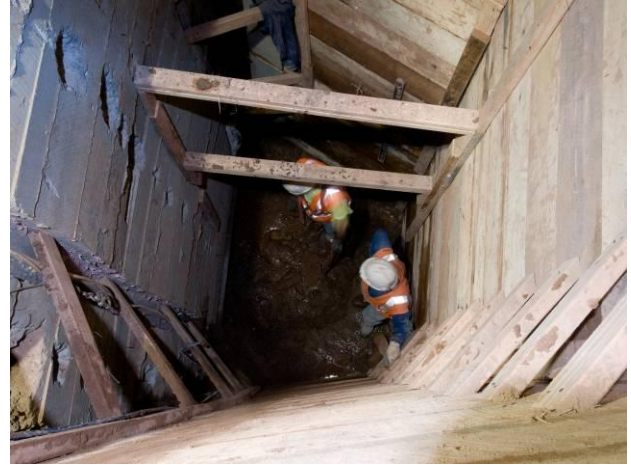
Figure 9. Hand excavated pit.

Once water tightness had been achieved, hand excavated pits were constructed and concrete underpinning piers were formed beneath the existing foundations. Thirty four pits were excavated, these were 5ft by 5ft and ranged from 10 to over 30ft deep, as shown in Figure 9. To reduce the likelihood of settlement, the

pits were carefully shored and sequenced in a similar manner to the secant piles ensuring that no adjacent pits were opened at the same time.

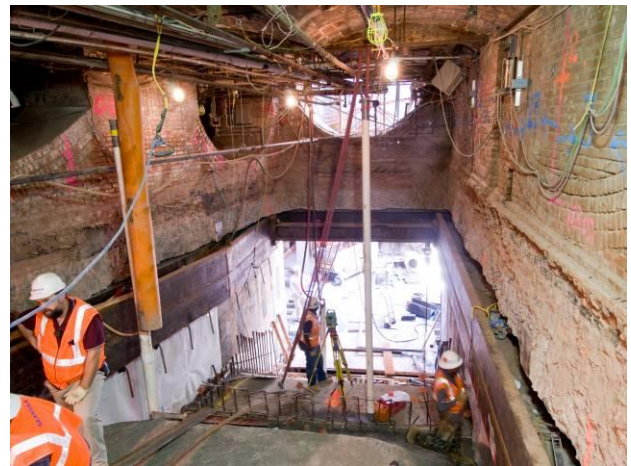
Figure 10. The escalator pit beneath the Corbin Building, facing west.

Once the underpinning piers had been completed, the excavation for the escalator pit was carried out, and the connections to the newly poured Transit Center substructure. See Figure 10.

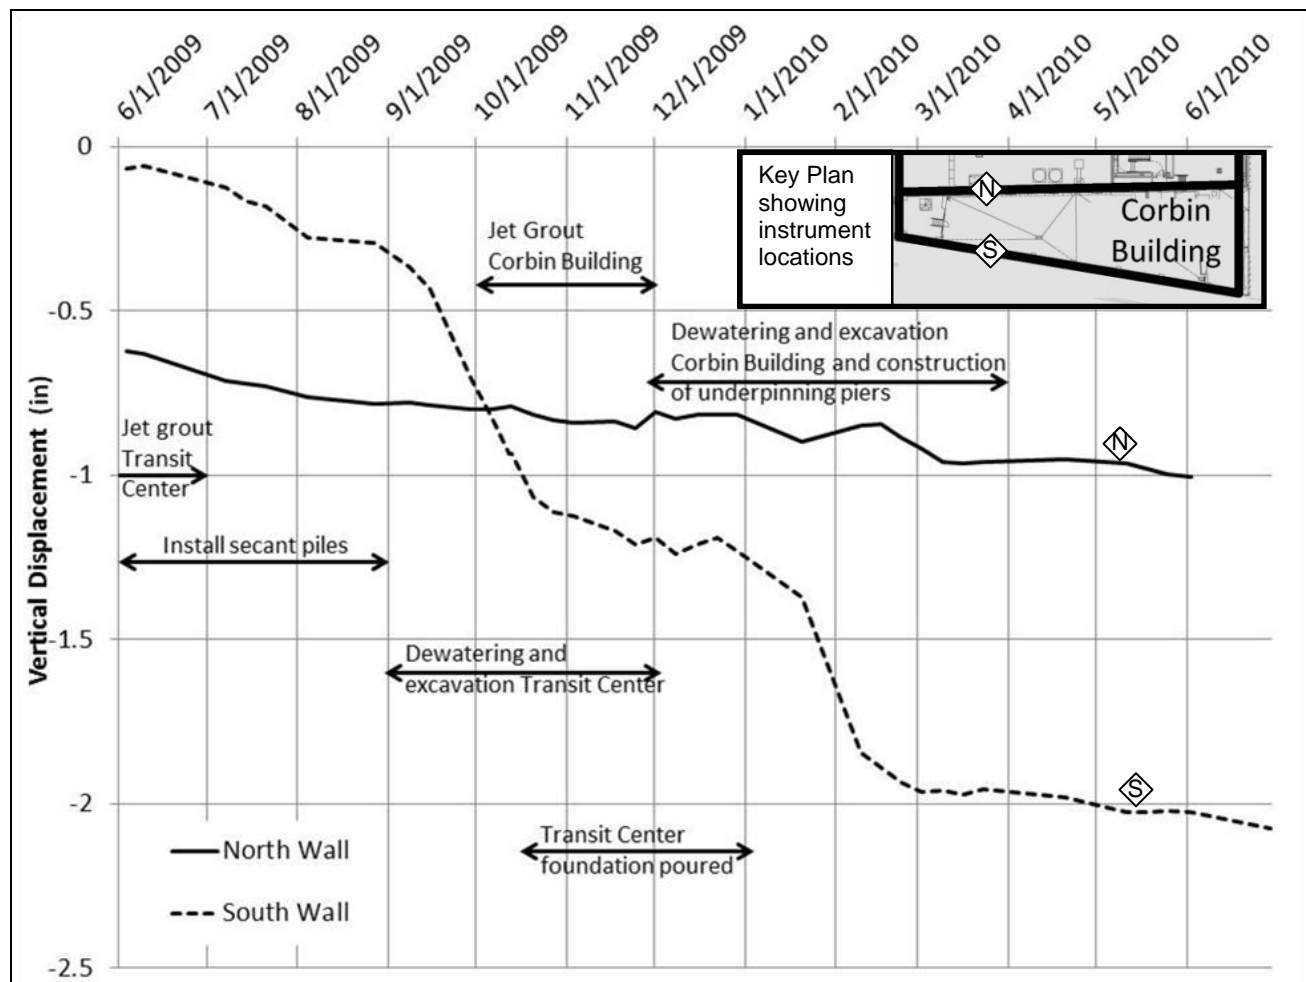
Figure 12. Plot showing the settlement for two of the columns of the Corbin Building, one in the north wall and one in the south. The north wall was underpinned with jet grout prior to the excavation of the Transit Center site.

Settlement results for a sample point on the north wall of the Corbin Building and a sample point on the south wall are shown in Figure 12. These points represent the highest movements observed at the north and south faces of the structure.

The north wall of the Corbin Building, immediately adjacent to the Transit Center site shows approximately 0.6in of settlement before June 2009. This movement was due to the demolition of the existing buildings on the site (approx 0.475in), and the installation of the jet grout columns beneath the wall (approx. 0.125in). Once the jet grout was installed, the settlement of the wall due to the installation of the secant piles, excavation of the Transit Center site, construction of the underpinning piers and excavation of the escalator pit beneath the Corbin Building was relatively small, when compared to the south wall, only experiencing a further 0.4in of vertical movement.

The south wall of the Corbin Building is approximately 25ft further from the Transit Center site and was not underpinned by jet grout. It experienced little settlement due to the demolition of the existing buildings on site, and the installation of jet grout and secant piles to the north (0.25in). However, the south wall continued to settle throughout the remainder of the construction works, most significantly during the dewatering and excavation of the Transit Center site and of the Corbin Building site.

The dewatering and excavation of the Transit Center site took place from September through November 2009, during that time the south wall of the Corbin Building settled by approximately 0.9in. By comparison, the north wall settled by less than 0.1in in the same time period. During the same period, a jet grout curtain was installed to create a water tight bath tub beneath the Corbin Building, as this was located away from the building footings the effect was not expected to be significant and the majority of the movement of the south wall during this period is assumed to be due to the main site works.

The second significant movement of the south wall occurred during the dewatering and excavation of the escalator pit beneath the Corbin Building itself, approximately 0.75in. Daily monitoring at the time indicated that the excavation, construction and the transfer of load onto the underpinning piers caused about 0.125in of this, the remainder being due to the dewatering and excavation of the escalator pit itself. Once the escalator pit was completed, settlements decreased to effectively zero.
