Stabilization of Alberta Highway Landslides using Pile Walls

Tarek S. Abdelaziz, Donald W. Proudfoot
Thurber Engineering Ltd., Edmonton, Alberta, Canada
Roger Skirrow
Alberta Transportation, Edmonton, Alberta, Canada

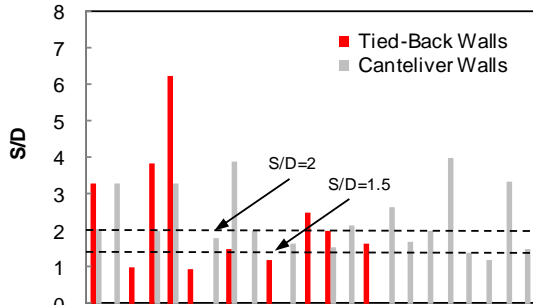
Figure 2 shows the distribution of S/D for all of the pile wall sites. The ratio typically varied between 1 for tangent piles and 4 for spaced piles, with average values of 1.5 and 2 for cantilever and tied-back walls, respectively. Figure 3 shows the distribution of L_b/H_u for all of the pile wall sites. The ratio varied from 0.7 to 4, with average values of 1 and 1.5 for cantilever and tied-back walls, respectively.

Figure 2. Distribution of S/D for pile walls

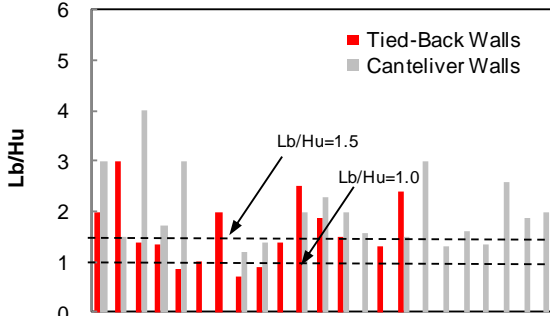
Figure 3. Distribution of L_b/H_u for pile walls

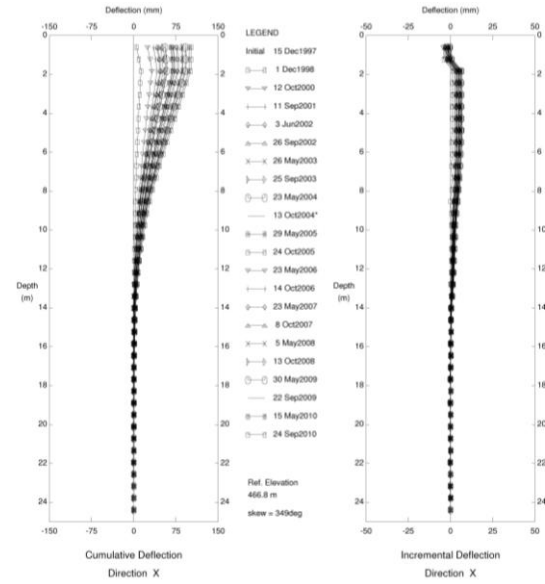
Figure 4 presents an example of slope inclinometer plots for a cantilever pile wall. Plots of incremental and cumulative deflections from one of the slope inclinometers installed at Site 10, Meikle River upper wall, are shown in this figure. It should be noted that positive and negative deflections indicate downslope and upslope movements, respectively. The incremental deflection plot shows no distinct kink in the plot at the slip surface (10-12 m depth). This indicates that the pile wall successfully retained the slide mass without sacrificing the integrity of the wall. The cumulative plot indicated that the pile head has deflected downslope of the highway by about 100

Figure 4. Incremental and cumulative deflection versus depth plots for the Meikle River upper wall.

mm between December 1997 (installation date) and September 2010 (i.e. wall moved at a rate of 6.6 mm/year) and that the lateral deflection occurred primarily between the top of the wall and 14 m depth (2-4 m below the location of the slip surface). The plots basically pointed out that the pile wall was embedded sufficiently into the stable stratum below the slip surface to develop the required resistance and stabilize the slide movement, and deflected by about 0.4 % of its height.

Table 2 summarizes the lateral pile head deflection (δ) to pile depth (H) ratio from available slope inclinometer data. It can be seen from the table that cantilever pile walls deflected by 0.1 to 0.5%, with a typical value of less than 0.5 %, of the full height of the wall. The available information for tied-back walls indicated that the pile walls deflected by less than 0.05 % the full height of the wall. Tied-back walls exhibited less deflection compared to cantilever walls due to the pre-stress forces in the anchors. In TRANS projects, a 70 mm pile head deflection was considered to be a reasonable upper threshold for deflection. For the Meikle River slide, one of the piles has deflected by more than 70 mm. The ongoing monitoring will determine whether supplementary measures are required to fully restrain the landslide block at this site.

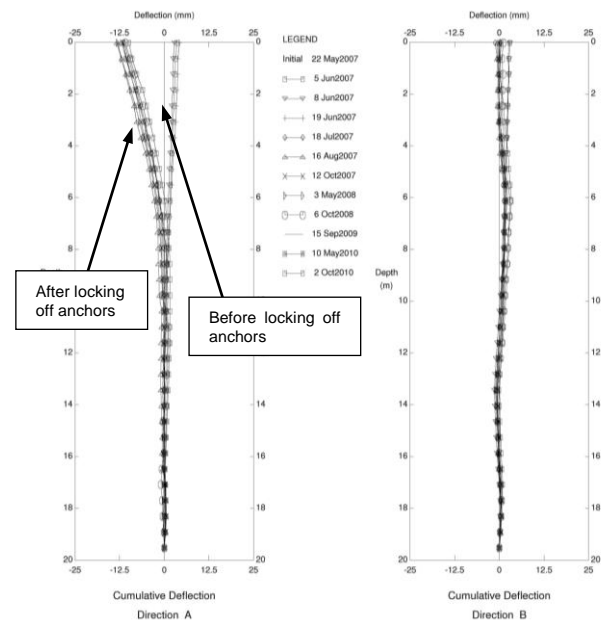
Figure 5. Incremental and cumulative deflection versus depth plots for the Lindbergh Hill wall

Figure 5 presents an example of the slope inclinometer plots for a tied-back pile wall. Plots of incremental and cumulative deflections from one of the slope inclinometers installed at Site 20, Lindbergh Hill

wall, are shown in this figure. At this site, the grouted anchors were locked-off one month after the installation of piles was completed. It can be seen from the cumulative deflection plot that the wall deflected a bit in the downslope direction prior to locking off the anchors (i.e. cantilever type pile wall behaviour). Immediately after locking-off the anchors, the pre-stress forces in the anchors pulled the wall into the upslope direction (towards the highway) by about 12.5 mm. Minimal movements were noted in the slope inclinometer after applying the pre-stress forces in the anchors. In this case, the slope inclinometers were very helpful during and after construction to capture slide movements prior to the locking off the anchors and monitor the effect of locking-off anchors on the overall behaviour of the wall.

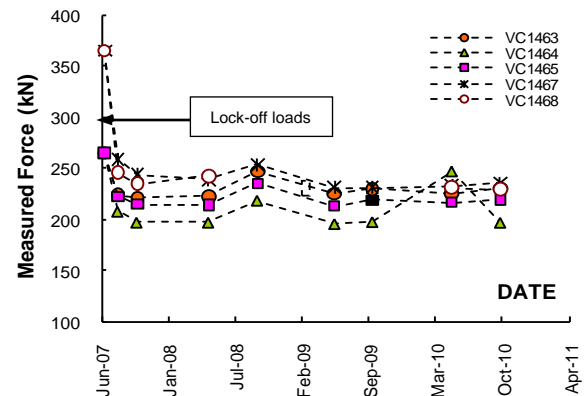
Figure 6 shows the variation of anchor loads with time for the Lindbergh Hill pile wall. Although the anchor design loads dropped by 15 to 30 % one month after locking off the loads in 2007, the variation in loads afterwards remained negligible in the majority of monitored anchors and varied by 6 to 9%. The reduction in the anchor loads was probably due to the non-simultaneous locking of anchors and re-distribution of loads along the wall. No evidence of cracking other than reflective cracks was noted on highway surface and the site continued to perform satisfactorily.

Figure 6. Variation of anchor loads with time for the Lindbergh Hill wall
