Study of a large landslide and mudflow at Gaspar, SC, Brazil

Marcelo Heidemann & Luiz A. Bressani
*Department of Civil Engineering – Federal University of Rio Grande do Sul,
Porto Alegre/RS, Brazil*
Juan A. Altamirano Flores
*Department of Geosciences – Federal University of Santa Catarina,
Florianópolis/SC, Brazil*

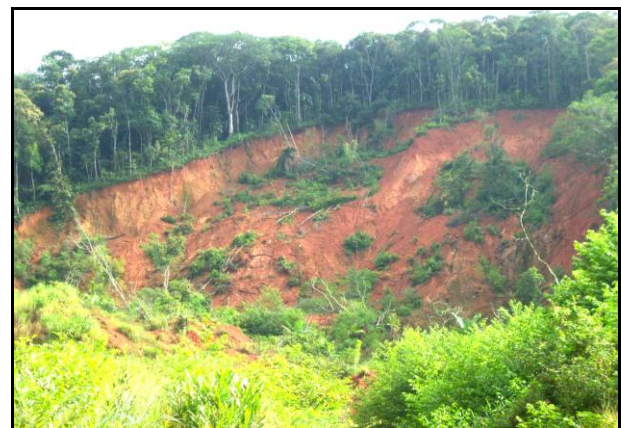
It was only on December 6th that the 2 main movements occurred. The first, classified as a fast rotational sliding of wet soil (Cruden and Varnes criterion, 1996), was followed almost immediately by a great mass movement in the form of an extremely fast rotational sliding of wet soil, followed by very rapid mud and debris flow. This big slide moved a volume of soil estimated at 110,000 m³ (estimate based on the method proposed by Cruden and Varnes, 1996). The resulting scar of the movement is shown in Figure 2 (February 2010). Figure 3 shows an aerial view of the area of instability (on the left) and an older scar close by.

Figure 2. The scar of the movement – photo of February 2010.

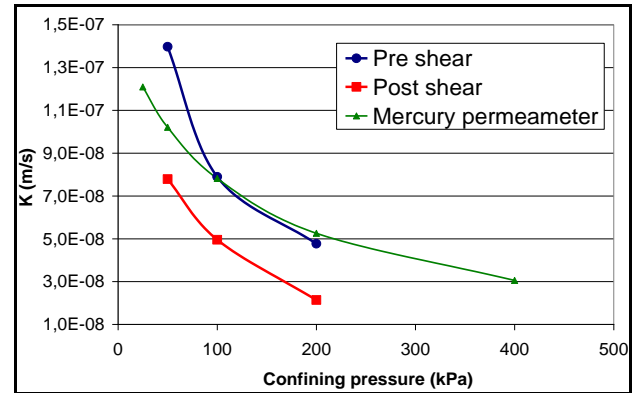
In Figure 5 are presented the coefficients of hydraulic conductivity (K_s) obtained from tests in the triaxial compression chamber and in the permeameter.

The coefficient of hydraulic conductivity measured at different confining stresses showed a well-defined reduction in the k_{sat} coefficient with increasing confining stress. The value of k_{sat} was found to be within the range of silty soils.

The results obtained before and after shearing in triaxial tests show that there is a slight reduction in hydraulic conductivity after the failure and associated deformations. In the test with confining pressure of 50 kPa this variation was more pronounced than in higher pressures.

Figure 5. Hydraulic conductivity tests results

The granulite soil has low hydraulic conductivity, with typical values of silts ($k = 1 \times 10^{-7}$ to 3×10^{-8} m/s). After failure by shearing in triaxial tests, the soil showed a reduction of about two times of the hydraulic conductivity (perpendicular to the plane of failure). In the field, such characteristic can give rise to the appearance of low permeability zones and the consequent increase in pore pressures. Such low permeability may have contributed to the observed delay of about one week between the intense rainfall episodes and time of sliding.

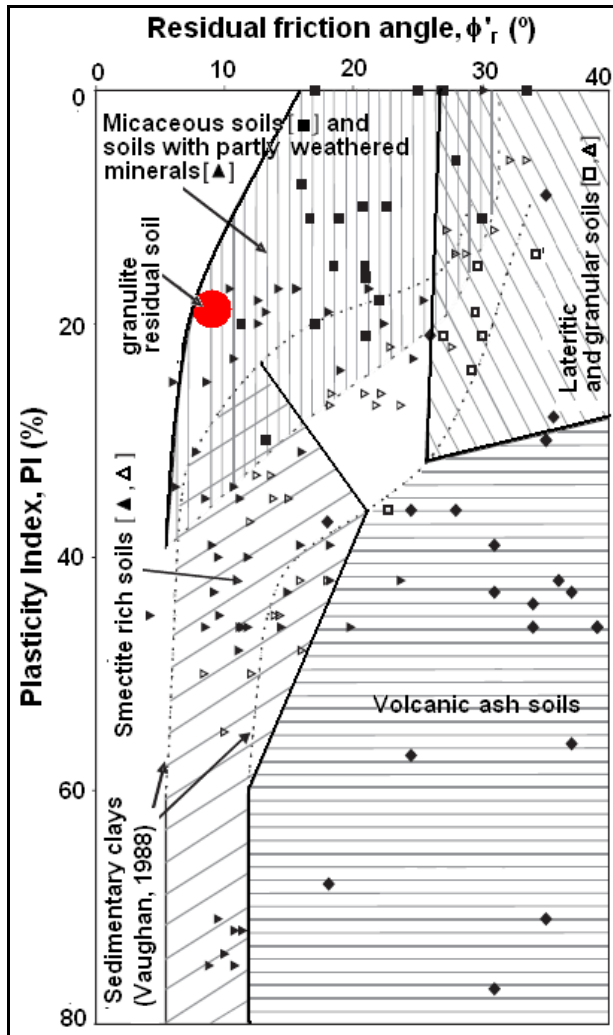
This value of $\phi'_r = 8.8^\circ$ is quite low when compared to those obtained in several Brazilian tropical soils. However, according to data presented by Rigo et al. (2006) (Figure 7), the residual soil of granulite is similar to some soils composed of partially weathered minerals, as they present low residual friction angle in spite of their low IP. According to Rigo et al. (2006), this is due to degradation of the partially weathered minerals when subjected to large shear strains, with subsequent orientation of the particles and so promoting failure under transitional or even sliding conditions.

Figure 7. Graph of plasticity index versus residual friction angle for tropical soils showing results of this work (modified from Rigo et al. 2006)

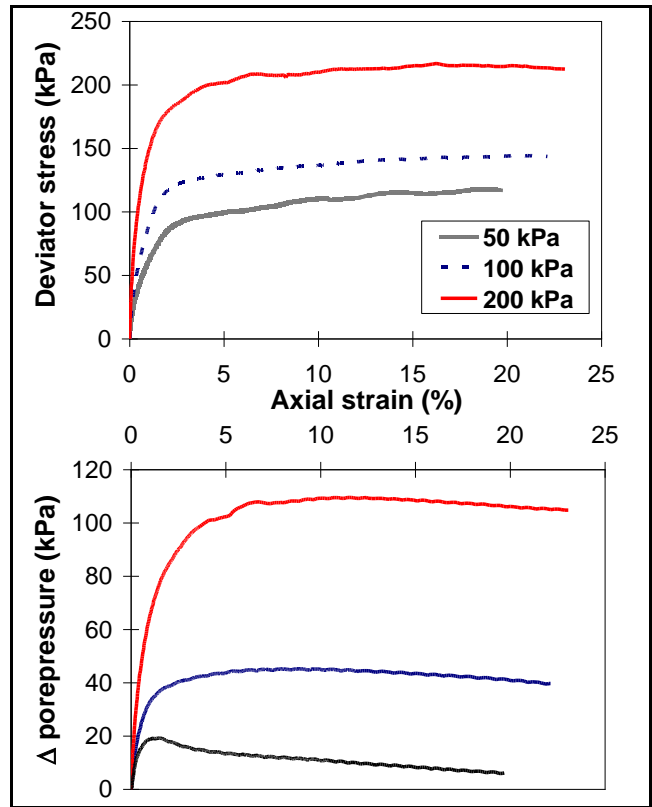
The results of CIU triaxial tests on remolded specimens are shown in Figures 8 and 9. The first presents the stress- strain curves and the second the effective stress paths found.

The effective stress path test with $\sigma_c = 50$ kPa shows a typical behavior of dense materials (due to compaction), with clear curvature to the right. The tests with $\sigma_c = 100$ kPa and 200 kPa show changing behaviors with greater tendency to the vertical or even to the left of the graph. It is interesting to observe that the TTE of the 3 tests reaches a well defined straight envelope of failure (kf line).

Figure 8. Deviator stress and pore-pressure versus axial strain curves obtained on CIU triaxial tests on remolded specimens

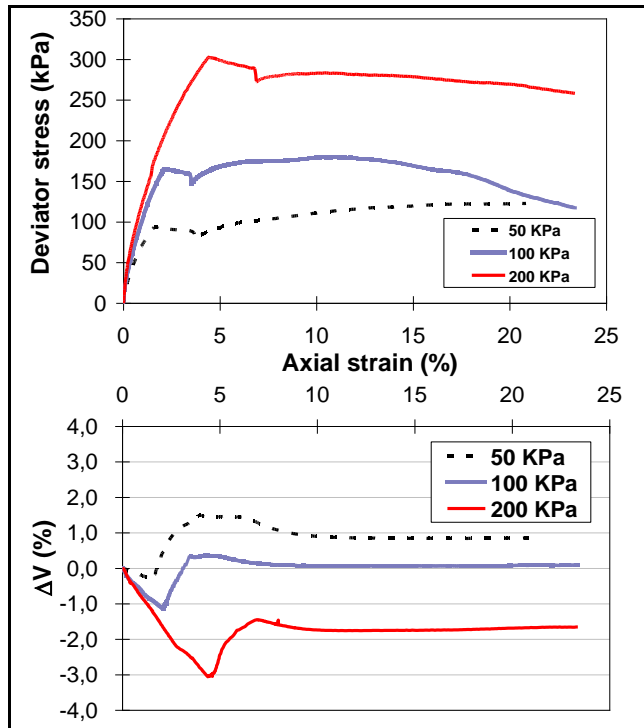
Figure 10 shows the main results obtained from the special CID-U triaxial tests (stress-axial strain and volumetric strain – axial strain) and Figure 11 shows the effective stress paths (ESP) partly induced on the specimens (see methodology above).

Figure 10. Deviator stress and volumetric strain versus axial strain on special CID-U tests

In these tests during the stage of pore pressure increase there was a slightly tendency to reduce the shear strength, until close to failure, when there was a clear drop of shear stress. The amount of axial strain up to this point varied depending of the confining stress applied (2-5%).

Using results of triaxial CID-U it was possible to verify the influence of elevation of pore pressure in this soil. Close to failure, the tendency to reduce the shear stress was very marked, and difficult to maintain the specified value. This may indicate a certain degree of soil brittleness.

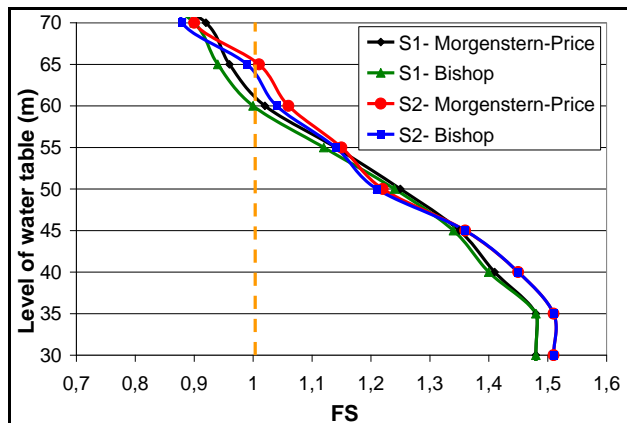
Figure 13. Factors of safety in relation to the water level inside the slope (SlopeW results)

Figure 13 shows the FS as a function of the adopted water level. In the figure is clear the small difference between both methods of analysis. As the water level was increased from 35 m, the FS reduced almost linearly reaching the value of 1 around 59m. In this condition the obtained failure surface was in agreement with the observed field geometry.

It is interesting to note that when trying to perform these simulations using shear strength parameters of large deformations (or residual condition) the FS drop to values close to 0.5, even without the water level. This shows that when the stability of the slope is influenced by these parameters, which may occur after a certain level of straining, the slope will present a major reduction in its stability condition. Such reduction on stability condition could induce the very quick failure reported by the eye witnesses.

The stability analyses using the reconstructed topography showed that the FS of the slope becomes very close to 1 when the water level reaches the elevation 59m.
