Case history: Continuous flight auger (cfa) piling at coastal region in the island of Madagascar

Tatsuo Iryo
SNC-Lavalin Inc, Vancouver, BC, Canada
Hafeez Baba & Farbod Saadat
SNC-Lavalin Inc, Toronto, ON, Canada
Edward Kolakowski
SNC-Lavalin Inc, Oakville, ON, Canada

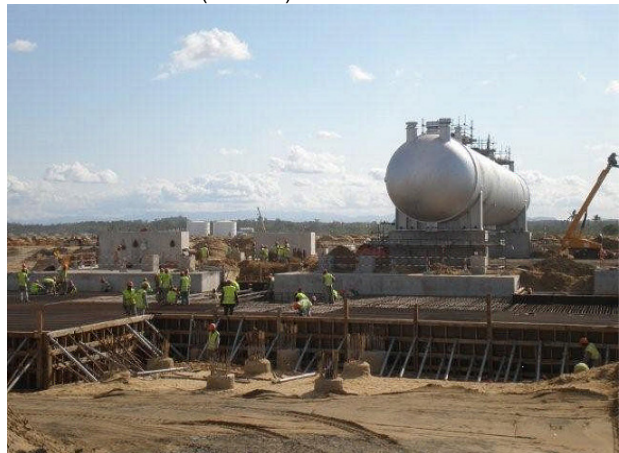
Figure 1. Autoclave Installed at the Process Plant

The process plant site of Ambatovy Nickel Project is located at the east coast of the island of Madagascar. The plant site, approximately 200 hectare, accommodates numerous units and large equipment for mining (Nickel and Cobalt) process. Figure 1 presents a view of one of the major pieces of equipment. Major structures required deep foundation due to heavy loadings and small total and differential settlement tolerances. Relatively loose ground condition and high wind loads due to frequent cyclones also contributed to the deep foundation selection. Several deep foundation alternatives were considered during detail design stage. CFA (Continuous Flight Auger) / ACIP (Augered Cast-In-Place) piles were selected since they provided a cost and schedule effective foundation system, and allowed construction on multi fronts within the facility. Piles were 16 m long with diameters of 600 and 750 mm. A specialized international piling contractor with experienced operators was selected. Pile installation was monitored continuously.

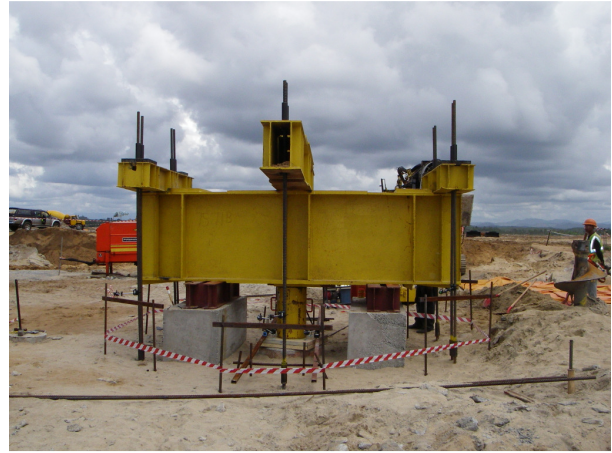
Figure 5 shows the loading system used for the compression test. The load was applied by a hydraulic jack supported by the loading frame. Four anchor piles were installed for each test pile. Relevant measured items were the loading on top of pile, the settlement of pile head, the displacement of tell-tale (if available) and the movement of anchor piles. Tell-tales made of steel bar were installed at the pile tip of some test piles. The load applied on top of pile was calculated based on reading of a pressure gauge of the hydraulic jack, which was verified by calibrated load cell utilized for some of the compression tests. The pile head settlement was measured by four dial gauges equally spaced and supported by two independent steel beams. The system was modified for the uplift test so that the hydraulic jack pulls up test pile instead of compressing it.

Figure 5. Loading Frame

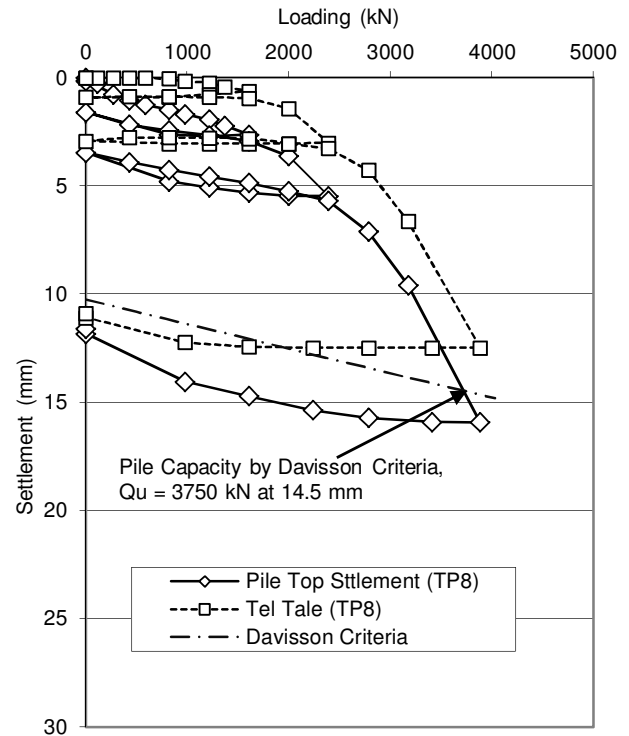
The pile head settlement and loading curve from the compression test on TP8 is shown in Figure 6 as a typical compression test result. TP8 was equipped with a tell-tale at the tip of the pile, thus displacement of the tell-tale and loading curve was recorded as shown in Figure 6.

Both the pile head and the tell-tale loading curves show smooth hyperbolic shape. After applying Davisson failure criteria (Eq. [10] (Canadian Geotechnical Society (2006)), the pile capacity was estimated to be 3750 kN for a corresponding pile head settlement of 14.5 mm.

Figure 6. Typical Compression Test Result

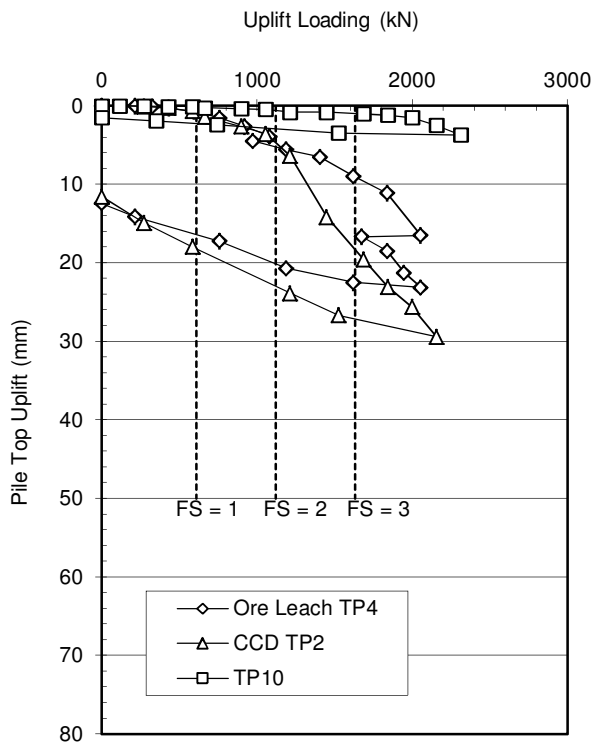
Pile top displacement (upward) and uplift loading curves from three load tests are shown in Figure 8, along with three lines specifying FS = 1, 2 and 3 based on the design value. The results seem to vary as the compression tests. However, a FS = 2 was achieved at uplift displacement less than 10 mm in all tests. Thus it was confirmed that a satisfactory uplift capacity was achievable.

Figure 8. Summary of Uplift Tests

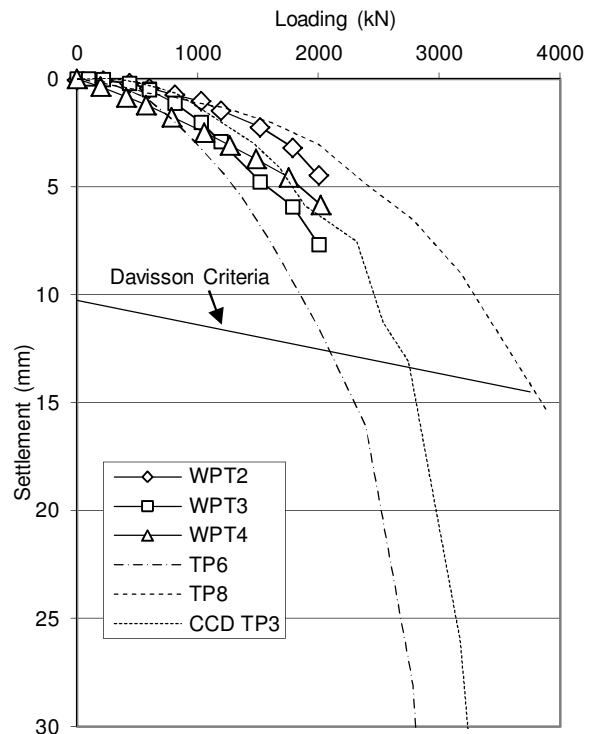
Load tests were also conducted on five production piles throughout the period of pile production as summarized in Table 3. The maximum applied load was approximately 150% of the designed load, that is 2000kN for piles with D (diameter) = 750 mm and 1500 kN for piles with $D = 600$ mm. Figure 9 shows the pile head settlement versus applied load curves from three tests on the piles with $D = 750$ mm along with the test piles discussed earlier.

The curves falls within the range of those of the test piles, i.e. the production piles performed as expected based on the behaviours of the test piles, and their performances were considered to be satisfactory. This provided further confidence on the pile production.

Figure 9. Summary of Compression Test on Production Piles

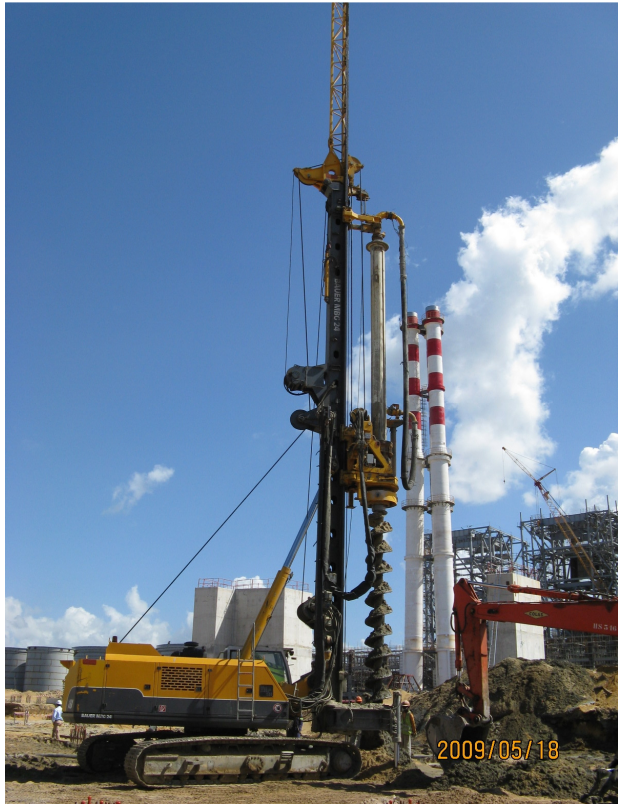
device and recorded various aspects of piling, e.g. concrete pressure, auger lifting rate, concrete flow rate, auger torque, auger rotation rate and drill rate. One of the CFA piling rigs utilized for this project is shown on Figure 10.

Figure 10. Typical CFA Piling Rig
