Soil Cracks related to land subsidence. The main geotechnical hazard affecting to constructions in Aguascalientes City, México.

2011 Pan-Am CGS
Geotechnical Conference

J. Pacheco-Martínez, M.E. Zermeño-De-León & J. A. Ortiz-Lozano
CCDC de la UAA, Aguascalientes, México
A. Solís-Pinto
CGeA-Consultores en Geociencias Aplicadas S.C., Aguascalientes, México
Miguel A. Romero-Navarro
MARN-Servicios en Geotecnia, Aguascalientes, México
Francisco Aguilar-Valdez
CITIA-Ciencia de la Tierra Asesores, Aguascalientes, México
Juan A. López-Fuentes
GEO-Geofísica y Geotecnia Aplicada, Aguascalientes, México

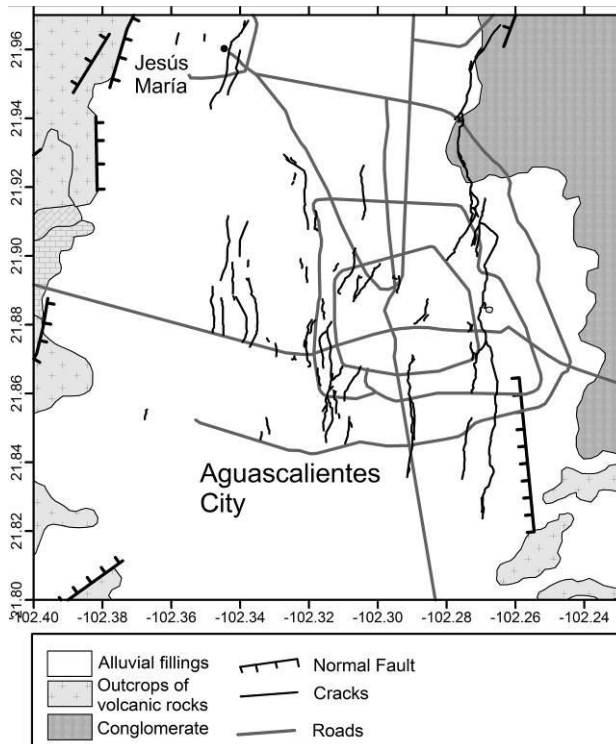
The cracks are widely spread over the entire valley of Aguascaliente, however its effects are more critical in the urban zones, mainly in the City of Aguascalientes (figure 2), At this place, the cracks have been inventoried and included in cartography that is annually updated by the office of public works of the municipality of Aguascalientes (SIDDIS ,2010).

The soil cracks at present are of several kilometres in length. Initially, they start as cracks with only some centimetres in width, but according to observations in the AGSV, their width can enlarge until near to 4 meters by the erosion, which is caused mainly by the rain. There are not measurements about their depth, but It was estimated that they can reach several tens of meters depth (Pacheco et al. 2006).

Figure 2. Soil cracks in the urban zone of Aguascalientes city
