Geotechnical aspects of damages in Concepción, due to the M_w 8.8 Chile earthquake on February 27, 2010

Manuel J. Mendoza¹, Efraín Ovando¹, Felipe A. Villalobos², Miguel Rodríguez¹ & Paulo Oróstegui³

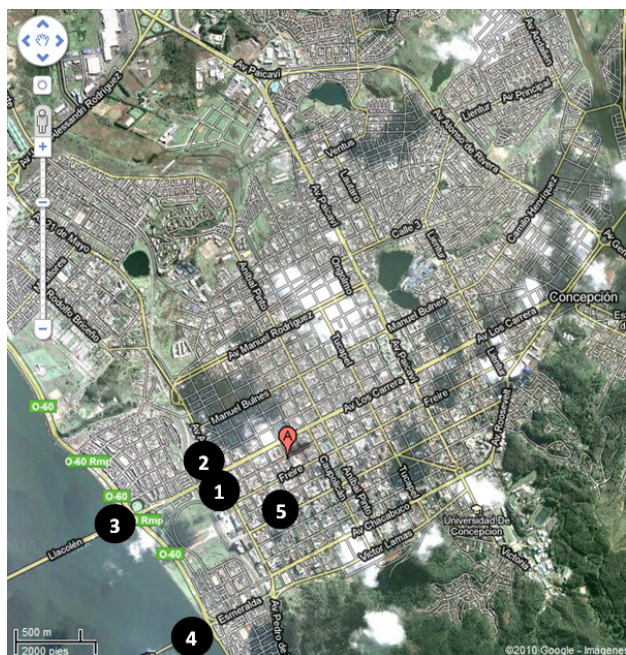
Although damage to constructions is appreciated all over the city, a zone stands out where the damage is more accentuated. The zone is a quadrant of no more than one kilometer per side next to the Bío Bío river, at the height of the Llacolén bridge that connects to the commune of San Pedro La Paz; the following collapses occurred there, which are identified in Fig. 6:

As mentioned before, the five sites indicated in Fig. 6 with collapsed structures fall precisely in Zone I of Concepción's seismic zoning, where in particular the subsoil responds with a natural period of up to 1.7

Figure 6. Satellite view of Concepción, Chile “(taken from Google 2010)”. (Figure numbers are included)

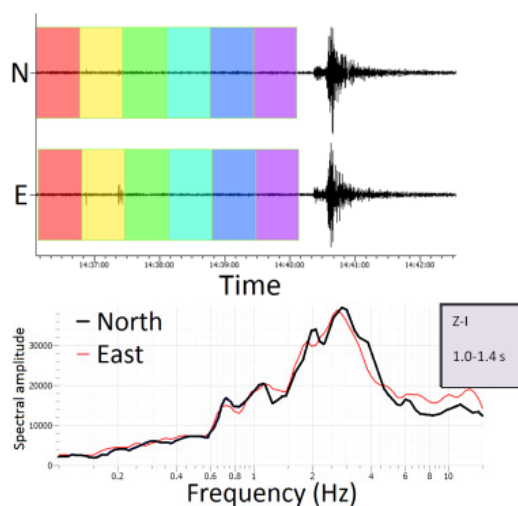
The records of environmental noise presented here, Fig. 8, correspond to the horizontal and orthogonal directions among them, measured on the sidewalk, some 50 meters from O'Higgins tower. Both the amplitude spectra of these records and those obtained from the recording of a replica, Fig. 9, which occurred just as measurements were being recorded, show similar spectral shape, but with different relative amplitude.

Figure 8. Speeds recorded and spectral amplitudes measured on sidewalk near O'Higgins tower in Concepción, 2010-03-13 (Six windows of 40 seconds each were recorded).

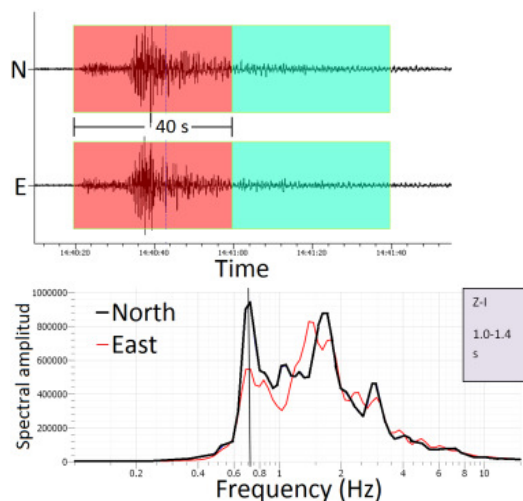
Figure 9. Replica's accelerograms and spectral amplitudes recorded and measured at sidewalk near O'Higgins tower in Concepción, Chile.

The event's spectrum has a very clear spectral maximum on approximately 0.71 Hz, in both components. Also, there are two additional maximums, on approximately 1.4 Hz for the east component and 1.6 for the north component, as well as another one near 3 Hz. The amplitudes associated to the spectral maximums are smaller for increasing frequencies. Both the difference in dominant frequency –certainly significant– associated to the maximum near 1.5 Hz, and the fact that this maximum is not manifested in the noise spectrum, stand out.

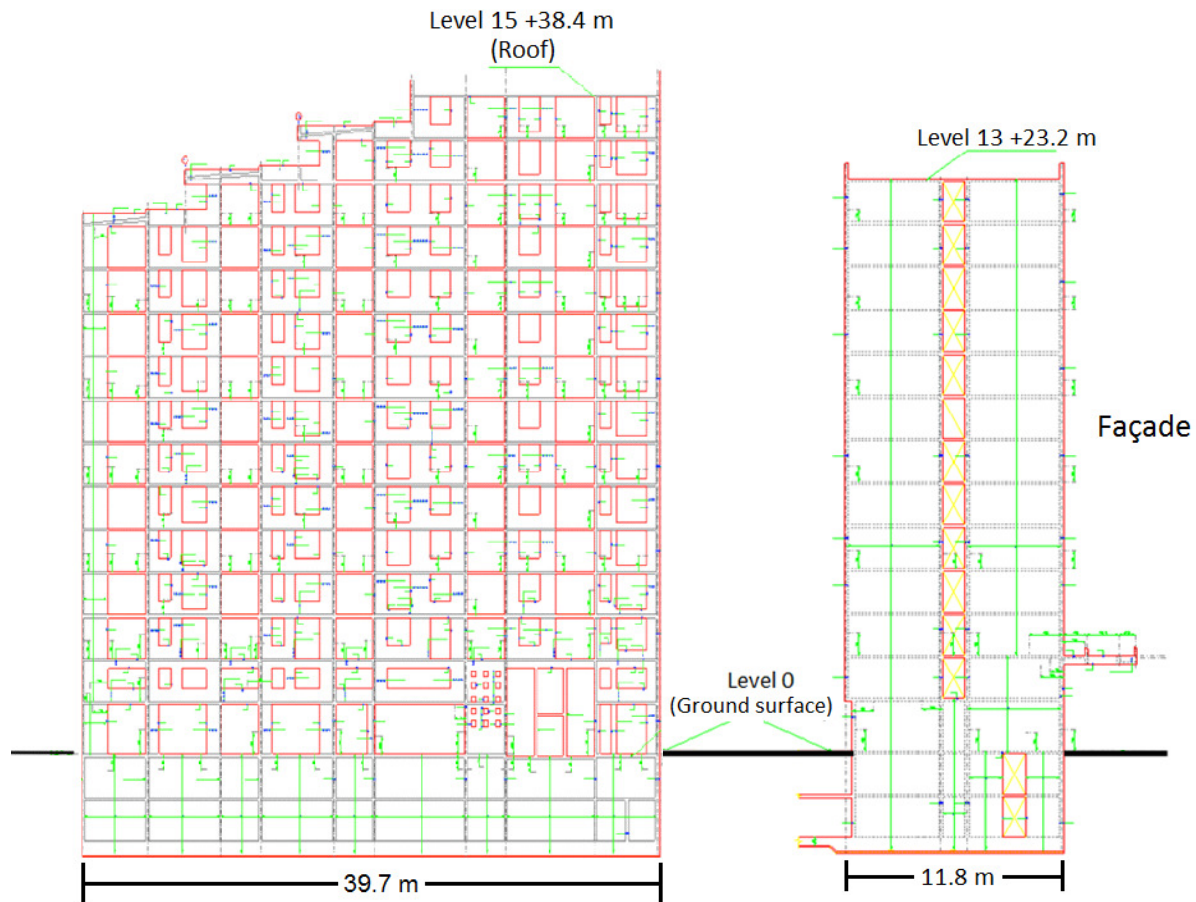
With respect to the behavior of its foundation, the Alto Río building that completely overturned in Concepción, Fig. 1, deserves a particular review. The construction had 14 floors and two basements. Fig. 20 shows a longitudinal cut of the building, which had a floor plan proportion of length versus width of 3 to 1. The structure consisted of reinforced concrete walls, typically 20 cm thick, and floor slabs also of reinforced concrete, of 15 cm thickness. The building reached a height of approximately 40 m. The foundation was solved with a solid slab of reinforced concrete 80 cm thick in the area under the tower, set from ground level at -5.94 m, from which the concrete walls rose. In the parking area that was located behind the

Figure 20. Longitudinal section of Alto Río building.

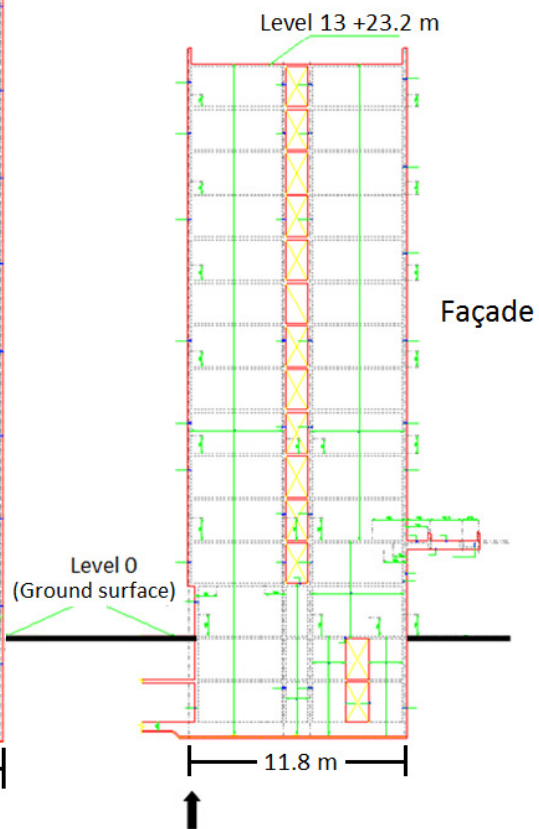
The failure occurred when the vertical elements of the ground floor and/or basements collapsed, apparently from compression, on the vertical back plane opposite that of the façade, indicated with an arrow on Figs. 21 and 22. Fig. 22 shows the ground floor plan, indicating the area occupied by the building itself, and the underground parking behind it and out of its projection. Apparently, the reduction or non existence of walls along the longitudinal axis of the building's back façade, indicated with arrows, seems to have propitiated the failure by compression which, in turn, gave origin to the failure by tension of the front façade's vertical elements. The building as a whole overturned with rotation from the ground floor level, the vertical elements of the façade zone failing by tensile rupture, Fig. 23, and therefore the building fell on its back.

Figure 21. Transversal section of Alto Río building.
