Stability slopes study of dams of Necaxa Hydroelectric System

Nicolás Melchor-García & Roberto Ruedas-Medina
Instituto de Investigaciones Eléctricas, Cuernavaca Morelos, México
Oliver Nava-Tristán
Comisión Federal de Electricidad, México.

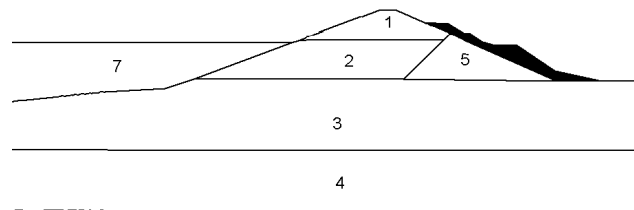
Figure 7. Critical cross section 1, Tenango dam (between landmarks 2 and 3)

thickness of rockfill that covers the finest soil materials. During the drilling of boreholes, drilling mud was lost at different depths. The most outstanding is the borehole on the landmark 2 located on the crest, where the mud was lost to 2.4 m depth, probably due to cracks in the clay or piping.

In the boreholes close to 25-26 y 35 landmarks drilling mud was also lost. The extracted materials were identified as CH and CL. The percentage of fines that passed the No. 200 mesh was generally greater than 90% in almost all samples taken from the hydraulic fill. As for the rockfill, a friction angle of 36° was considered (Marsal, 1975), taking into account that the material was placed to turn and has compacted during its operation period getting more stability. The critical sections of the dam were defined based on the stratigraphy results of the exploratory drilling. Table 1 and Figure 7 present the mechanical properties and permeability of critical sections.

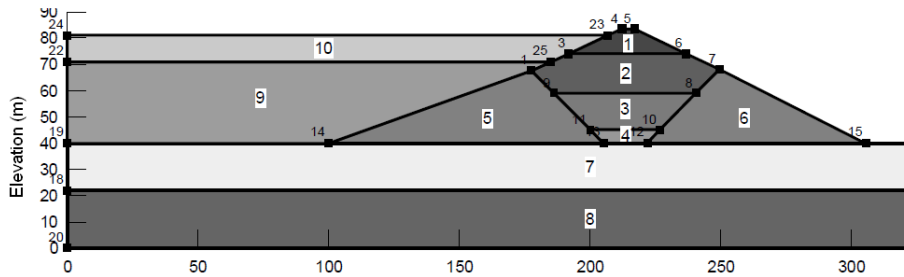
Figure 9. Critical section 1, Nexapa dam

To obtain the material properties of the core of the Nexapa dam, three boreholes were made on the crest: 43, 50 and 60 m deep, respectively. To measure the thickness of rockfill that covers the fine earth materials four boreholes were drilled in the slopes of the curtain. Permeability tests (Lefranc type) were conducted at different depths in the body of the curtain. In the exploration and sampling works, there was not loss of mud, so it can be seen that the curtain has no cracks or piping. Limestone rock makes the foundation of the dam. Its impermeable core could be considered homogeneous according to soil type, but not if the number of blows of SPT and the permeability coefficient are considered. For this reason the critical section was analyzed with the stratigraphy shown in Table 3 and Figure 9. In some drilling, more than 25 blows in the SPT were needed, which is indicative of having a firm consistency.

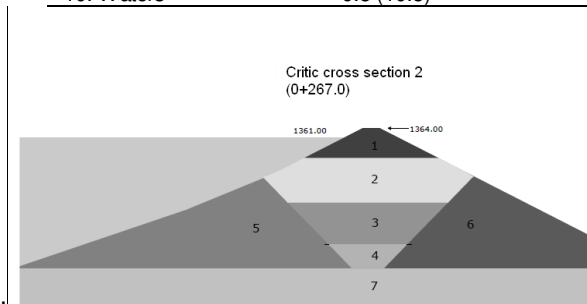
Figure 10. Critical section 2, Los Reyes Dam

The materials found in all the drillings on in the core of the curtain of Los Reyes dam have a heterogeneous composition, ranging from clay particles to sand and gravel. Therefore, an average value of resistance may be considered. The downstream slope is composed of plastic material overlying boulders and rocks packaged in fine materials. In this section of the dam, the Le Franc test showed high permeability.

One of the critical sections for analysis was selected where the body of the dam is founded on a natural slope which contains fine soil (silty-clay).

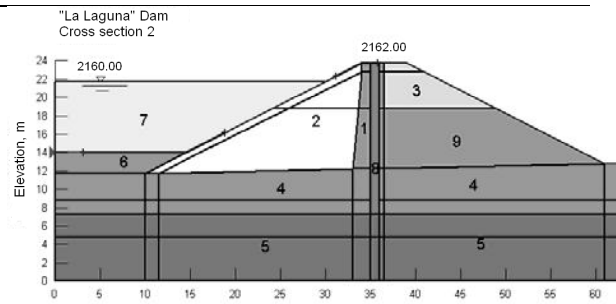
Figure 11. Critical section 2, La Laguna Dam

At La Laguna Dam, 4 borings were made in the core (9, 17, 20 and 21 m deep) and 6 boreholes on the slopes of the curtain to detect the thickness of rockfill that covers the fine earth materials (15 m deep). Permeability tests were conducted at different depths, both on the material of the curtain as on the natural support soil. The materials found in the upstream slope, in general show a soft, low resistance, with a high degree of uniformity in the longitudinal direction. The core material shows a large variability in permeability and resistance. In the most superficial zone there is low permeability silty material, which is followed by very permeable boulders and gravel. The foundation of the curtain is made up of cracked basalt rock with signs of injections in some places and disturbed basalt of varying thickness, also reported by Marsal and Resendiz (1975). Table 5 and Figure 11 present a summary of the material properties of the La Laguna dam.
