# Field and laboratory procedures for investigating the fouling process within railway track ballast

2011 Pan-Am CGS Geotechnical Conference

Brennan Bailey, D. Jean Hutchinson & Duncan Gordon Department of Geological Sciences and Geological Engineering, Queen's University, and the GeoEngineering Centre at Queen's-RMC, Kingston, Ontario, Canada Greg Siemens Department of Civil Engineering, Royal Military College of Canada, and the GeoEngineering Centre at Queen's-RMC, Kingston, Ontario, Canada Mario Ruel CN Rail, Montreal, Quebec, Canada

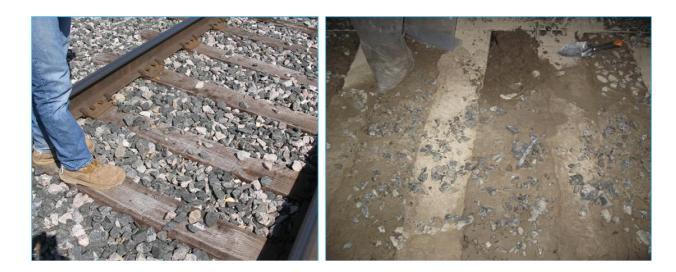
Figure 1. Exposure of clean ballast (left) and heavily fouled ballast (right), on the surface of the rail embankment.

The fouling of railway ballast, wherein fine grained materials become mixed with the coarse aggregate used to construct the rail track bed, is a wide-spread issue for railways world-wide. Eventually, as fouling progresses, the fine grained material will accumulate on the ballast surface, as shown in Figure 1.

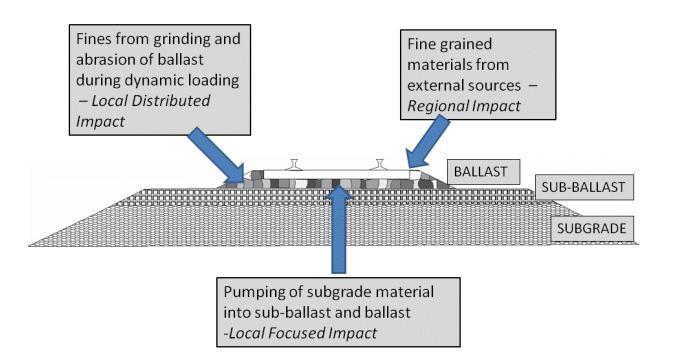
Figure 3. Potential sources of fouling materials within railway embankments.

The three primary hypotheses postulated to describe the possible modes of fouling were used as the main criteria for designing the field and laboratory work. The possible modes are in-place abrasion of ballast (with local, distributed impact), intrusion from an external source (with regional impact), and pumping of subgrade through the ballast (with local, focused impact) (Figure 3).

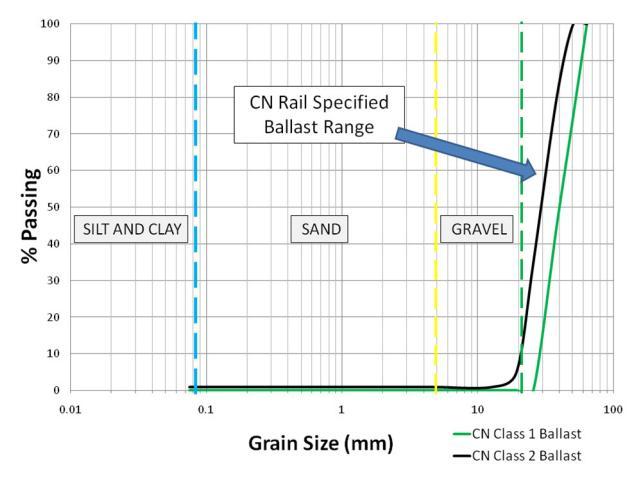
Figure 4:Grain size distribution for CN Specified ballast, based on CN Specification (1996).

The 1996 Canadian National Railway's Specification for Crushed Rock Ballast calls for specific criteria to ensure durability and stability of the ballast layer. The grain size distribution range for fresh ballast is presented in Table 1 and Figure 4.

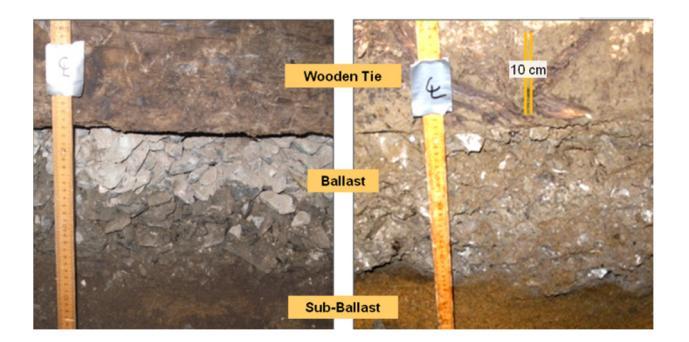
Figure 5: Examples of the condition of the ballast under the centre of the wooden tie. Left: Joliette Mile 92.8, lightly fouled; Right: Joliette Mile 98.7, heavily fouled. 3.2 Trenching

The apparent fouling severity of the ballast at the study site was also subjectively characterized as high, medium, or low fouling. Examples from trench excavations are shown in Figure 5. The subjective rating of the degree of fouling depended on the amount of mud intrusion observed, and the cohesiveness of the mixture.

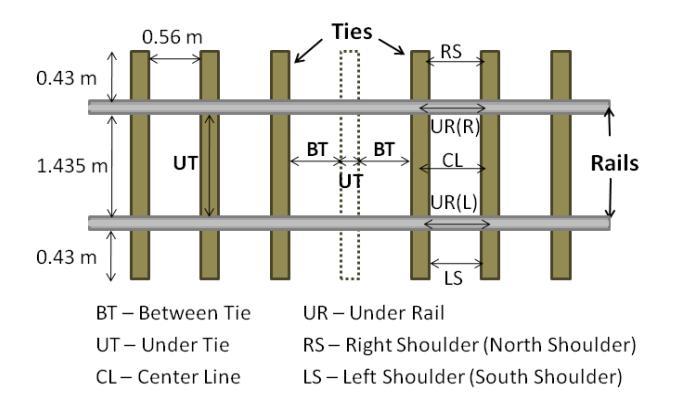
Exploratory trenches were excavated parallel to rail ties and perpendicular to the rail, using a backhoe. The removal of a tie, by CN personnel, was required to provide adequate space for the backhoe shovel to dig a trench between the ties. In the first stage, each trench was excavated to approximately 1m width, 3m length and 1m depth. Samples were taken from the locations and depths defined in Figure 6. Once the trench was completed, in the second stage, samples of the material exposed under the ties were excavated by hand.

Due to the width of the backhoe bucket (~ 60 cm), the first stage samples included material from between the ties and from under the removed tie. Thus, samples coded as BT (between tie) comprise roughly 1/3 of UT (under tie) material and 2/3 of BT (between tie) materials. Lifts of ~15 cm were removed by the backhoe operator at a time to allow for sampling at specific depths and locations within the embankment. The most common sampling depths were: 15 cm, 30 cm, 45 cm, and 60 cm (all relative the top of the ties). The removal of the tie also permitted sampling from the sections of the embankment not otherwise accessible – the shoulder and sections below the rails.

A set of samples was then taken from the trench wall, following the sample location and labelling plan shown in Figure 5. When the ballast was thicker than 30cm under the tie, two samples were taken from the bottom of the tie to 15 cm below, and from 15 cm to 30 cm below. If there was not sufficient ballast thickness within the trench, only a single sample could be taken under the rail and tie.

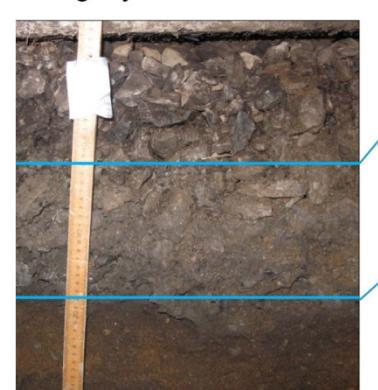
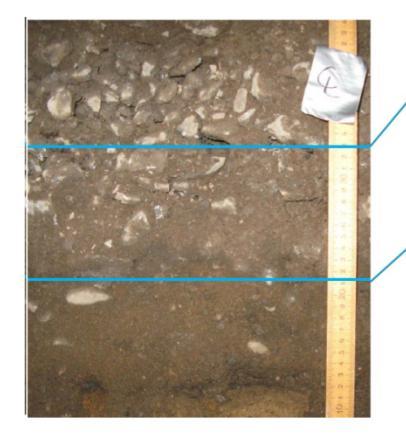
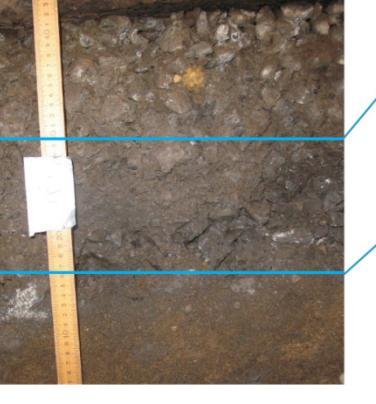
Lightly Fouled Mile 97.0

Moderately Fouled Mile 100.2

Highly Fouled Mile 98.9

The results of the analysis of grain size distribution for samples rated as highly, moderately and lightly fouled, are shown in Figure 8. The results indicate that the proportion of fine grained material contained within the ballast increases, with an increase in the observed degree of fouling, as would be expected.

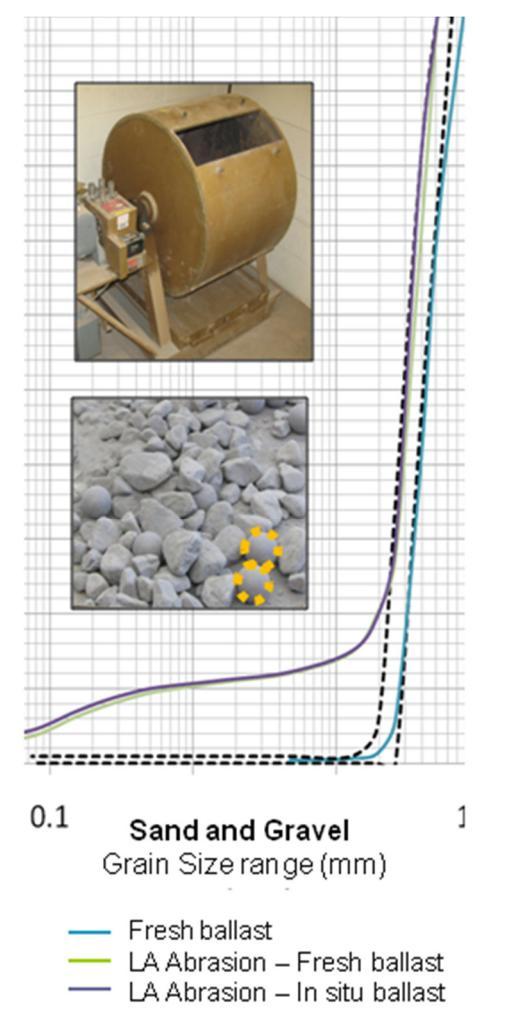
Figure 10: Average LA abrasion results on fresh and mixed samples of gravel sized ballast. Samples were created in accordance with ASTM C131.3530-1.

The overall results of the LA abrasion tests, shown in Figure 10, indicate that while fine grained materials are produced during the tests, they are not as fine as the particles found in-situ.

The duration and loading mechanism of the test appears to simulate the loss of weight from the larger diameter particles, but does not simulate the further breakdown of the finer particles produced during the test. This result is discussed in more detail in Bailey et al (2011, this conference).

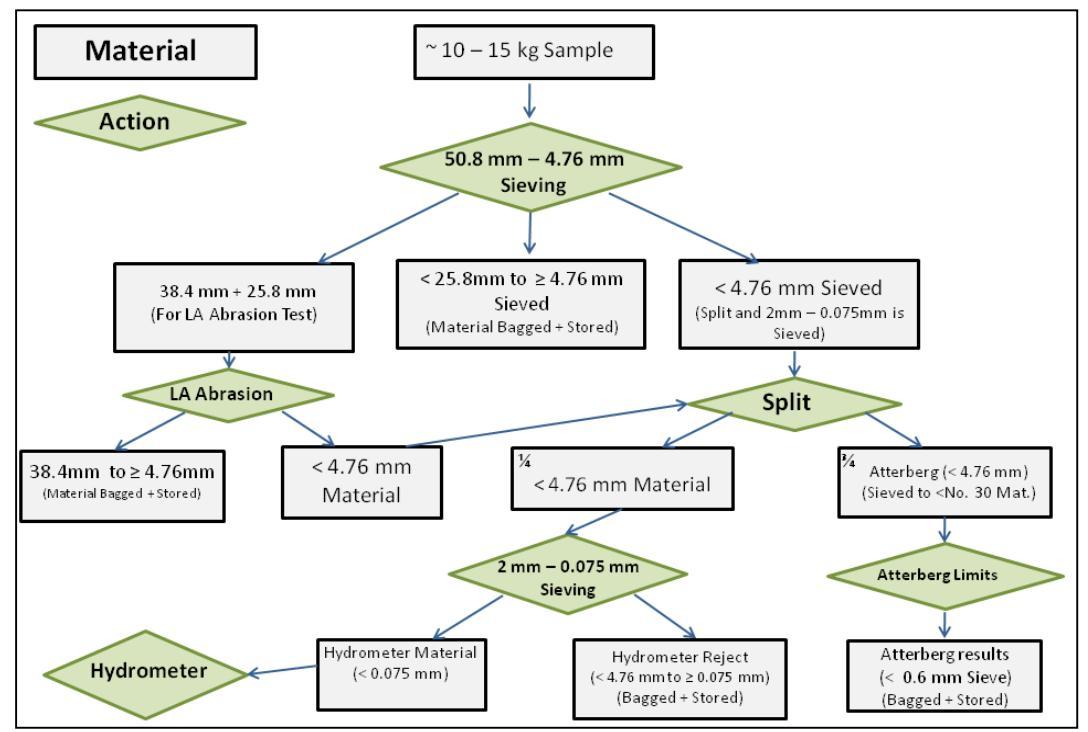
Figure 7: Laboratory work flow for processing ballast and sub-ballast samples.

Five separate laboratory procedures were used to procure geotechnical data from the ballast sampled. The five tests include: large pan sieving, small stack sieving, hydrometer testing, LA Abrasion testing, and Atterberg limits. A workflow diagram of the laboratory procedures is presented in Figure 7.
