Challenges faced in design & construction of 12 m high geosynthetic reinforced soil slope repair in urban setting

2011 Pan-Am CGS Geotechnical Conference

Philip A. Perzia, P.Eng. FORZA! GeoSolutions, Toronto, Ontario, Canada Michael J. Simons, P.Eng. Maccaferri Canada Ltd., Cambridge, Ontario, Canada

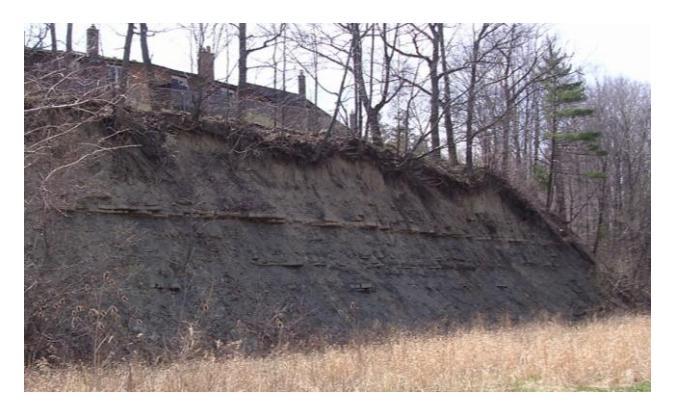
Figure 1. Failed slope (north is to the right). Layers of shale bedrock are visible. Note townhouses above.

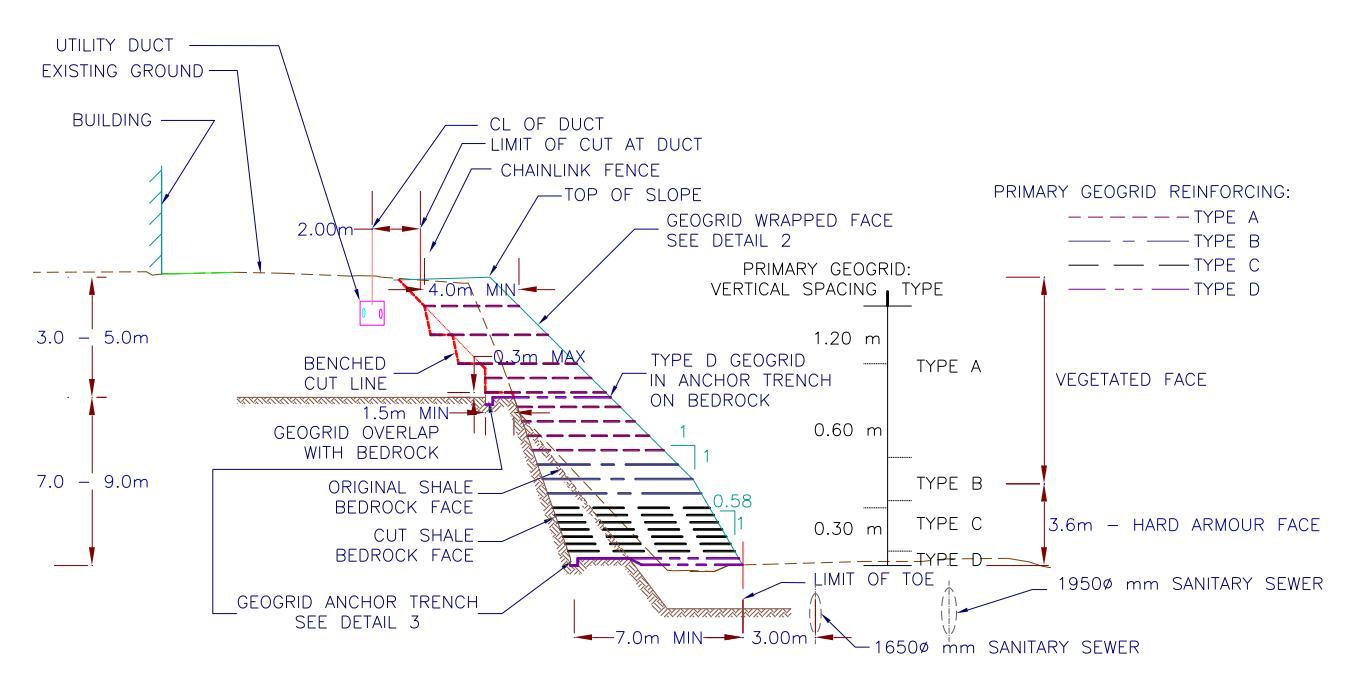
Figure 2. Original design cross-section through compound slope near north end. Note proximity of sanitary sewers just beyond the toe of the proposed slope repair.

A compound, vegetated reinforced soil slope was determined to be the most appropriate solution in this area. The final geometry consisted of a 60° angle at the bottom of the slope intersecting with a 45° angle coming down from the proposed shoulder of slope. The toe of the 60° slope started at the edge of the zone of influence of the nearest sanitary sewer.

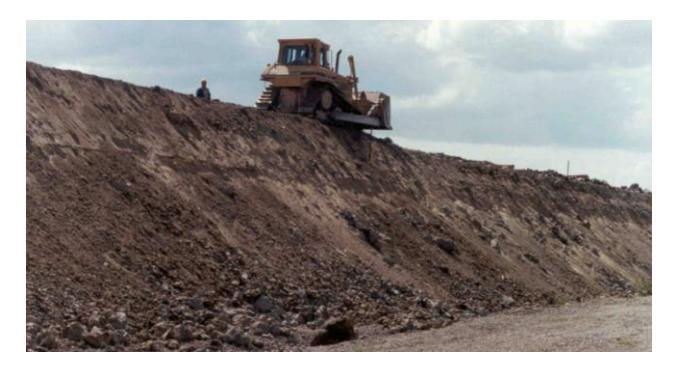
In Figure 3, the 11 m high, 45° slope shown under construction in 1993 on the Highway 407 Electronic Toll Route (ETR) just north of Toronto, Ontario demonstrates

how secondary reinforcing aids in the surficial stability of the face, allowing for heavy construction equipment to operate right up to the edge of the slope. Such heavy equipment would not be permitted to operate this close to the face of a reinforced soil retaining wall system.

Figure 3. Highway 407 ETR - Secondary geogrid reinforcing in slope face helps support heavy equipment operating along edge of 45° slope during construction.

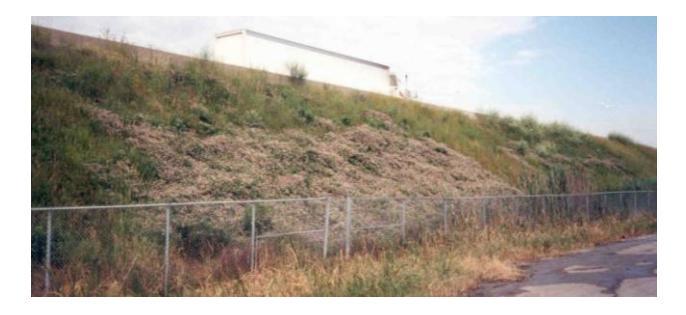
In order to help vegetate the original 45° geogrid reinforced soil slopes constructed nearly 30 years ago, a thin layer of topsoil, less than 25 mm, was spread on the surface of the slope onto a flat, net-like geosynthetic that was draped down the slope face. In 1983, one of the first geogrid reinforced soil slopes ever constructed in North and South America utilized this technique. Approximately 1 km of MTO's Highway 410 in Brampton, Ontario is supported by a 45° vegetated slope that reaches up to 8 m in height as seen in Figure 4.

Figure 4. MTO Highway 410 - One of the first geogrid reinforced soil structures built in the Americas: an 8 m high, 45° vegetated slope supporting a major highway for nearly 30 years.

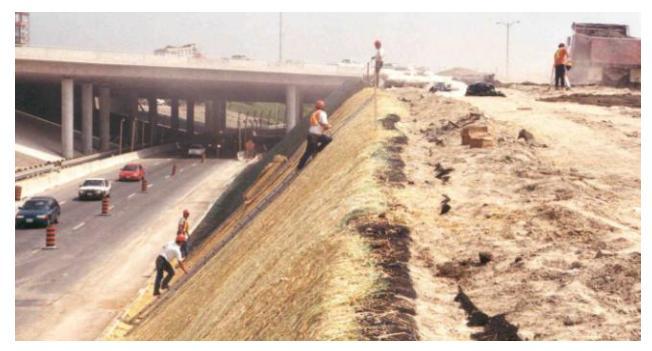
In 1994, six 45° slopes were constructed using this technique during the widening of MTO's Highway 401 near the Rouge River in Toronto, Ontario (see Figure 5).

Figure 5. MTO Highway 401 onramp - Biodegradable straw erosion control blanket being installed over topsoil filled and hydro-seeded TRM on 8 m high 45° slope.

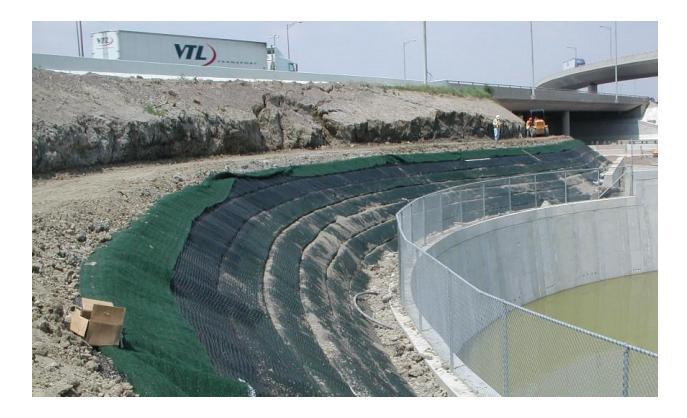
One of the first major projects to incorporate this technique was during the reconstruction of the Highway 427 and Highway 409 interchange in 2001 in Toronto, Ontario for MTO. A 45° slope was required to support an on ramp that circled a storm water management facility (see Figure 6).

Figure 6. MTO Highway 409 onramp - Construction of 45° slope with geogrid wrapped face to contain and support 300 mm of topsoil in face of slope.

A 0.6 m high wrap was created with a biaxial geogrid. Inside the face of the wrap, a non-biodegradable permanent erosion control blanket was installed. In the middle of the wrap, a horizontal layer of secondary biaxial geogrid was installed unless a layer of the primary uniaxial geogrid was to be installed at that elevation. This resulted in a vertical spacing of geogrid in the face zone of 0.3 m for the entire height of the slope. This helped increase the stability of the face, in particular during construction.

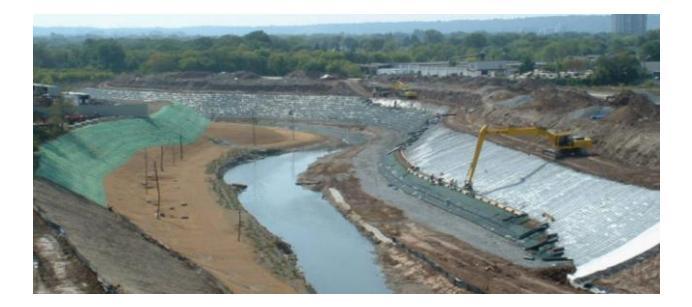
In 2002, this same wrapped face technique was used to help stabilize a 1.2 m thick soil veneer directly on the uniaxial veneer support geogrid and allow for vegetation to grow on the 1.5H:1V slope on the aforementioned Rennie Street Landfill project (see Figure 7).

Figure 7. Rennie Street Landfill - On right bank, geogrid wrapped face is used to help stabilize soil veneer on GCL cap lining system. Anchor trenches were used to support the uniaxial soil veneer geogrid and GCL cap liner.

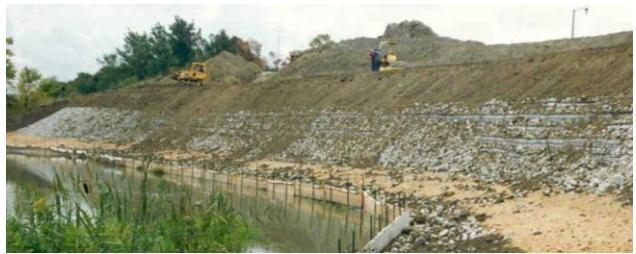
In 1993, a 9 m high, 45° geogrid reinforced soil slope was constructed along the Humber River in Vaughan, Ontario to help support a residential subdivision. This project also required the approval of the TRCA. The bottom 3 m of the slope was covered in riprap as the hard armour. The riprap was then filled with topsoil (see Figure 8) and hydro-seeded with a native wildflower seed mix. Once the vegetation was established, the hard armour was barely visible (see Figure 9). As far as the authors are aware, this was the first use of vegetated hard armour.

Figure 8. Humber River - 45° slope supporting residential subdivision under construction. Riprap filled with topsoil to create vegetated hard armour.

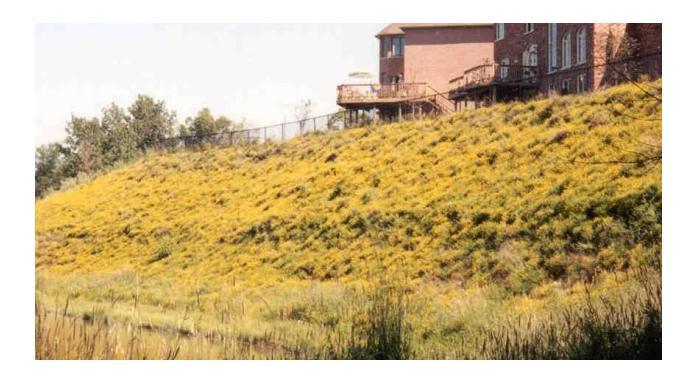
Figure 9. Humber River - 9 m high, fully vegetated, engineered structure blends in with natural ravine environment.

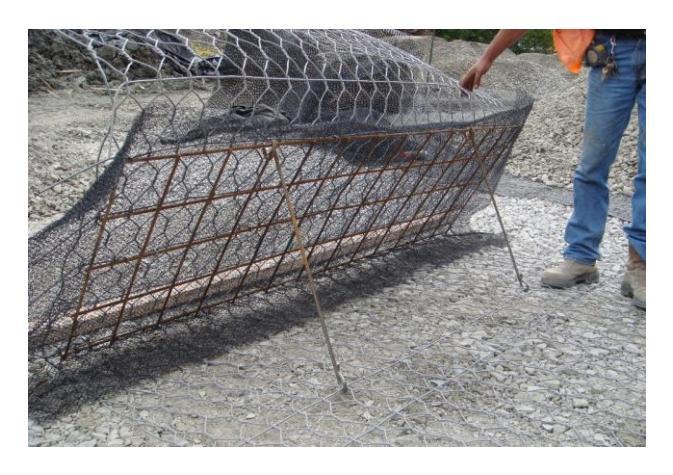
Figure 10. 60° face created with stay-in-place woven wire mesh supported by welded wire mesh with permanent erosion control blanket sandwiched in between.

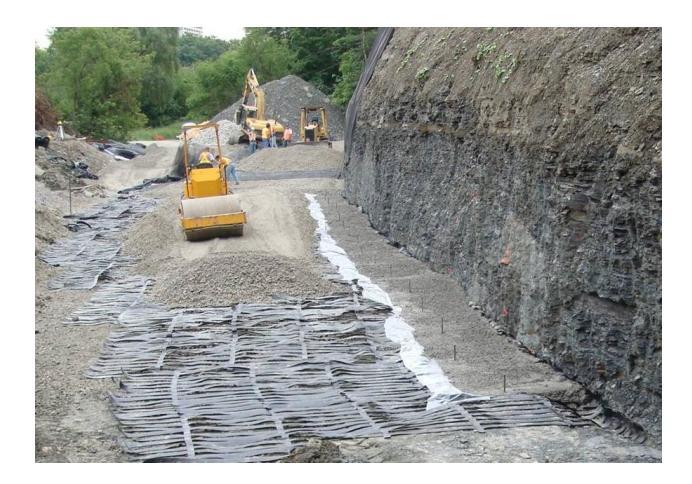
One of the unforeseen construction challenges was encountered during the installation of the anchor trenches for the two high-strength layers of primary geogrid reinforcing. For part of the bottom anchor trench, the shale bedrock was breaking apart too much and not allowing for an actual trench to be formed. As shown in Figure 11, the anchoring of the geogrid to the bedrock in this area was enhanced by using concrete as the backfill material for the trench and by installing vertical rebars through the concrete and geogrid into the bedrock. Concrete ended up being used as the backfill for all of the lower and upper anchor trenches to maximize the bond between the geogrid and the bedrock.

Figure 11. High-strength primary geogrid being installed in anchor trench. Concrete was used to fill anchor trench with Granular B used to cover rest of geogrid. The layer of geogrid at 0.3 m vertical spacing at the face of a 45° slope significantly helps with constructability because it helps support construction equipment near the face. However, placing the 0.3 m layer thick of topsoil is a challenge. A useful technique contractors have employed, including on this project, is to create a series of movable wooden forms as demonstrated in Figure 12. The face of the formwork is set at 45° at the location of the finished face. The reinforced fill is placed to within 0.3 m of the finished face. The topsoil is then placed between the reinforced fill and the temporary formwork and lightly compacted.

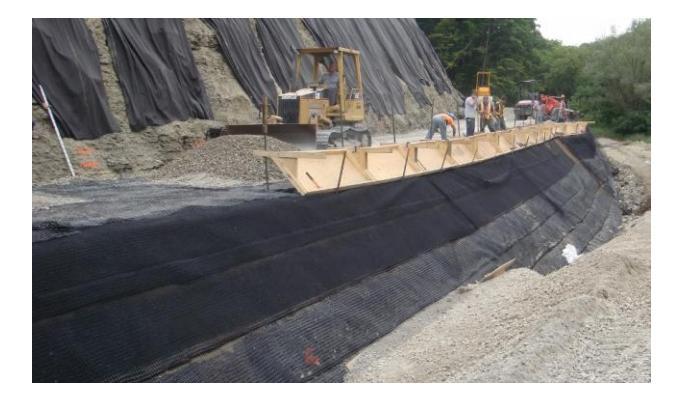
Figure 12. Temporary wood formwork used to help create 45° angle face in geogrid wrap.

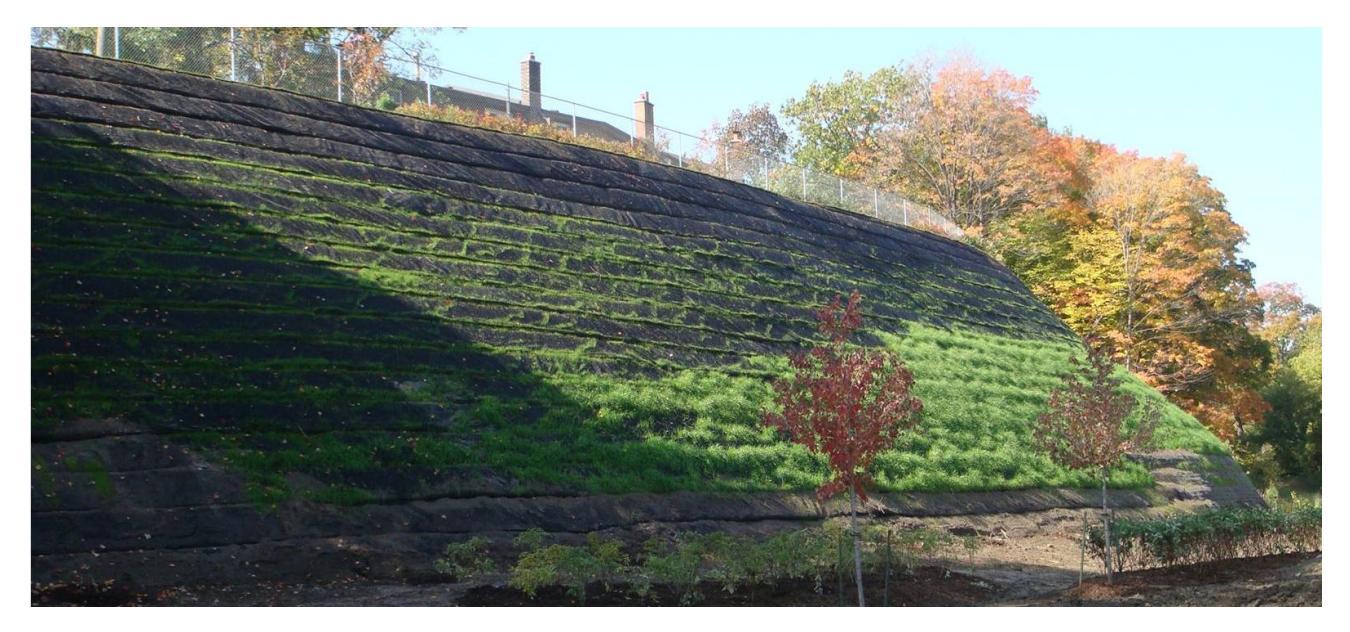
Construction was successfully completed on schedule and within budget in the autumn of 2008 (see Figure 13). Since then, the geogrid reinforced soil slope appears stable and the slope face is well vegetated.

Figure 13. Geogrid reinforced soil slope after completion of construction. At north end, note 60° face with 45° above.

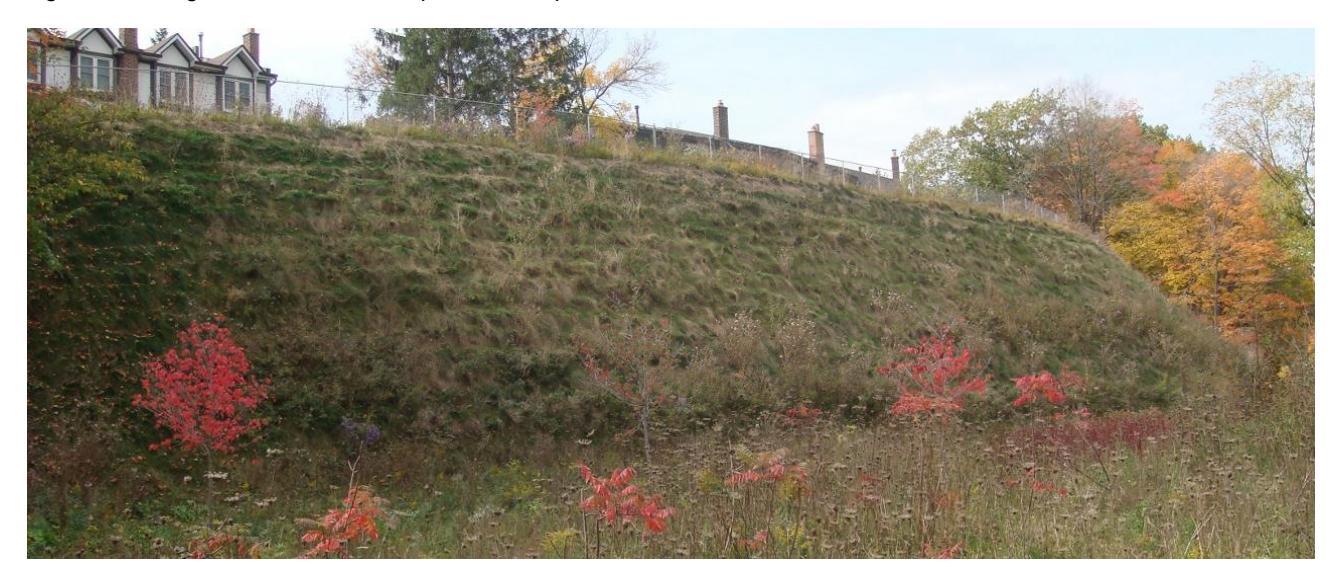
The use of geosynthetics in the design and construction of this slope failure repair made the project technically and economically feasible. In addition to allowing for the construction of a stable slope, geosynthetics helped this fully engineered structure blend into the natural ravine environment as shown in Figure 14.

Figure 14. Two years later, fully engineered structure beginning to blend in with natural ravine environment.
