# High-pressure puncture testing of HDPE geomembranes

R.W.I. Brachman, R.K. Rowe & H. Irfan  
*GeoEngineering Centre at Queen's-RMC, Queen's University, Kingston,  
Ontario, Canada*  
S. Gudina  
*Stantec Consulting Ltd., Ottawa, Ontario, Canada*

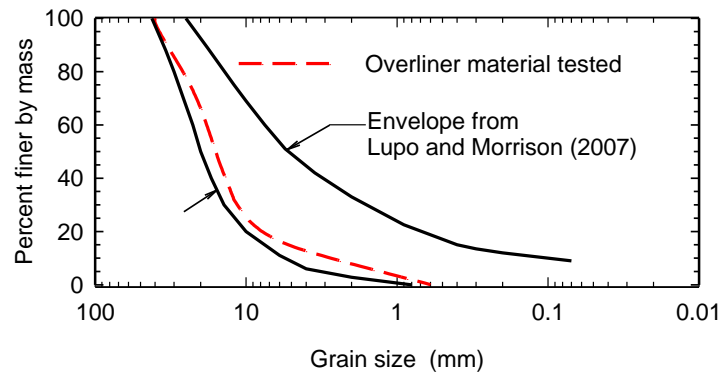
Figure 2. Grain size distribution curve of overliner material tested.

Recognizing that the materials above and below the geomembrane in any heap each project will be site specific, the testing reported here may not necessarily be applicable for different conditions. The grain size envelope of overliner materials from several mining projects compiled by Lupo and Morrison (2007) was used as guidance to select the material placed above the geomembrane in these tests. As shown in Figure 2, the overliner material used in this preliminary study was selected to be towards the coarser limit of their envelope. The coarse particles were crushed from limestone that produced sub-angular with some sub-rounded particles. Material with the same gradation as the overliner but with added silty-sand such that 10% by mass was finer than 2 mm was placed beneath the geomembrane. Figure 3a is a photograph of the resulting surface just beneath the geomembrane where there were discernable voids in between the coarser particles. These conditions are expected to be more extreme than those described by Lupo and Morrison (2007). In test 2, silty-sand was used to fill in the voids between gravel particles in the top layer in contact with the geomembrane, as shown in Figure 3b.

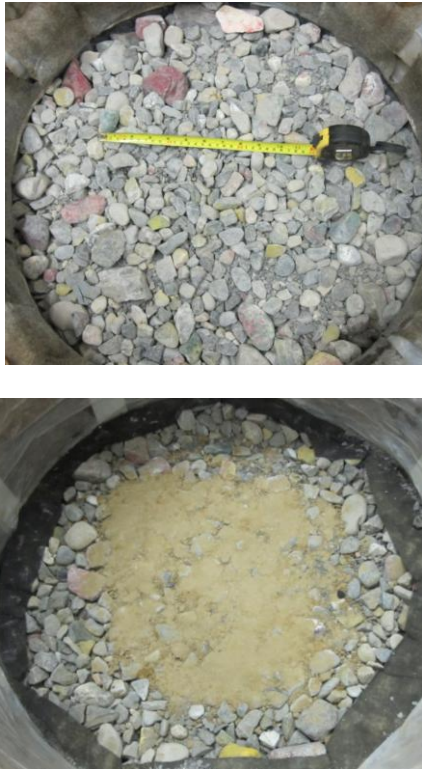
Figure 3. Photographs showing surface directly beneath the geomembrane prior to: a) test 1 and b) test 2.
